Hauser Road Engine Rollover

Facilitated Learning Analysis

On Tuesday, Sept. 12, 2017 a Type 6 Engine was involved in this a rollover accident while returning from a smoke investigation. An isolated storm had turned the clay-based road the engine was traveling on into slippery mud.

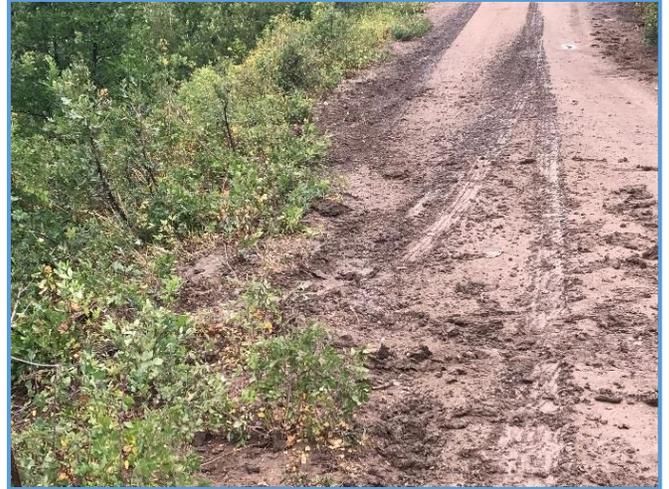
At 1227, Captain 36 called Dispatch and reported the smoke “UTL (*unable to locate*) and that they were returning to station.” As the engine approached a small decline and curve in the road, the engine started to slide in the sticky clay mud. (See photo on right.)

A “perfect horrible alignment” of slope, slick mud and curve in the road all lined up.

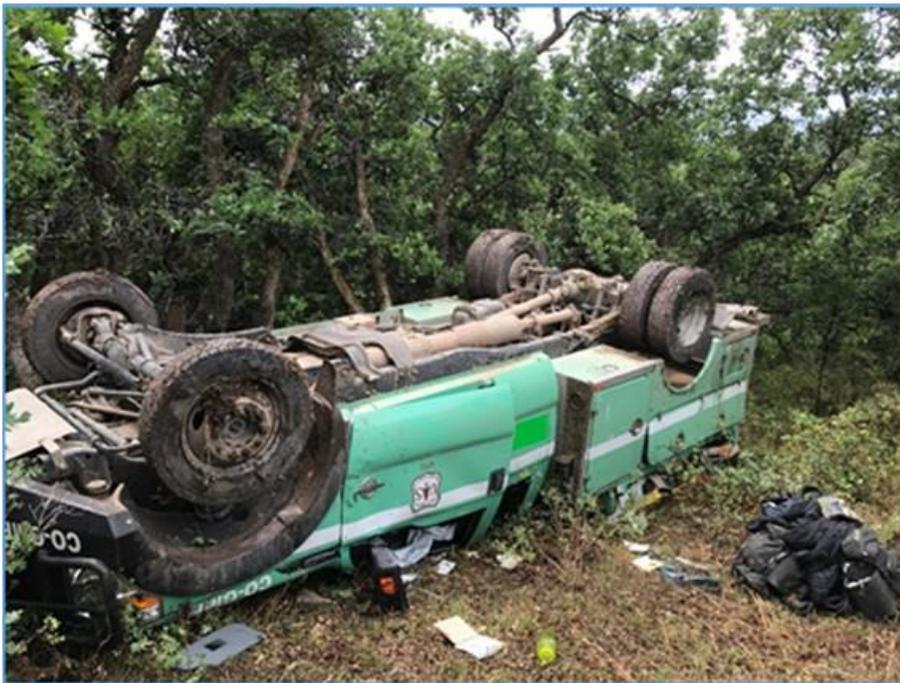
Engine 36 came to rest on its roof, braced against large trunks of oak brush. Everything in the cab came to a stop. A muffled and intermittently eerie buzzing came from the horn. Water hissed. As the crew steadied themselves, calling out to check the status of each other, a loud “pop” from the roof was heard.

As they felt the vehicle’s cab start to give a little bit, the decision was made to exit as quickly as possible. The curtain airbags were still partially inflated. Captain 36 had to deflate them with his personal knife. Exiting out the passenger side window, the crew barely had enough room to crawl out the opening with metal scraping against their backs and stomachs.
