Informational Summary Report of Serious CAL FIRE Injuries, Illnesses, Accidents and Near-Miss Incidents

Jesusita Fire Burnover

Firefighter Burn Injuries with Engine Burnover, and Additional Related Near Miss Incidents

**CA-LPF-001479 – P5EV5C
CA-CSR-000031**

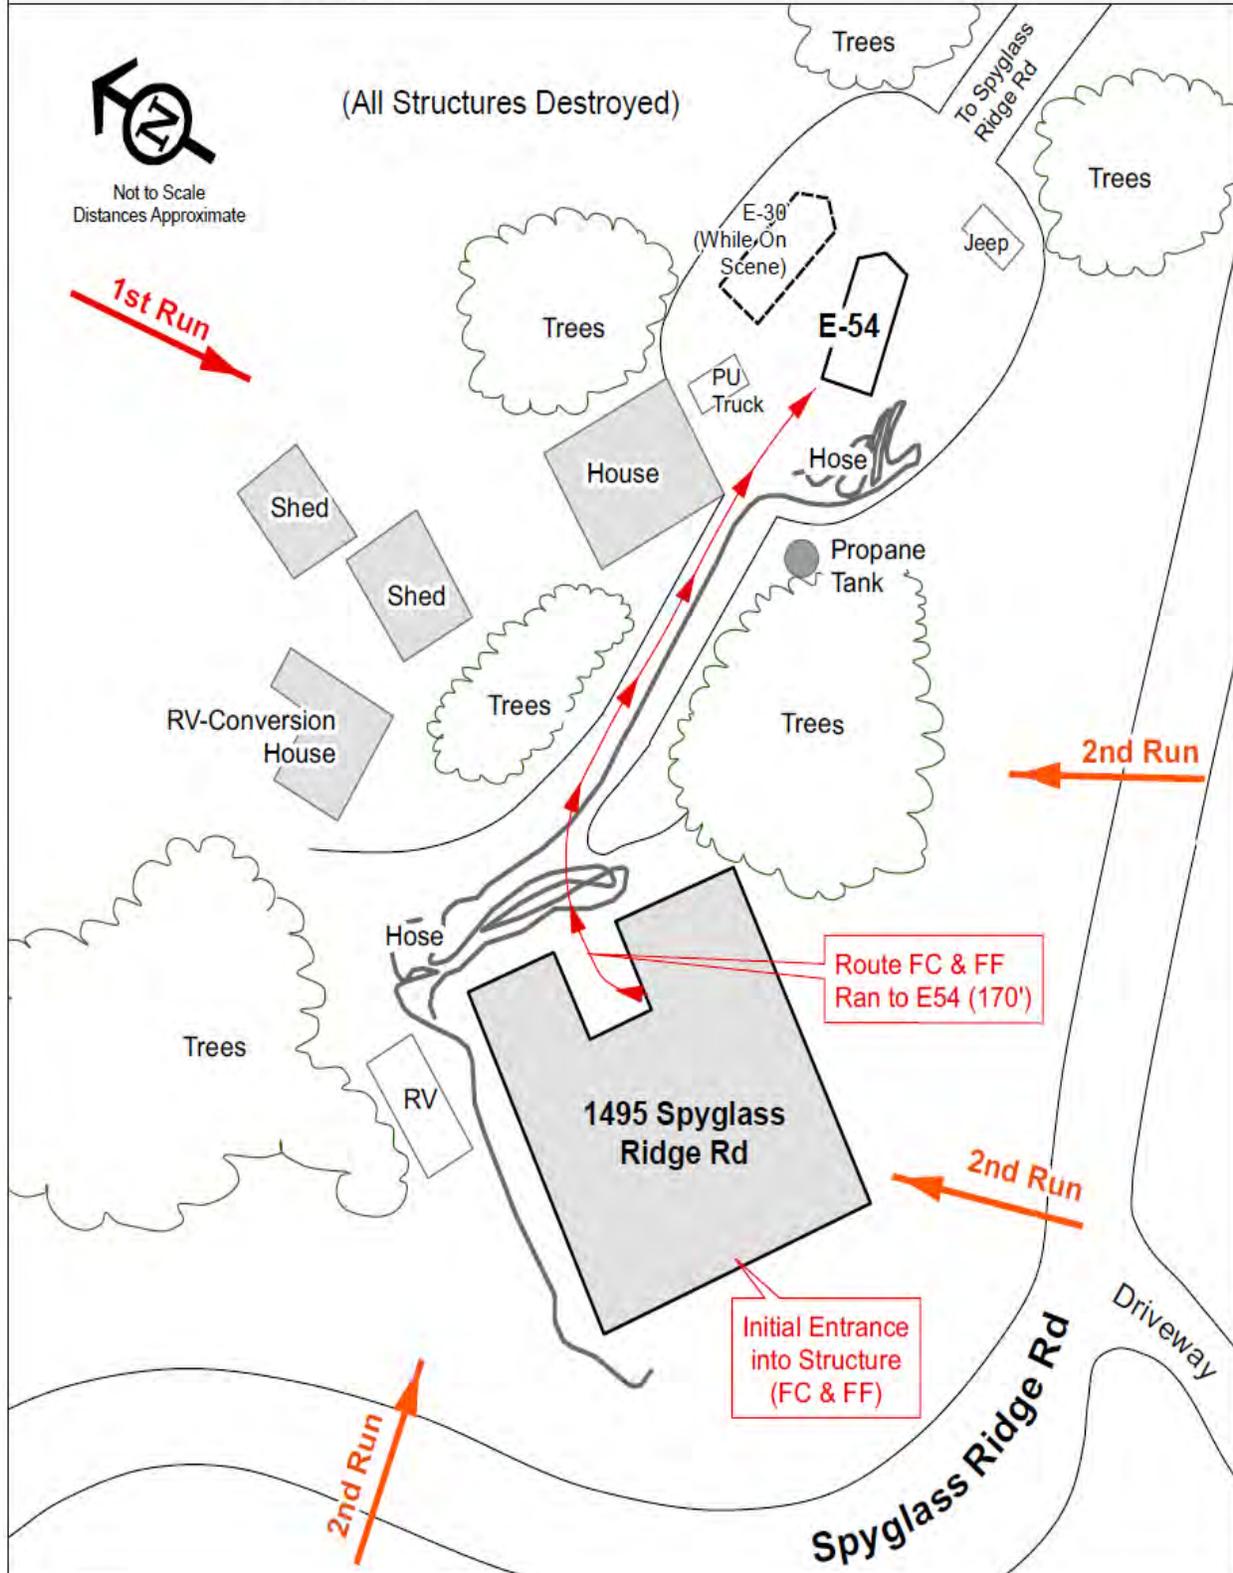
1495 Spyglass Ridge Rd

At approximately 4:00 p.m. the fire made extreme advances towards the Spyglass Ridge Road area. Numerous spot fires caused a condition similar to area ignition around 1495 Spyglass Ridge Road. FC-54 told FF-54 to protect the rear of the main structure. After several minutes of firefighting, FC-54 took FF-54 into the structure, entering through the back door on the Southwest side to wait for the fire to pass. While inside the structure, FF-54 removed his web gear and fire shelter and donned his SCBA. FC-54 also donned his SCBA over his web gear and fire shelter.

As FC-54 and FF-54 exited the structure, FC-54 instantly felt his skin burning. FF-54 fell to the ground as FC-54 ran up the driveway towards E-54. FC-54 thought that FF-54 was attempting to deploy the fire shelter at that location. FC-54 yelled at FF-54 to continue to the fire engine. FC-54 arrived at the fire engine and climbed into the back seat on the passenger side still wearing his SCBA. FC-54 could not locate FF-54 and his low air warning device was sounding on his SCBA.

- VNC E-54 had severe fire damage to the front and left side of the apparatus. The hose bed had major damage from the cribbing and hose that caught fire. The apparatus had a transmission leak along the left frame rail, but was physically driven off the mountain.
- VNC E-30 received minor exterior heat/fire damage.

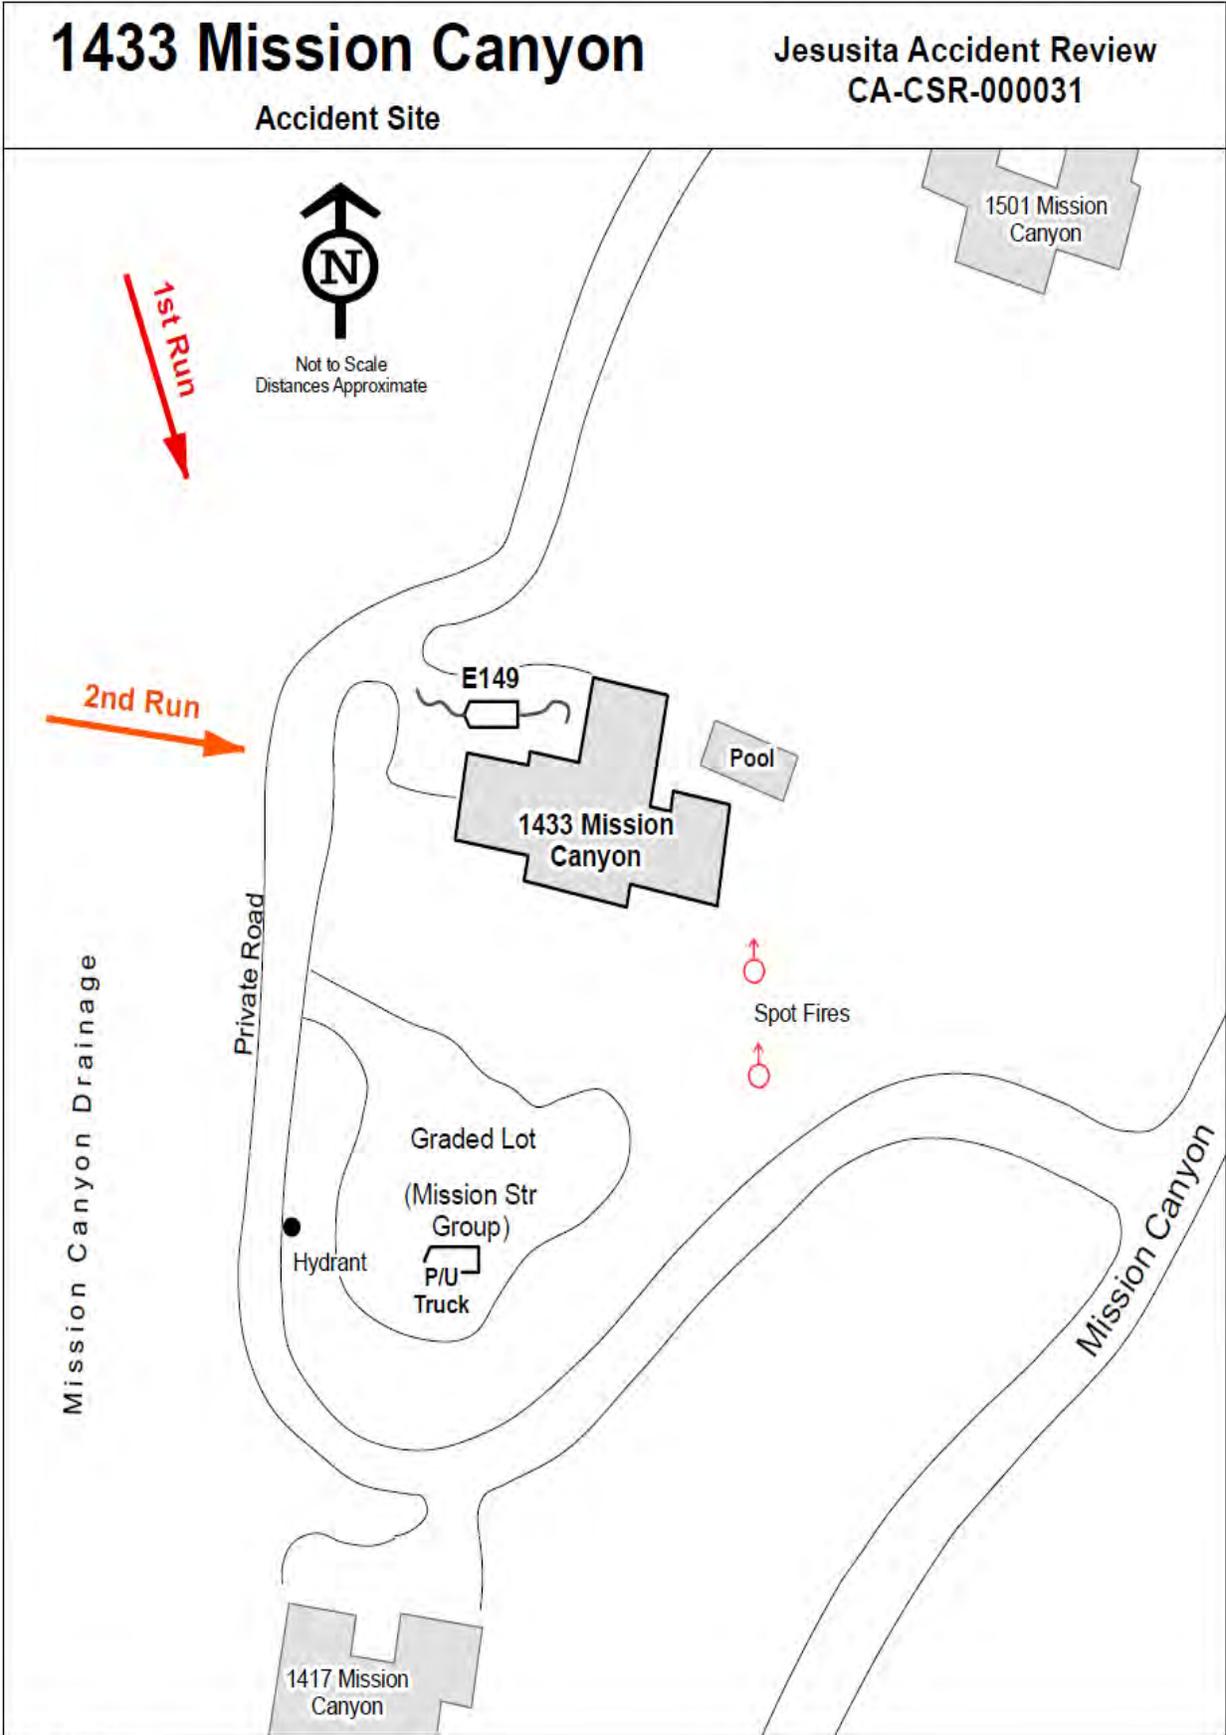
LAC E-149 had the ladder cover with heat/fire damage.

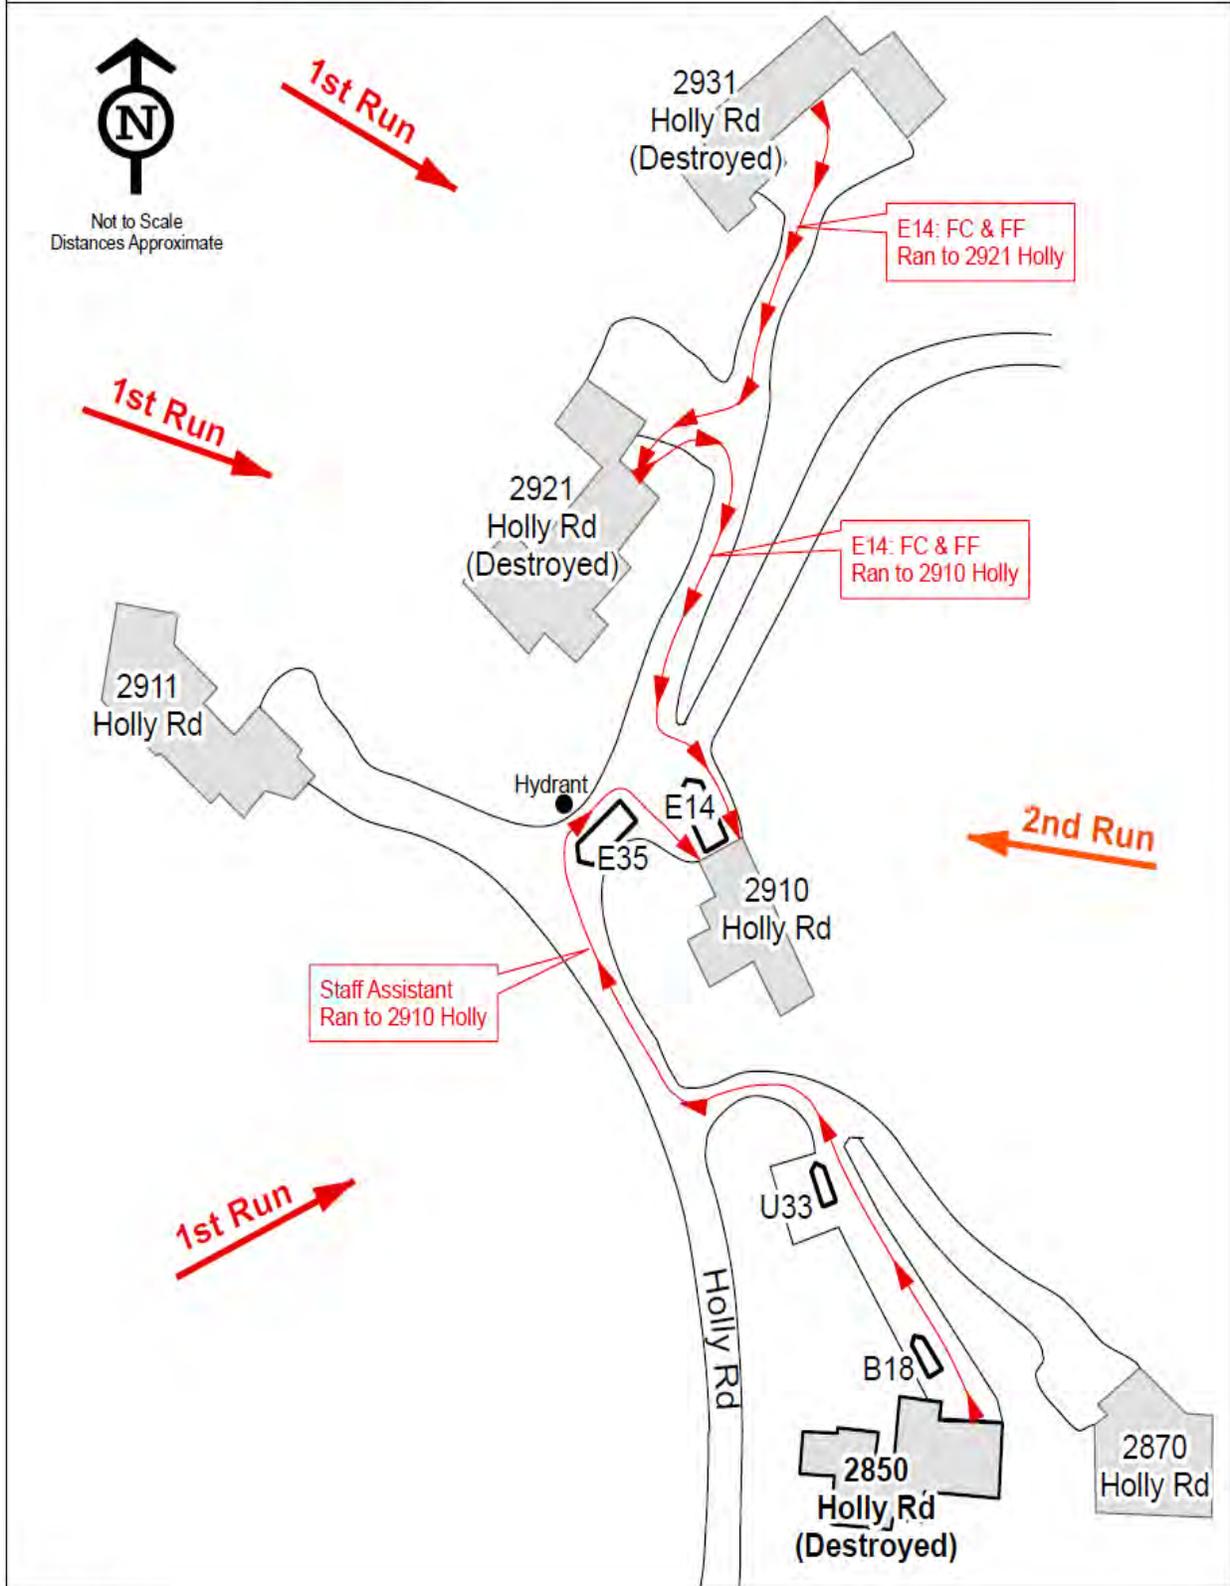
2850 Holly Rd

The Staff Assistant originally took refuge in a structure at 2850 Holly Road and moved to the garage after the front window gave way and the fire moved into the house. The staff assistant moved to the home at 2910 Holly Road when conditions permitted. Eight fire personnel took refuge at 2910 Holly Road and remained there with the five civilians for approximately 20 additional minutes. Structure PPE and 5 SCBA's were brought inside

- LFD B-18 was completely destroyed.
- LFD Utility 33 was completely destroyed.

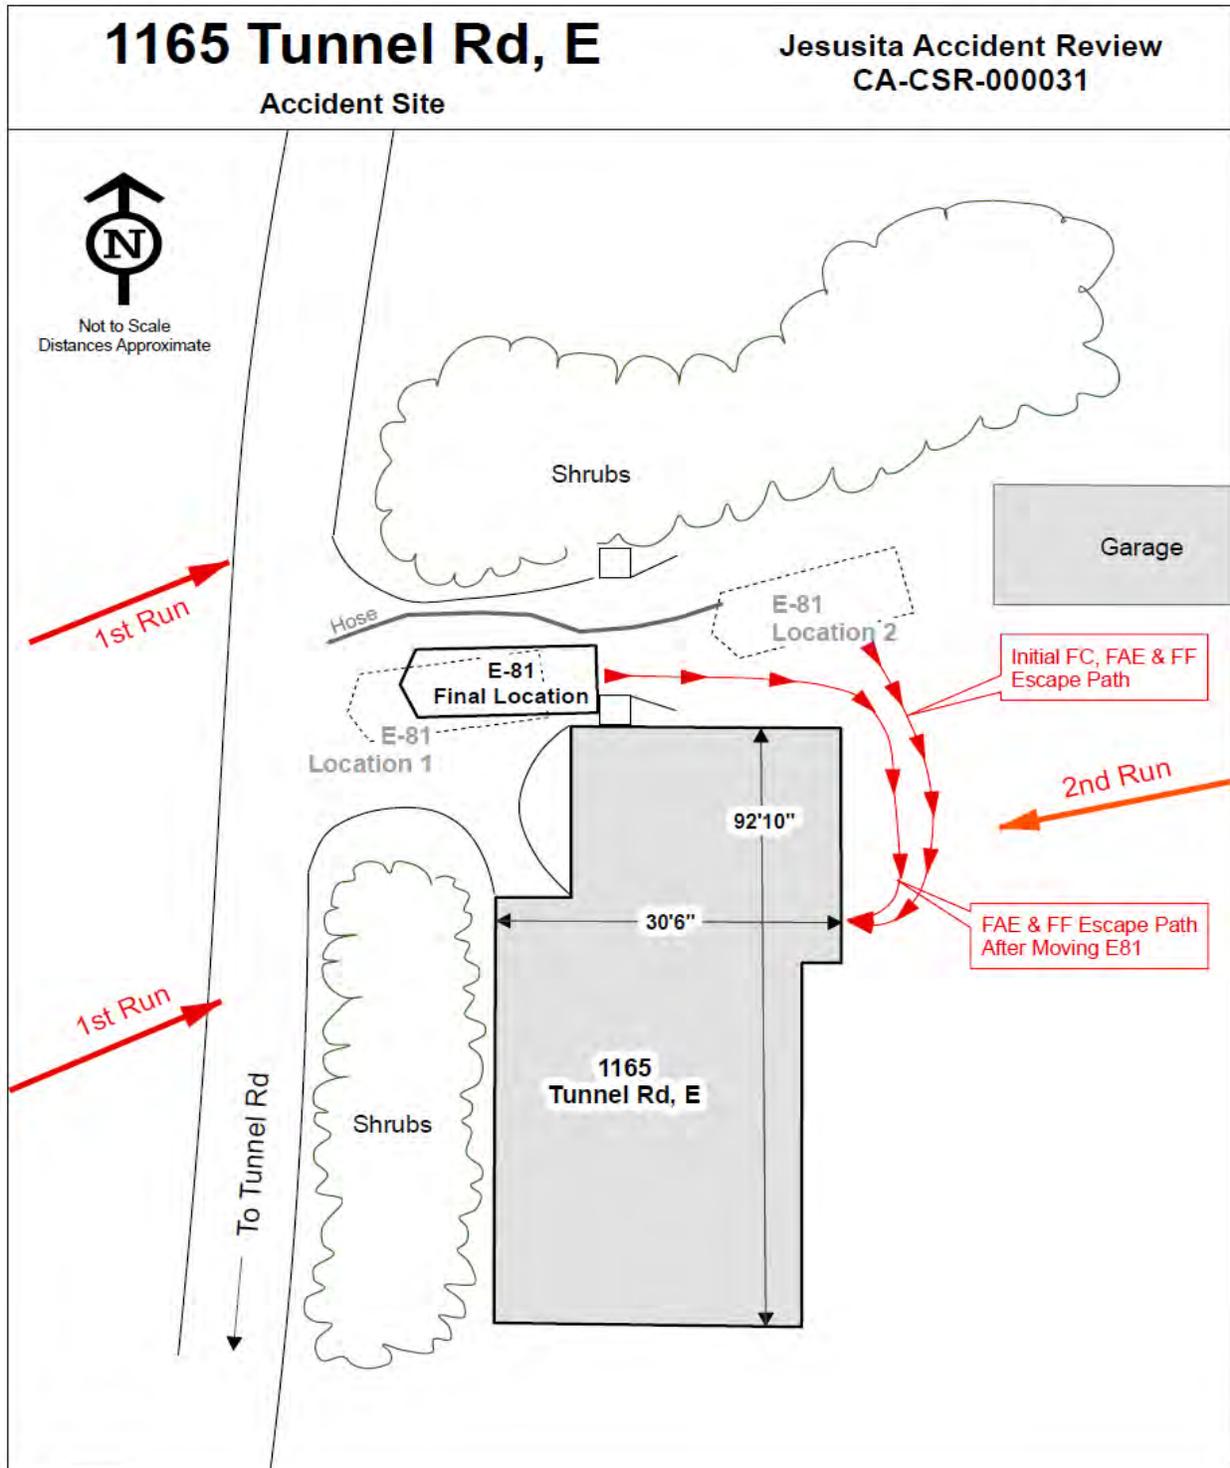
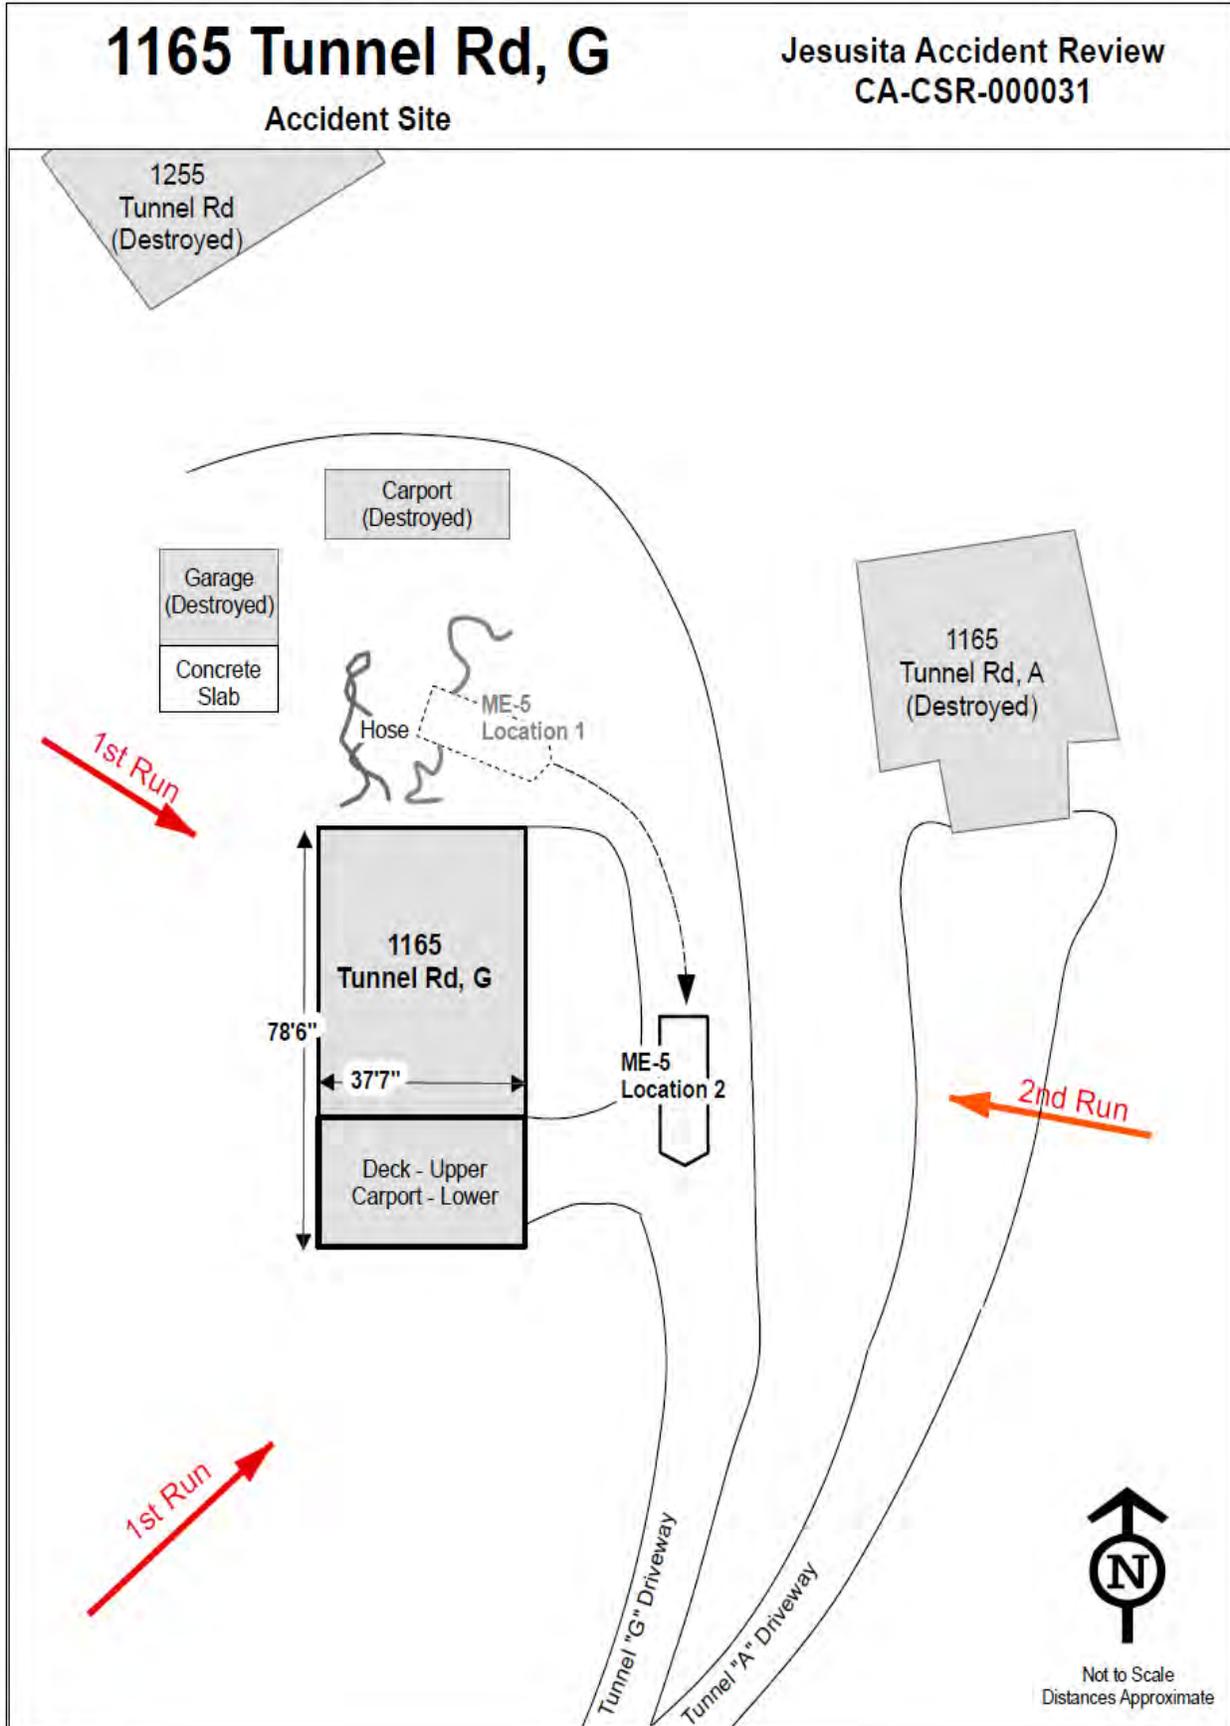
The engine received minor damage to the left rear upper equipment compartment while being repositioned. The crew from E-81 returned to firefighting duties and completed their shift. No injuries resulted. Minor Damage occurred to the wall at 1165 Tunnel Road #E from the contact with E81.

Out buildings were destroyed at 1165 Tunnel Road #G. The main structure received minor damage. All structures were destroyed at 1165 Tunnel Road # A and 1255 Tunnel Road.

SPA E-81 received damage to the left rear upper compartment door and the body had scraping damage consistent with striking a concrete wall. The chrome bezel around the left rear stop, turn signal and back up light assemblies had scrape damage. The engine did not have an ember screen installed in the motor air intake system.

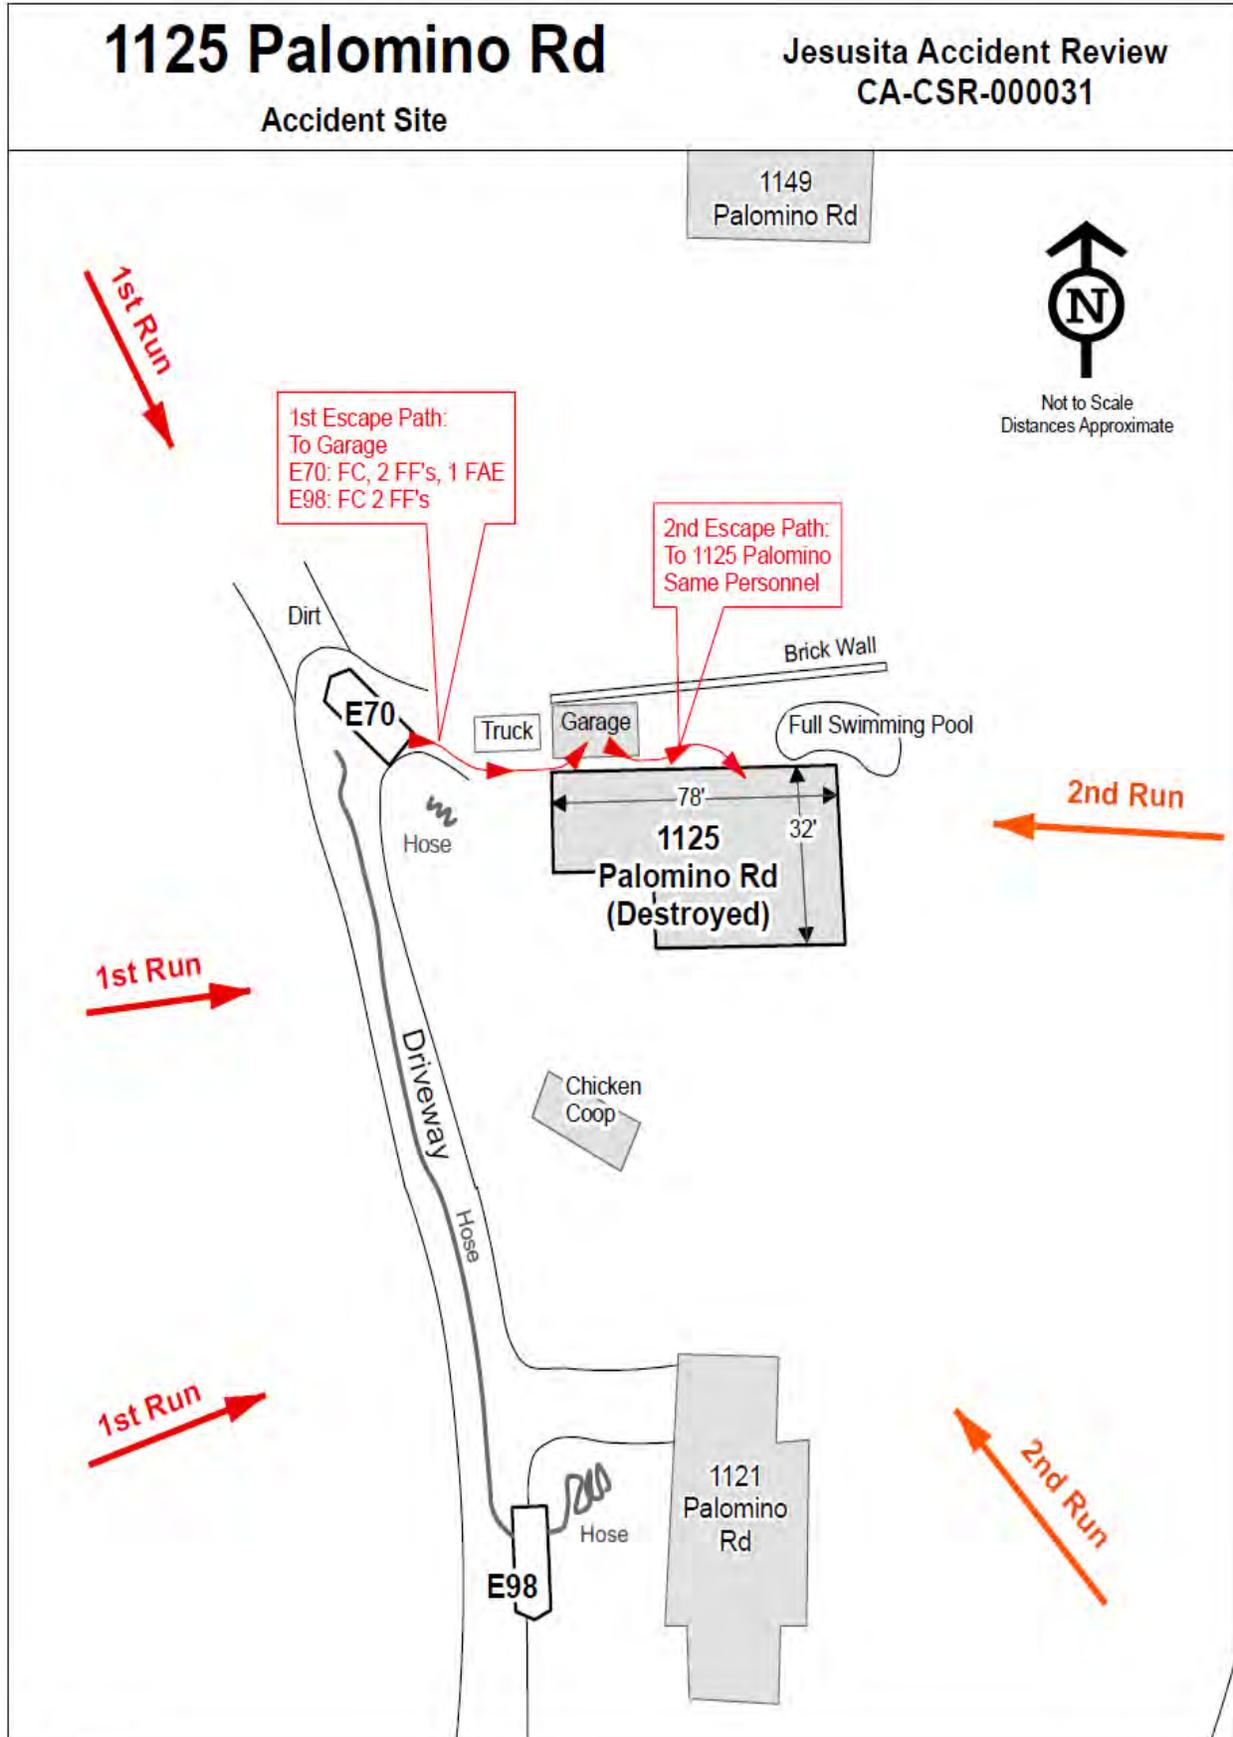
LAC FAE-70 suffered heat exhaustion, was transported to the hospital via ambulance, treated and released. LAC E-70 received moderate damage. The structure at 1125 Palomino Road was destroyed.

LAC E-70 had moderate fire damage to the complete front side of the vehicle, including cracks to both front windshields and the cab mounted light bar destroyed. Left side tires were damaged. The motor had stalled on the incident, and the crew discovered the air cleaner had burned. The engine was equipped with an ember screen on the motor air intake.
