**State of Alaska
Department of Natural Resources
Division of Forestry**

ACCIDENT INVESTIGATION FACTUAL REPORT

Type of Incident:
Water Supply / Burns

Location:
AK-DOF, Fairbanks Area, Logging Slash Fire, Alaska

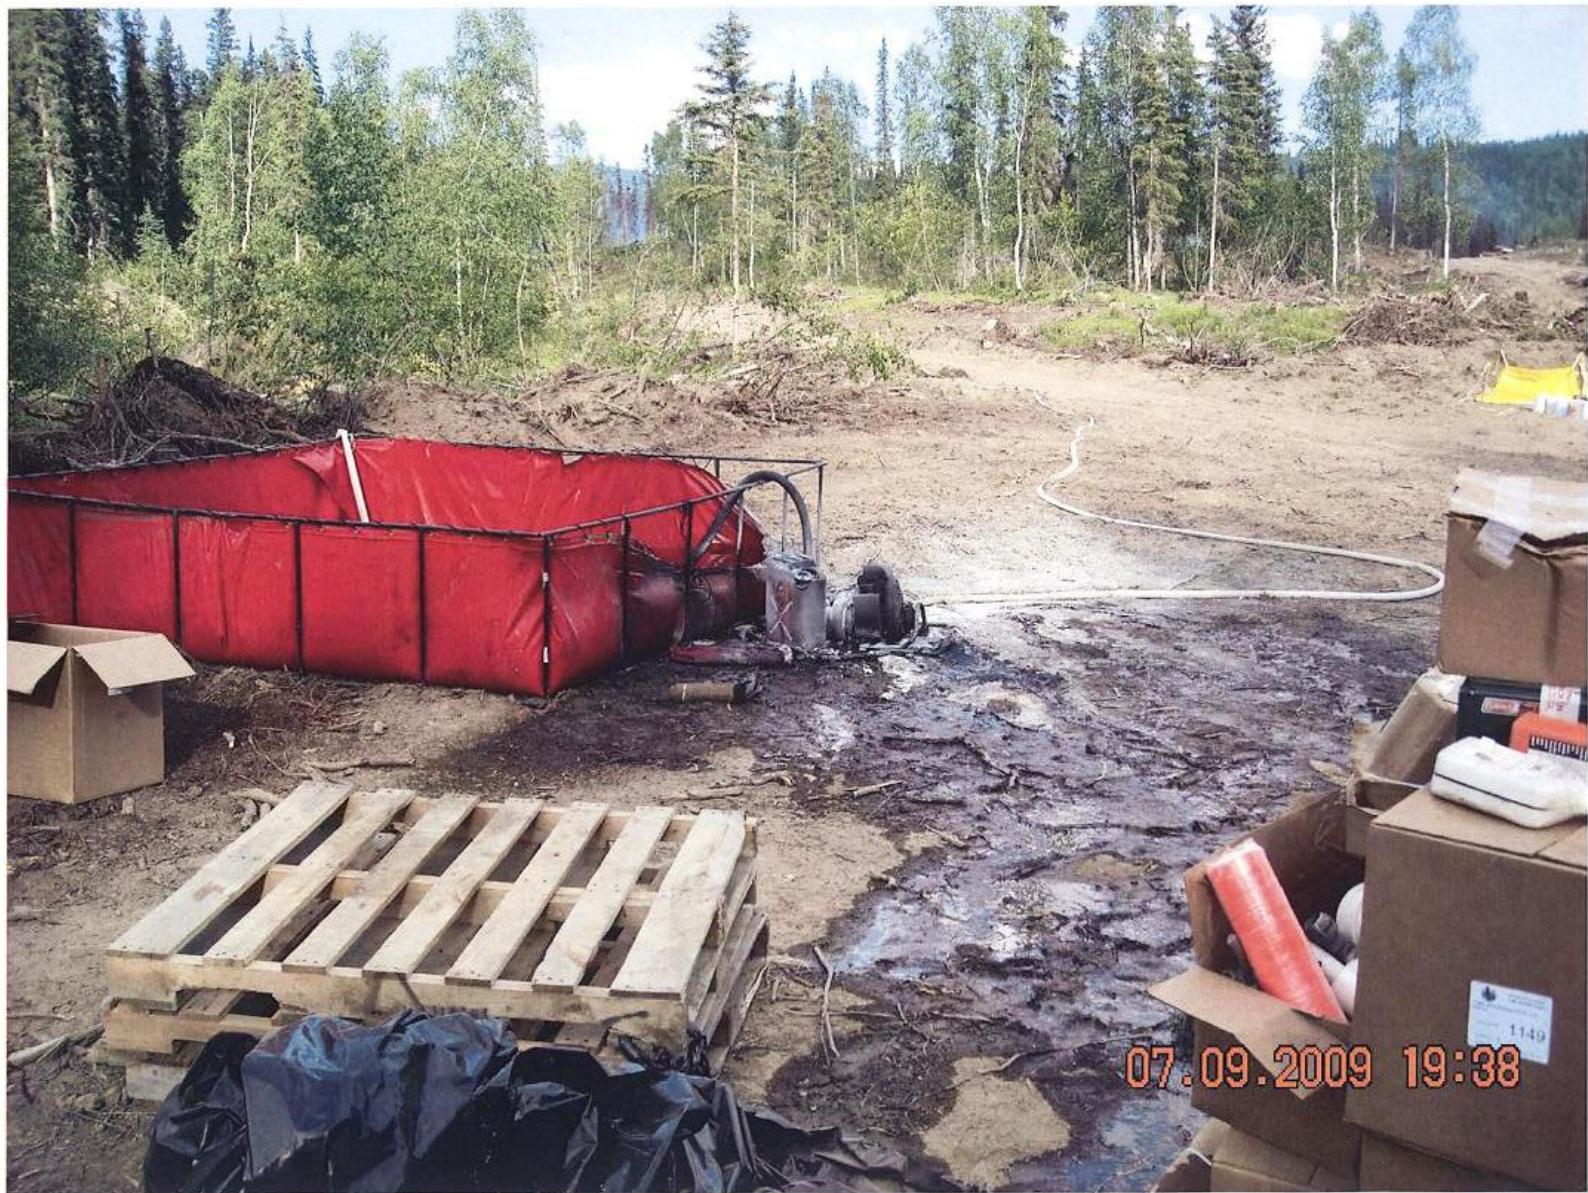
| Photo 1 | Mark 3 Pump, Jerry Can & Folda-tank |

- Placement of the jerry can in close proximity to Mark 3 muffler and in an angled alignment with the exhaust.
- Size/shape of fuel containment dyke may have been a contributing factor in the placement of the jerry can next to the muffler. The investigation team recommends additional research regarding whether the fuel containment dyke does readily lend itself to safe and practical set-up / operation while adhering to containment standards.
- Briefing IC-IHC received regarding very strict spill prevention and reporting may have been interpreted to include all incidents.

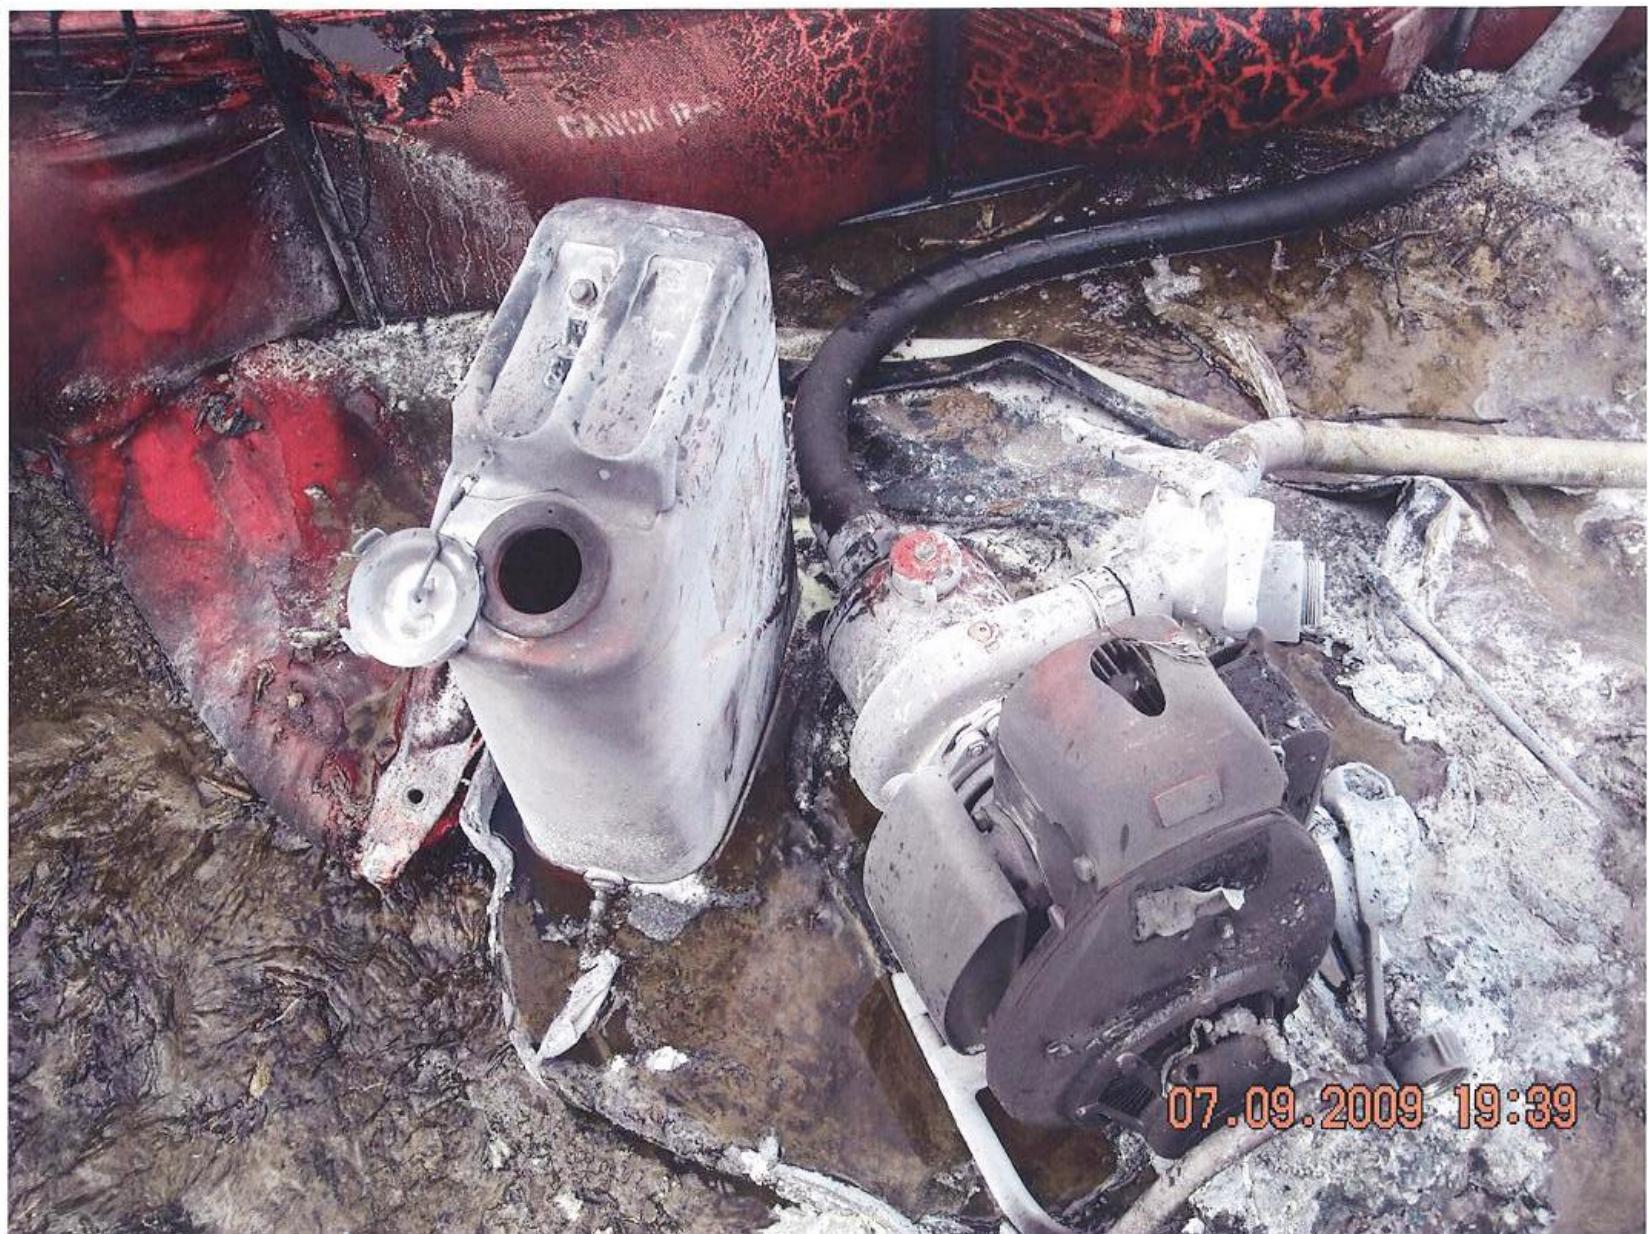
| Photo 2 | Mark 3 Pump & Jerry Can |

facility in Fairbanks. Detailed pictures were taken on scene shortly after the accident. Inspection revealed no mechanical deficiencies with the pump and/or fueling system. The air vent on the jerry can was open.

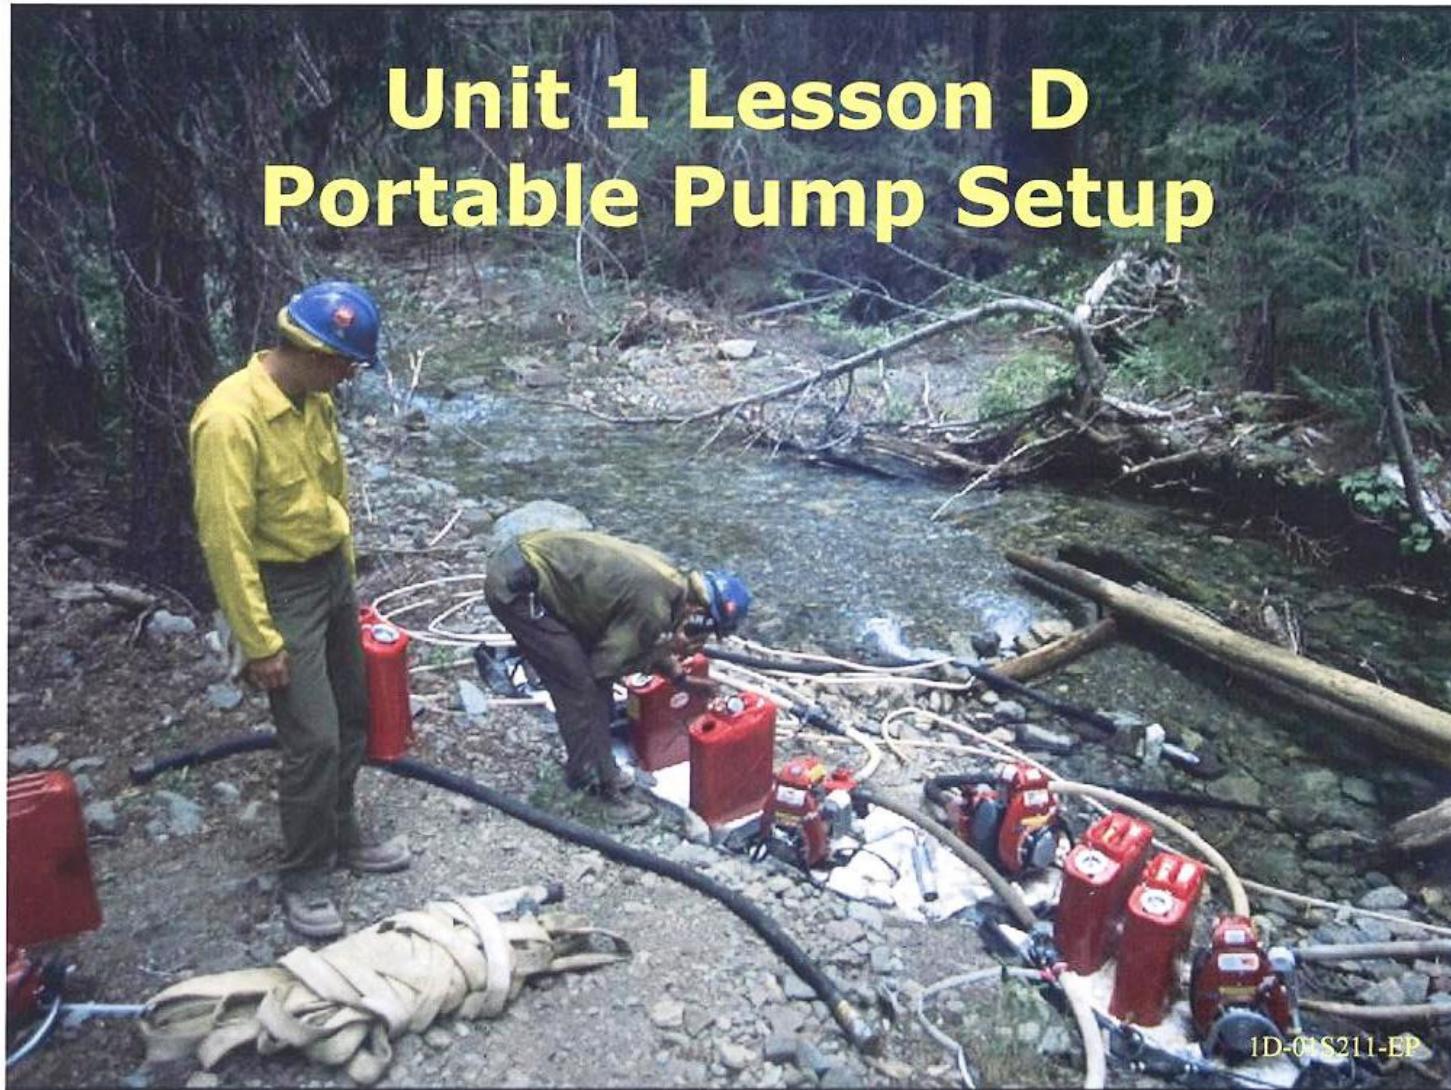
| Photo 3 | Slide from Unit 1, Lesson D, S-211 Class |

Unit 1 Lesson D

Portable Pump Setup

- ✓ Educate all wildland suppression agencies and organizations of the Burn Injury Criteria that is present in Chapter 7 of the 2009 Interagency Standards for Fire and Fire Aviation Operations.
- ✓ Update NWCG S-211 course to include more information regarding the proper use of spill containment devices and importance of keeping the jerry can away from muffler side of pumps
- ✓ Place a label near fuel line port of jerry can stating “Do Not Place Can Near Exhaust”
- ✓ All training should emphasize the proper use of PPE including eye and hand protection during all fueling operations
- ✓ All training should address the utilization of Crew Resource Management during any emergency
- ✓ All wildland fire suppression organizations/agencies should develop a “Safety Gram” to emphasize the dangers of placing fuel containers too close to mufflers or other sources of ignition
