**UNITED STATES AIR FORCE**  
**AIRCRAFT ACCIDENT INVESTIGATION**  
**BOARD REPORT**

**C-130H3, T/N 93-1458**

**156TH AIRLIFT SQUADRON  
145TH AIRLIFT WING  
NORTH CAROLINA AIR NATIONAL GUARD  
CHARLOTTE, NORTH CAROLINA**

**DATE OF ACCIDENT: 1 JULY 2012**

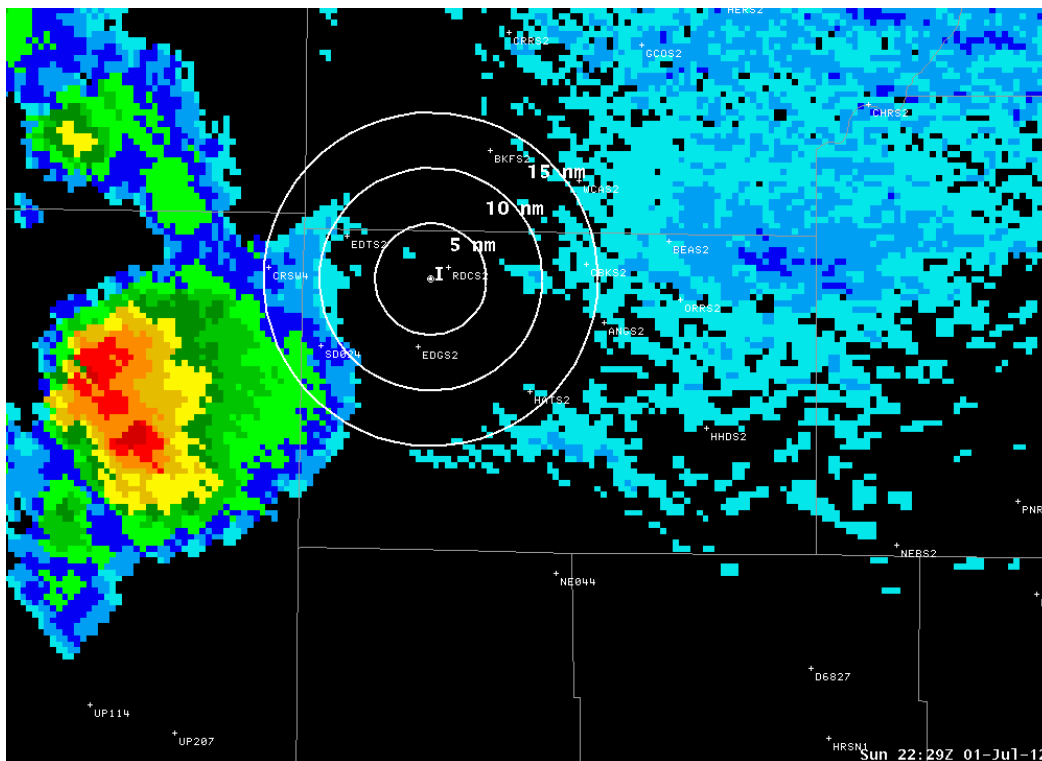
**Figure 3. Doppler Radar at 1629L  
Center of Inner Circle is Future Mishap Site**

On 1 July 2012, a low-pressure system was located over eastern Montana (Tab W-21). As the effects of the low-pressure system moved east towards South Dakota, an area of intense thunderstorms developed ahead of the front (Figure 3). As depicted in Figure 3, at 1629L a strong thunderstorm was located approximately 22 miles west-southwest of the future mishap site. Post-mishap, using radar animation, it was determined the thunderstorm was moving to the east-northeast at 20 miles per hour (Figure 3 to Figure 7).

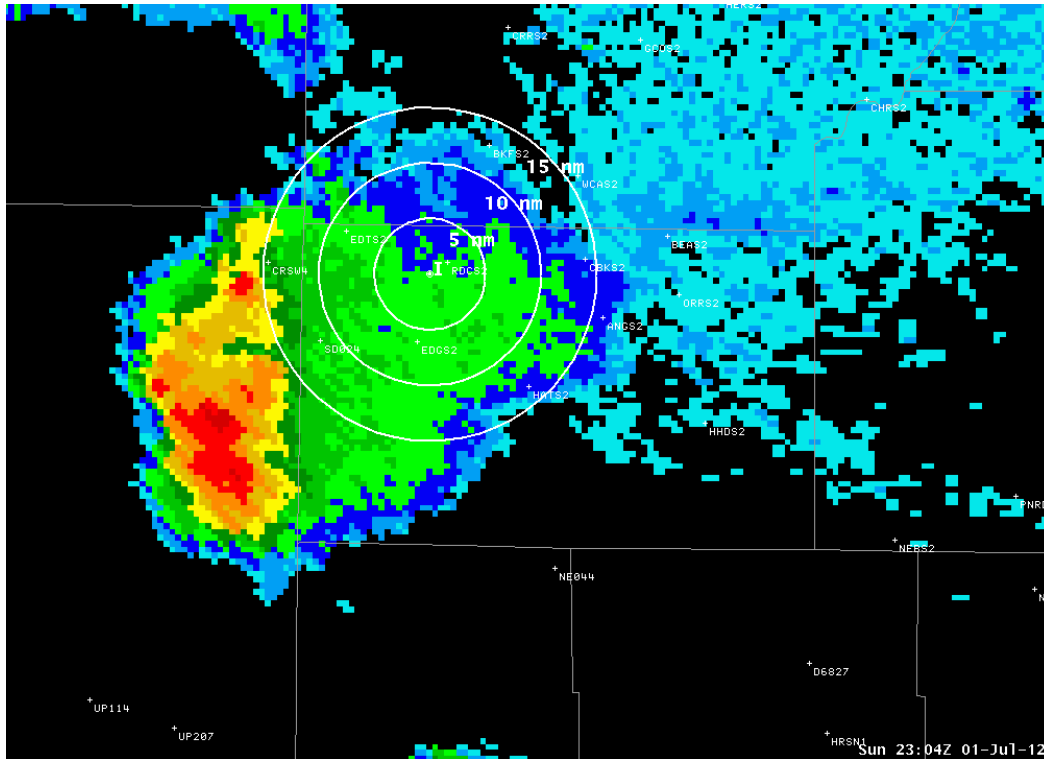
**Figure 4. Doppler Radar at 1704L**

At 1706L, as the MA approached the White Draw FTA from the southwest, the MC agreed to take a wide berth around the thunderstorm to the southeast of the fire as depicted in Figure 4 (Tab EE-3).

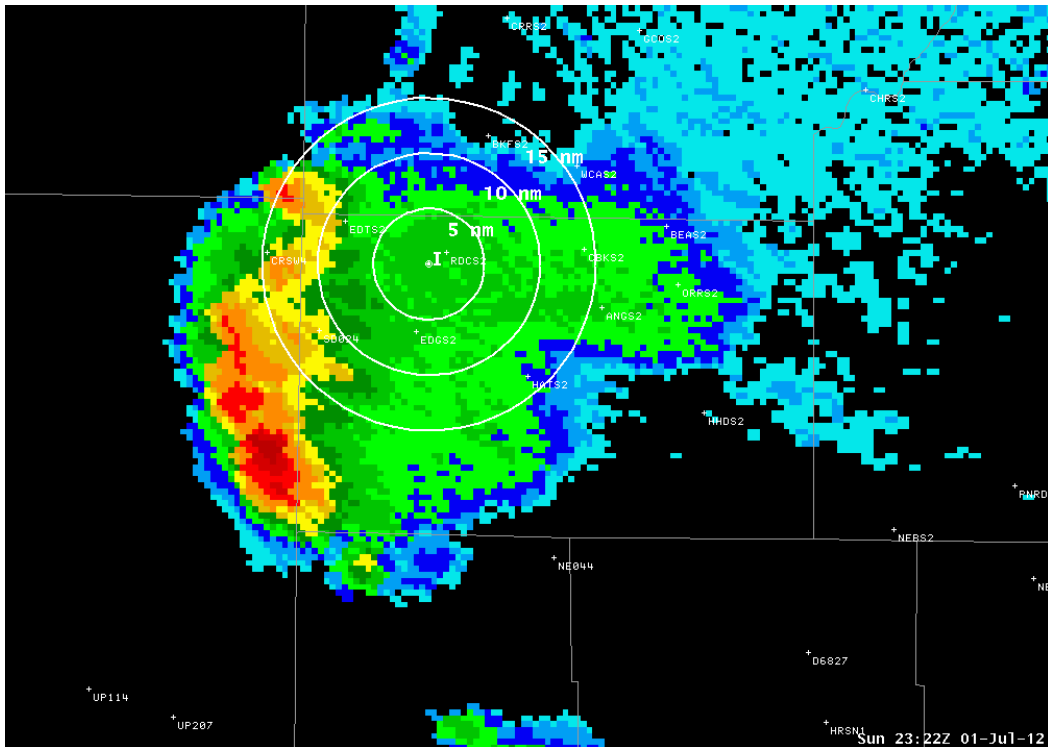
**Figure 5. Doppler Radar at 1722L**

While waiting for Lead B-5 to reach the White Draw FTA, ME witnessed lightning (Tab EE-15). At 1722L, MP1 made visual contact with Lead B-5 (Tab EE-15). Just moments later, MP2 stated the storm was “inside of 10 now” (Tab EE-16). As depicted in Figure 5, the leading edge of the thunderstorm was 13 miles west-southwest from the future mishap site. Showers were developing ahead of the thunderstorm as it moved across the Black Hills.

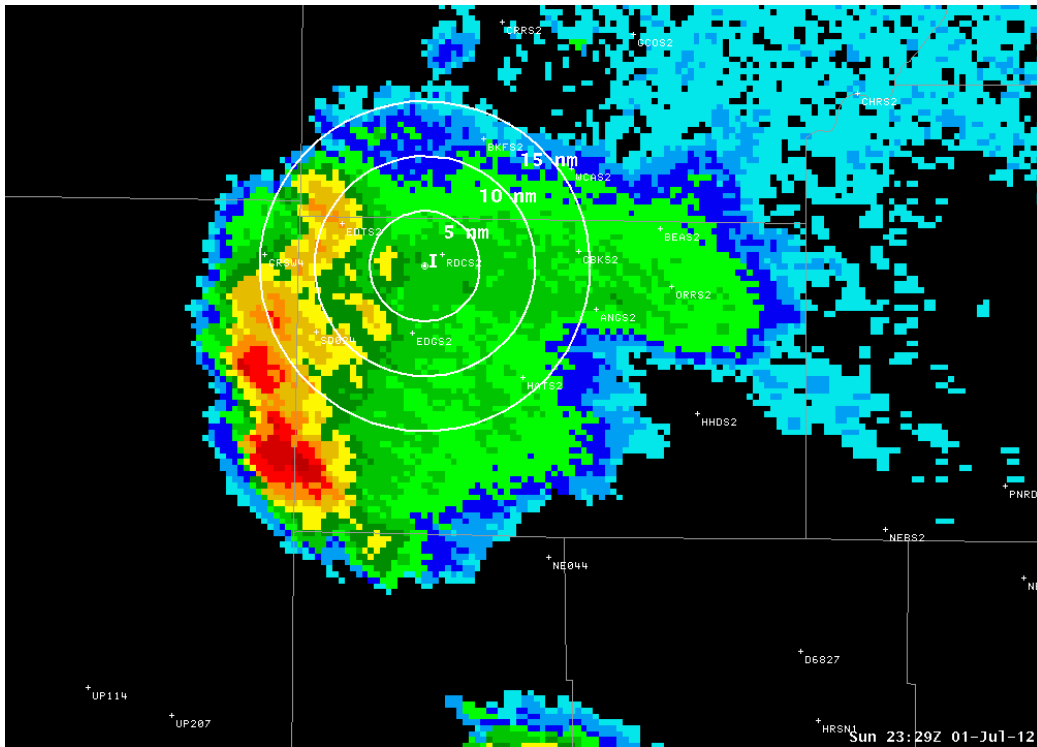
**Figure 6. Doppler Radar at 1729L**

At 1728L, in Air Attack, AA3 and ATGS witnessed virga and experienced “more than moderate turbulence” (Tabs R-141, V-7.8, V-43.9, V-43.10, EE-20). After the mishap, AA3 actually described the turbulence as severe (Tab R-136). Shortly thereafter, AA3 descended from an altitude of 9,500 to 7,000 ft MSL (Tabs R-136, V-43.9). During the “show-me” run, MP1 and MP2 acknowledged they were experiencing a “little bit of rain” (Tab EE-20). At approximately 1729L, rain showers were developing approximately five miles to the west of the White Draw Fire area as depicted in Figure 6.

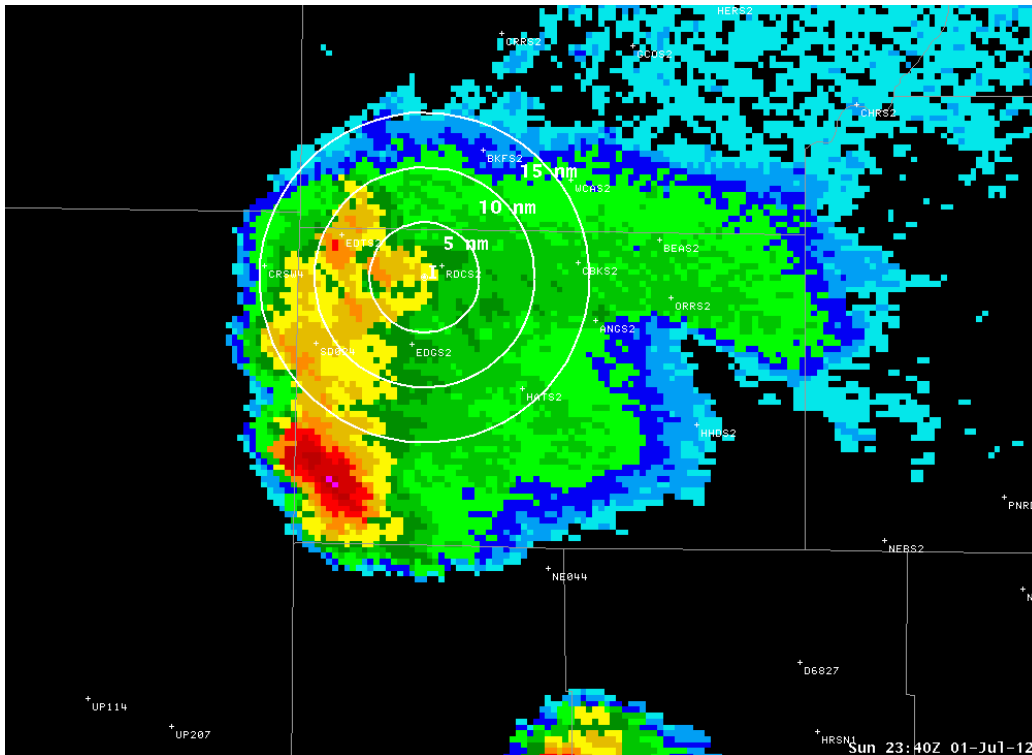
**Figure 8. Doppler Radar at 1740L**

Shortly after the mishap, a thunderstorm moved over the White Draw Fire area as depicted in Figure 8 above. As Air Attack moved away from the fire area, ATGS witnessed the weather cell on his weather display (Tab R-85). ML1 witnessed a thunderstorm coming and then experienced rain after the mishap (Tab V-1.7). Air Attack and Lead B-5 attempted to get back into the mishap site, but the turbulence was too strong (Tabs R-49, R-136, R-137, V-40.11). Due to the thunderstorm over the White Draw Fire area, as indicated in Figure 9, Air Attack had to loiter approximately 30 minutes for the storm to pass before reaching the mishap site (Tabs R-137, EE-45, EE-46). At approximately 1850L, the first rescue helicopter landed at the mishap site after waiting for the thunderstorm to pass (Tabs R-21, V-1.13, V-3.8 to V-3.9).
