**AVIATION INVESTIGATION REPORT
A14P0132**

**STALL AT TAKEOFF AND COLLISION WITH WATER
CONAIR GROUP INC. (DBA CONAIR)
AIR TRACTOR AT-802A FIRE BOSS AMPHIBIAN, C-GXNX
CHANTSLAR LAKE, BRITISH COLUMBIA
14 AUGUST 2014**

Aviation Investigation Report A14P0132

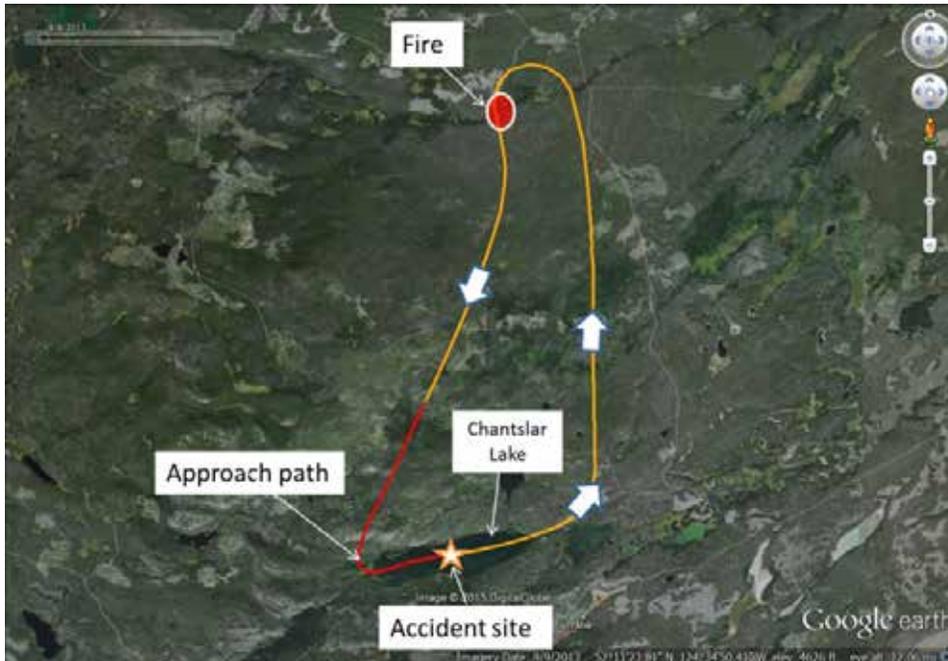
Figure 1. Circuit and accident site (Source: Google Earth, with TSB annotations)

Global positioning system (GPS) data showed that T685 touched down for the accident scooping run at 0.25 nm from the southwest end of the lake (Figure 1) and maintained an average heading of 076° magnetic (M) for 0.75 nm. The ground speed gradually increased and remained steady at 71 knots for about 4 seconds before the aircraft decelerated and came to a near stop 2 seconds later. The accident occurred halfway down the lake, after the aircraft had been on the water for approximately 44 seconds.

Moments after liftoff, control of the aircraft was lost as the aircraft rolled to the right, and the right-hand wing tip contacted the water. The aircraft then yawed further to the right, rolled to the left, and pitched down before the front outboard side of the left float contacted the water again. The aircraft remained right-side-up and came to rest on a northerly heading.

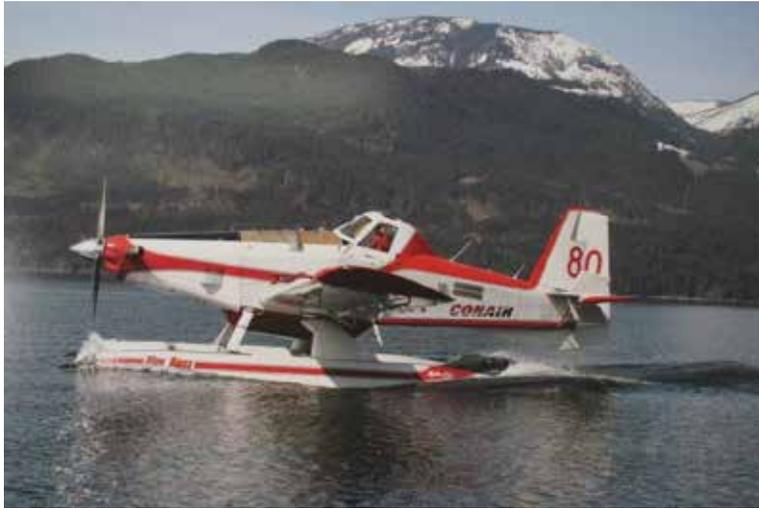
Photo 1. Fire Boss (Source: Conair)

- the Fire Boss conversion (Photo 1), which included the installation of the amphibious floats and stall performance enhancements (known as a stall improvement array); and
- a power upgrade, which increased the maximum takeoff power to 1600 SHP.

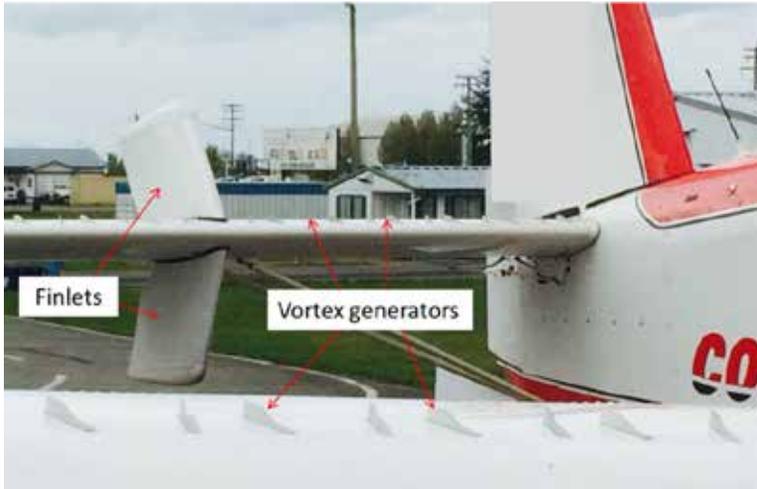
Photo 2. Finlets and vortex generators (Source: Conair)

Additional airframe modifications were found to be necessary to return the aircraft flight performance characteristics to regulatory standards in the restricted category. These modifications, collectively known as a stall improvement array, principally included the installation of finlets on the top and bottom of the horizontal stabilizers, a ventral fin under the empennage, and vortex generators on the wings and horizontal stabilizers (Photo 2). In addition, the pitot tube was relocated further outboard and the stall warning vane was repositioned.

The stall improvement array installation resulted in a reduction of the stall speed. The AFMS shows the power-off stall speed to be 73 KIAS (instead of 83 KIAS) with flaps 20°, bank 0°, engine power set to flight idle, aircraft total weight of 16 000 pounds, and a most-aft-allowable CG location. The stall improvement array also resulted in a delay of the stall buffet until full wing stall occurs, with engine power applied.

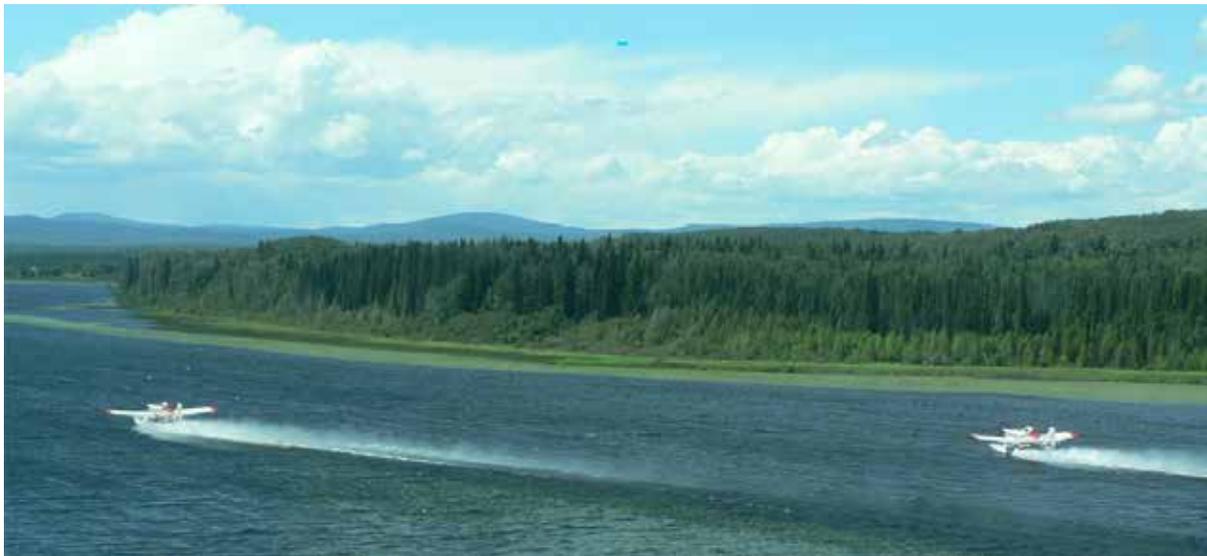
Photo 3. Fire Boss echelon-formation scooping operation

When firefighting with the Fire Boss, Conair normally operates in teams of 4 aircraft, in a loose line-astern arrangement. During scooping operations, the pilots adjust their relative positions to suit local conditions such as the lake dimensions, wind, and terrain in relation to the target fire. Scooping in an echelon or upside-down “V” formation, as they were on the accident flight, is common (Photo 3). At the fire (drop site), the aircraft are at minimum 10 seconds apart, normally line astern.

In the second scenario, wing-tip vortices may have been encountered. This phenomenon is always present somewhere behind an aircraft in flight and is well known to Fire Boss pilots, who usually operate in groups. Wing-tip vortices are unpredictable, and the light and variable wind on the lake produced conditions that were ideal for vortices to linger over the water. Given T685's position behind and to the right of the lead aircraft, it is not likely that T685 encountered the lead aircraft's left wing-tip vortex. However, it is possible that T685 overtook the lead aircraft's right wing-tip vortex at, or beyond, the lead aircraft's liftoff point. T685's right-hand wing may have encountered the down-flowing side, or the left-hand wing may have encountered the up-flowing side of the counter-clockwise-rotating vortex generated by the lead aircraft's right-hand wing, resulting in a roll to the right leading, in turn, to the right-hand wingtip making contact with the water.
