Collision with water involving a Sikorsky S-64E Skycrane helicopter, N173AC

Near Jericho, Victoria, on 28 January 2019

ATSB Transport Safety Report
Aviation Occurrence Investigation
AO-2019-008
Final – 17 April 2020

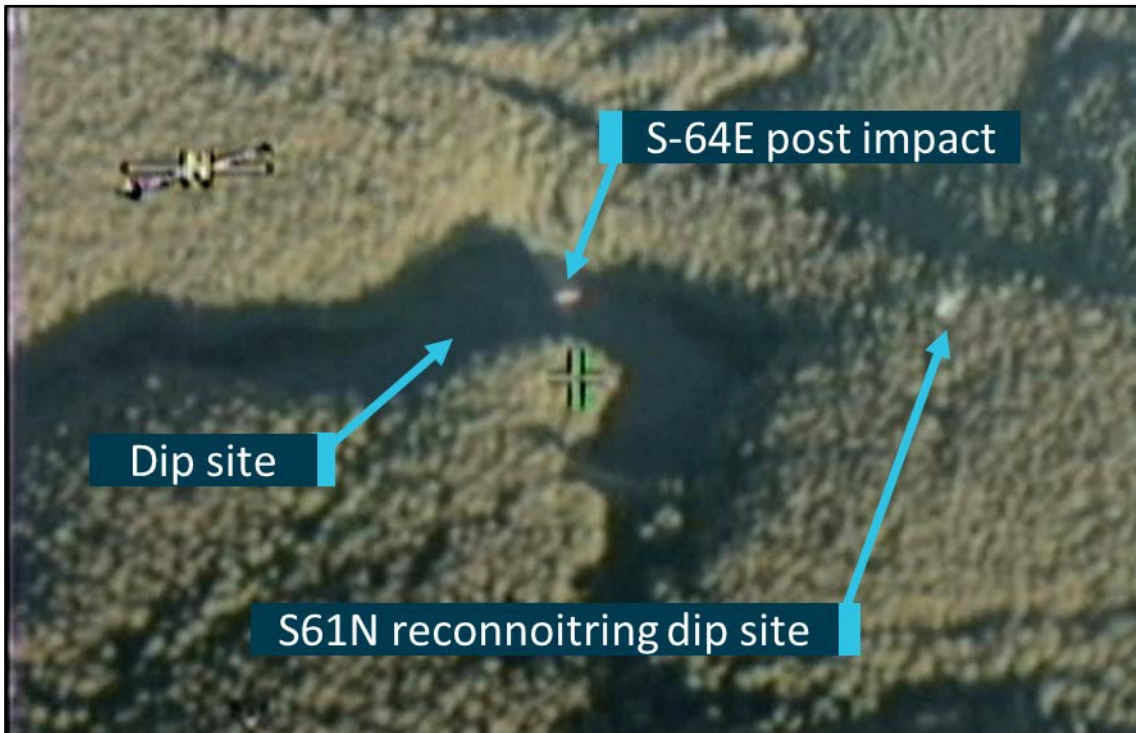
Figure 3: The steep sides and narrow body of the dip site pictured from the west

The dip site was Wood Creek Dam, 7 km west of the fire front. It sat at 3,480 ft above mean sea level, at the eastern base of Mount Gregory, in the Yarra Ranges National Park, Victoria (Figure 3). It had a narrow body and steep sides surrounded by tall trees. The crew assessed the dip site as confined, but not outside acceptable limits of operation.

During filling, the helicopter was positioned one main rotor diameter from the left-hand side of the dam for the PIC to keep visual hover references. This left no more than two rotor diameters to the right.

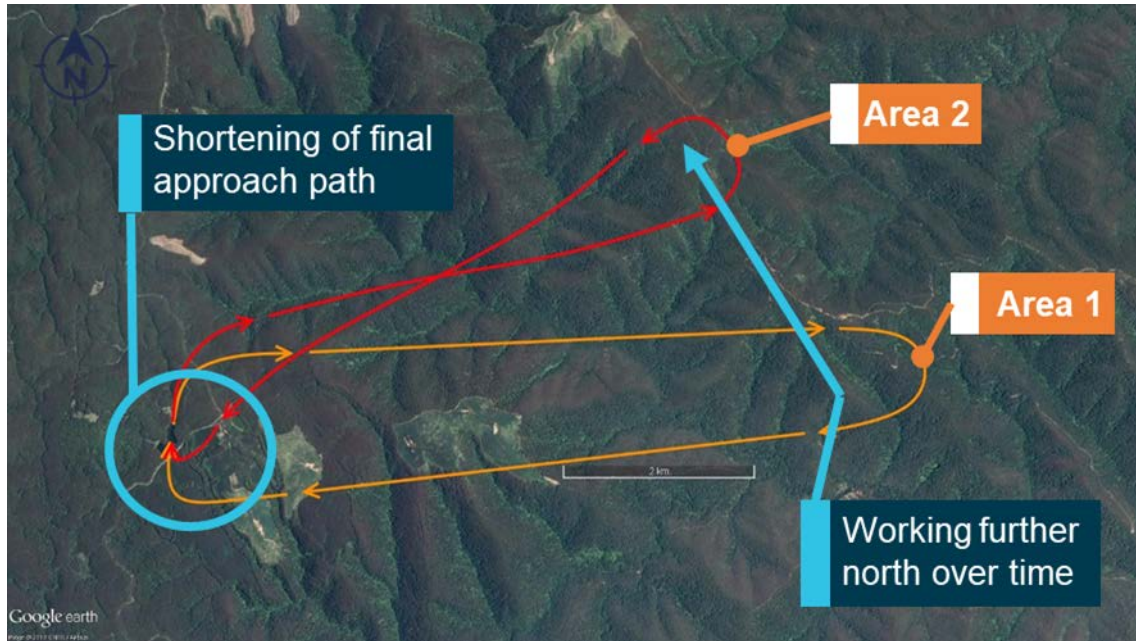
Figure 4: Change in working location over time

After a number of water drops, the AAS re-tasked the crew to fight a flame front further north, which was east-northeast from the dip site. Each drop was also incrementally further north. This resulted in the crew gradually tightening the approach to the dip site (Figure 4).

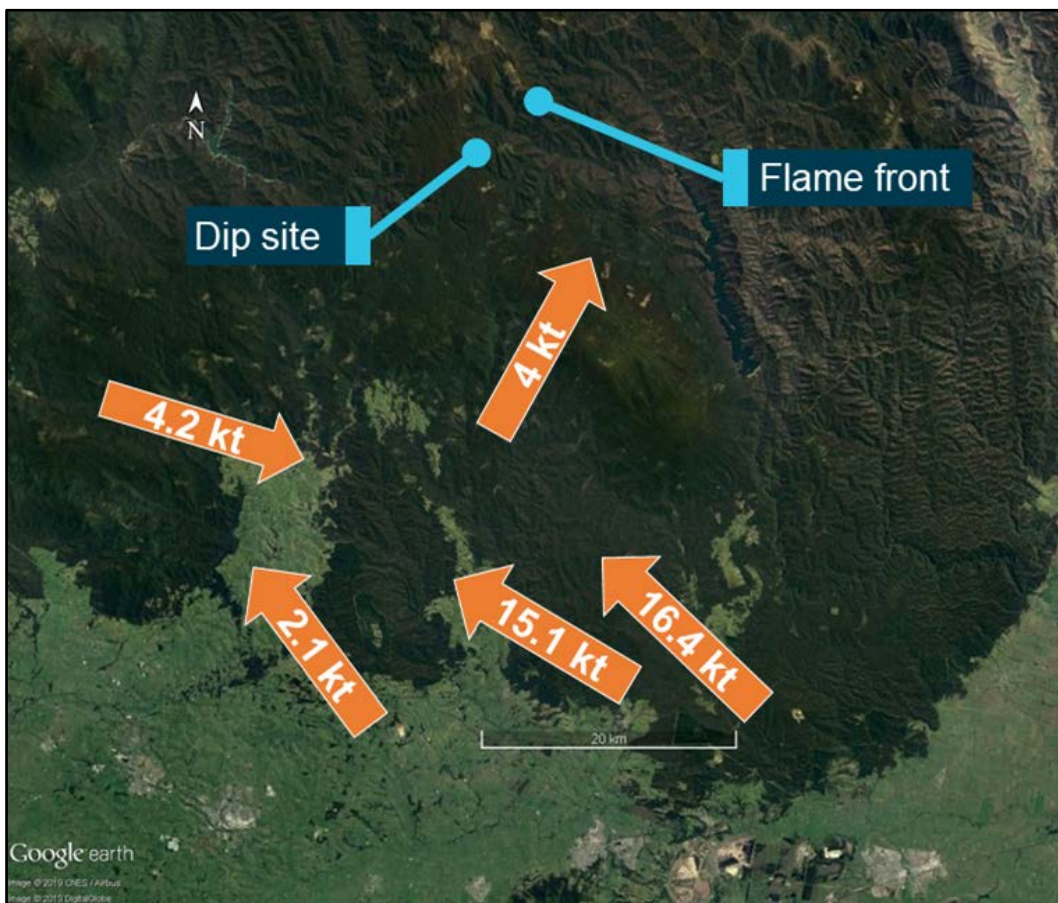
Figure 5: Local variation in wind speed and direction. (15-minute average 1900 to 1915)

Locations on the ground showed significant local variation in wind direction and strength throughout the day (Figure 5).

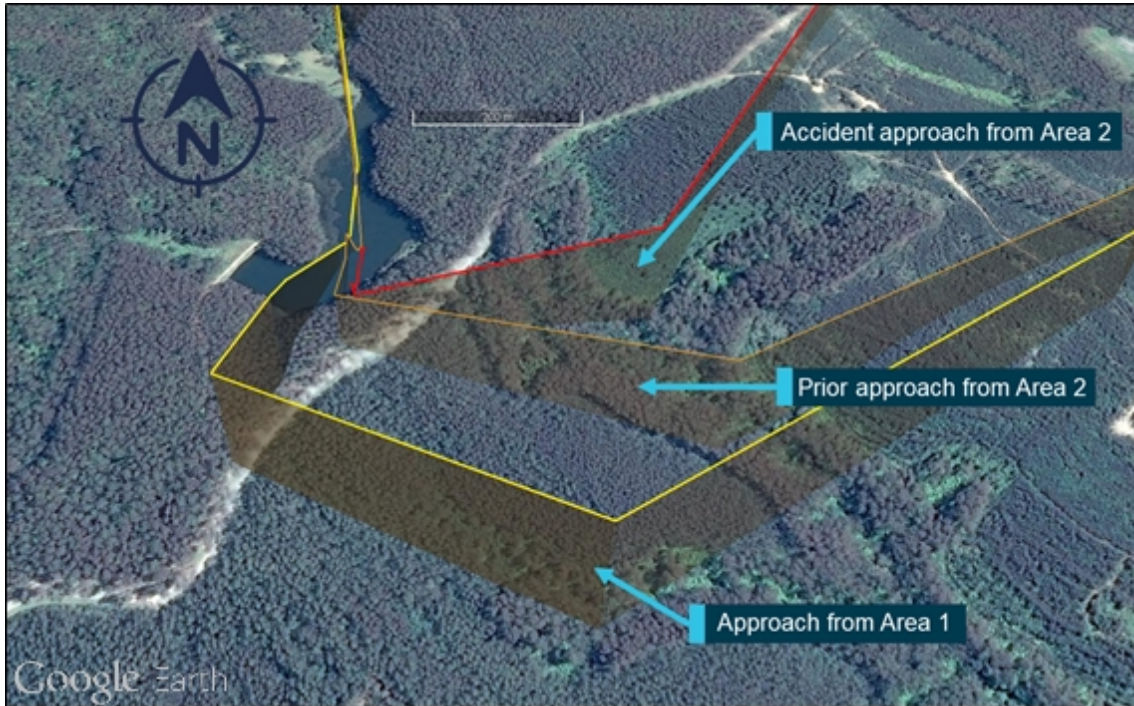
Figure 6: Shortening of final approach path

The satellite data showed the accident approach was a right-hand turn, with about a 30° angle of bank, and a radius of 150 m. The rate of descent developed from 650 ft/min to 780 ft/min. All flight parameters were within operational limits, however the length of the final approach was considerably shorter than earlier approaches (Figure 6).

The shorter approach at the upper end of the acceptable envelope of operation required a steeper than normal flare to stop the helicopter. The crew reported that once they descended below the tree line, the aircraft generated no lift and fell into the dip site, colliding with water. The crew stated

that they had very likely encountered vortex ring state (VRS). The topography, high rate of powered descent, and steep flare that reduced the airspeed, created conditions conducive to the onset of VRS. The crew reported that the rapidity of onset and dimensions of the dip site did not provide enough time or space to manoeuvre sideways to effect a recovery.

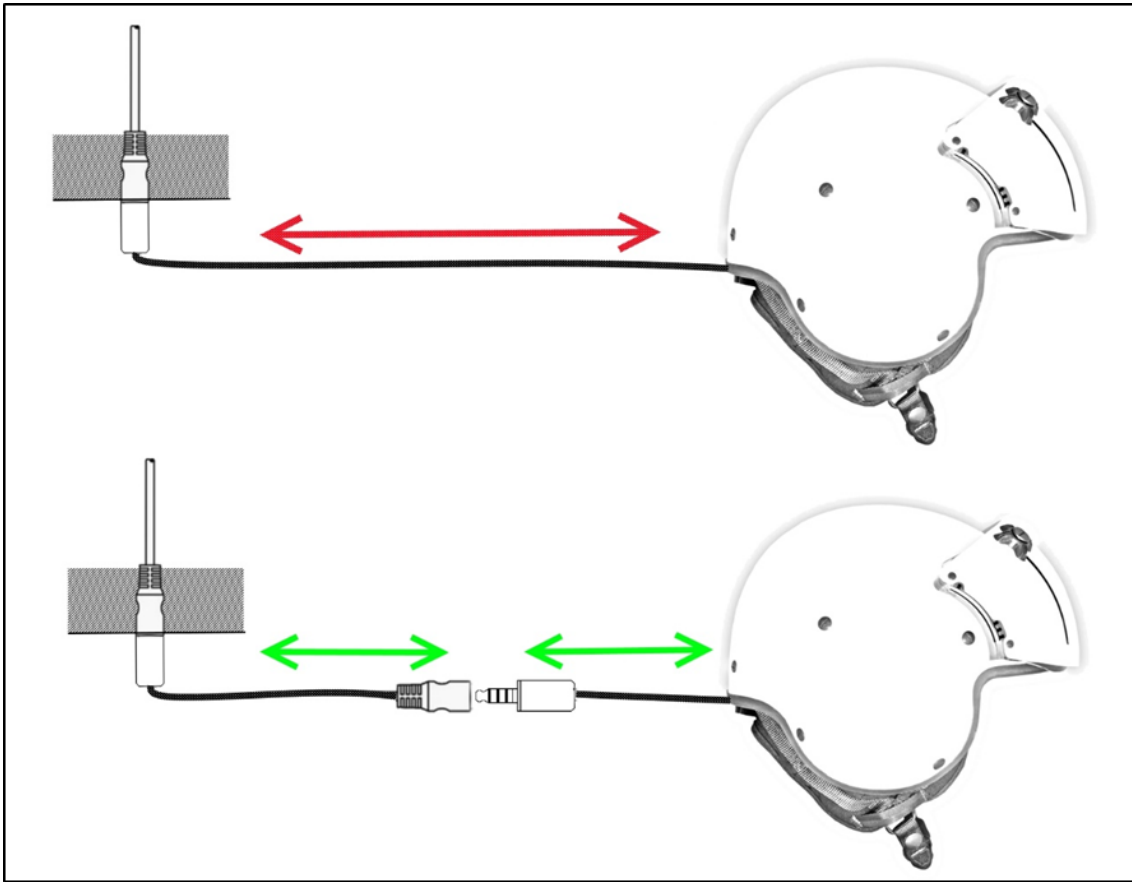
Figure 7: Helmet cord release mechanism

Neither pilot unplugged their helmet. However, the extension cords from the aircraft to the helmet plug allowed the plug to release, preventing the helmets from snaring the pilots. All three crew escaped, and inflated their life jackets. Two crew were uninjured, and one crewmember sustained a knee injury.

Additionally, the helmet cord release mechanism (Figure 7) prevented snaring and potential drowning after the pilots exited the submerged aircraft without unplugging their helmets.

Following an accident, it is common to overlook the need to unplug one's helmet. Using a good quality extension cable that will maintain the integrity of communications and release under tension in the event of an emergency can also save lives.
