Informational Summary Report of Serious or Near Serious CAL FIRE Injuries, Illnesses and Accidents

GREEN SHEET

Burn Over Fatalities

Carr Incident

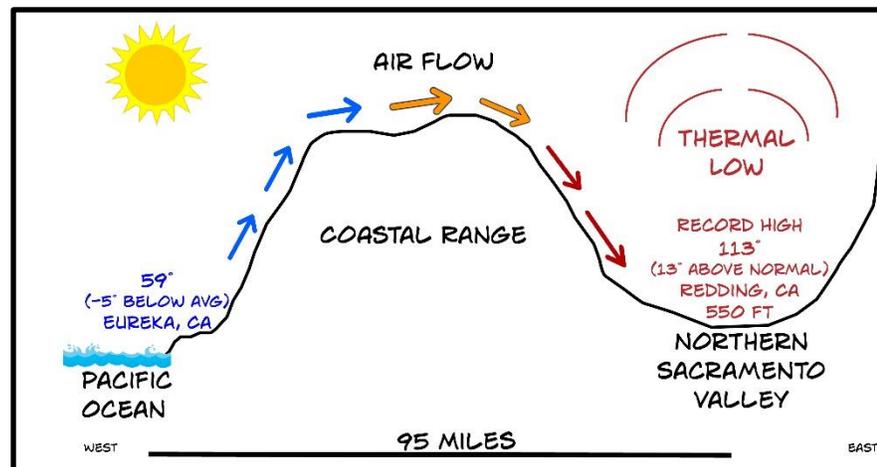
Figure1- As the sun sets and temperatures cool, the thermal low in the Sacramento Valley begins to fill by drawing air from surrounding areas. The western portion of the valley draws progressively cooler and denser air from over the coastal range. This results in increased winds due to downsloping, and increased temperatures due to compressional warming of the airmass.

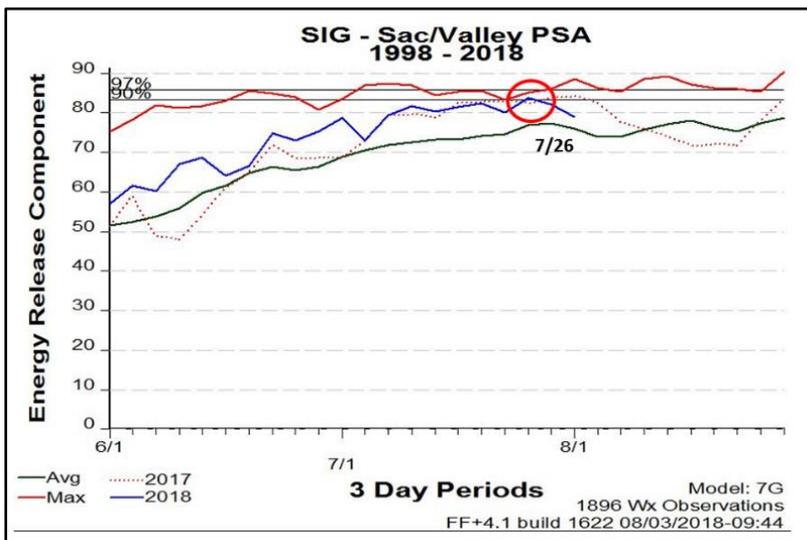
Figure 2- Energy Release Component values were near record highs for this time of year. 1,000-hour dead fuel moistures were also near record lows for this time of year.

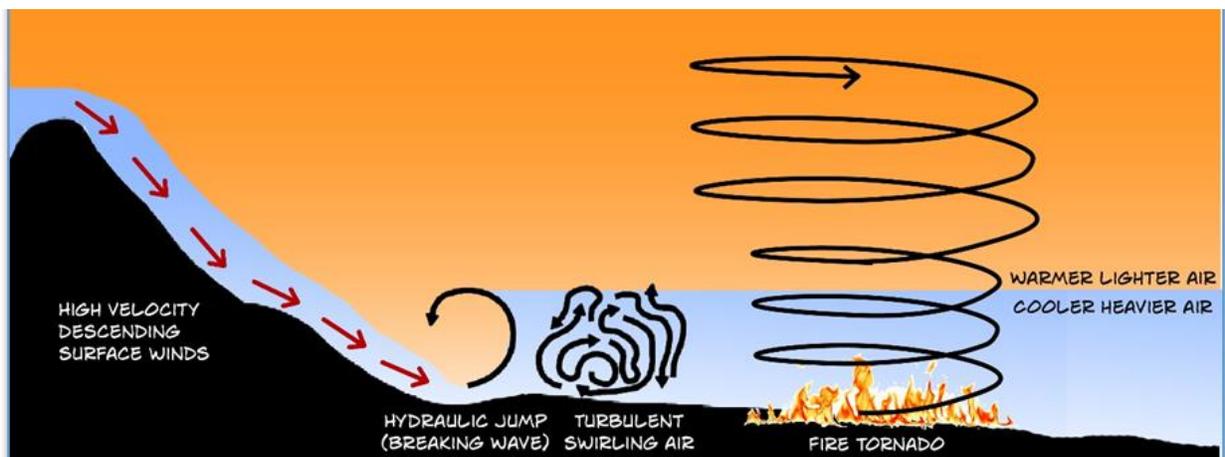
Assessment of air flow in the area using a weather prediction model indicates it is likely that large amounts of vorticity were present due to a hydraulic jump phenomenon. The phenomenon creating hydraulic jumps can best be understood when observing water travelling down a dam spillway. As fast moving water flows down a spillway, a breaking wave forms when the high-speed water impacts the slower moving pool of water at the spillway's base. The breaking wave is called a hydraulic jump, and results in increased turbulence and vorticity. Hydraulic jumps occur in atmospheric conditions as well.

Figure 3- Hydraulic jump illustration

Theoretical and experimental research shows that atmospheric hydraulic jump conditions cause very large increases in wind turbulence and vorticity. This likely provided the rotational air necessary for formation of the fire tornado.

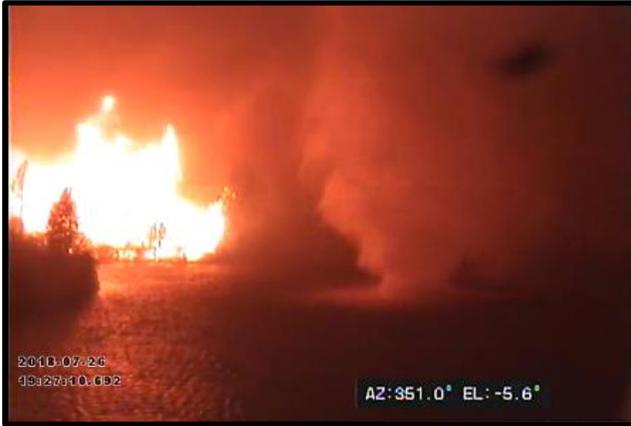
Picture 1- Example of swirling air generated by turbulence (Carr Fire burning down to Sacramento River).

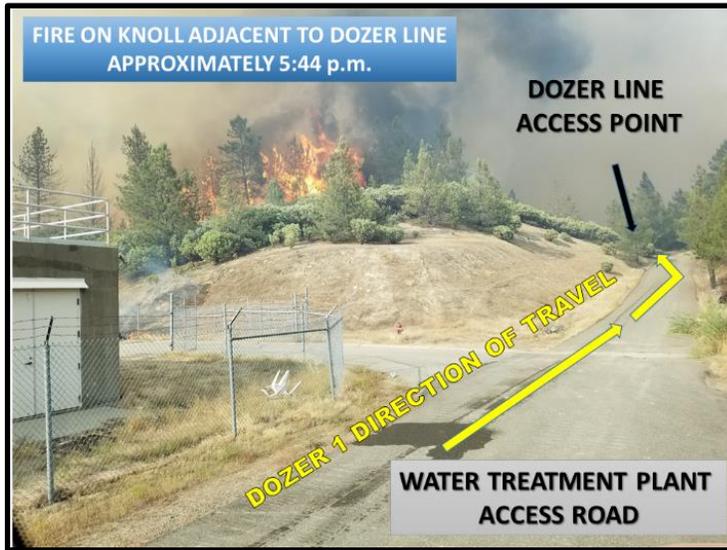
Picture 2 taken at 5:44 p.m.- Travel route of Dozer 1 up water treatment plant access road to dozer line.

At approximately 5:44 p.m., the fire jumped the top of the dozer line near the access road (picture 2). Multiple spot fires became established in the area. Approximately two minutes later, CREW1 Leader returned to the water treatment plant and asked where Dozer 1 was located. CREW1 Leader was told that Dozer 1 had proceeded down the dozer line. CREW1 Leader made several attempts over the radio to contact Dozer 1 in order to tell him to “get out of there”.

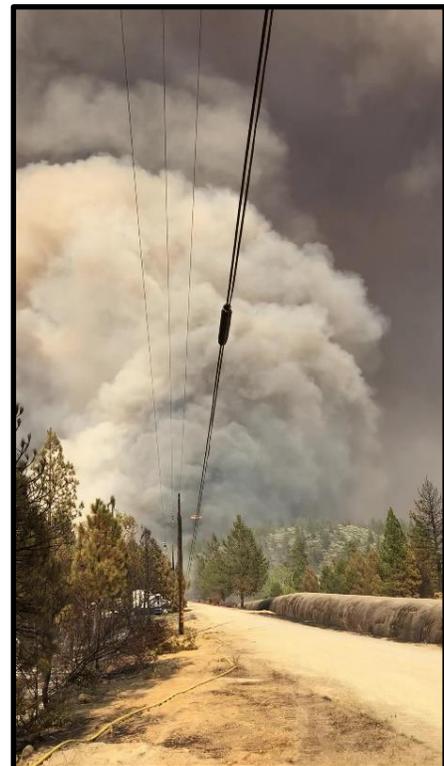
Picture 3 taken at 6:08 p.m.- Fire activity looking east down water treatment plant access road.

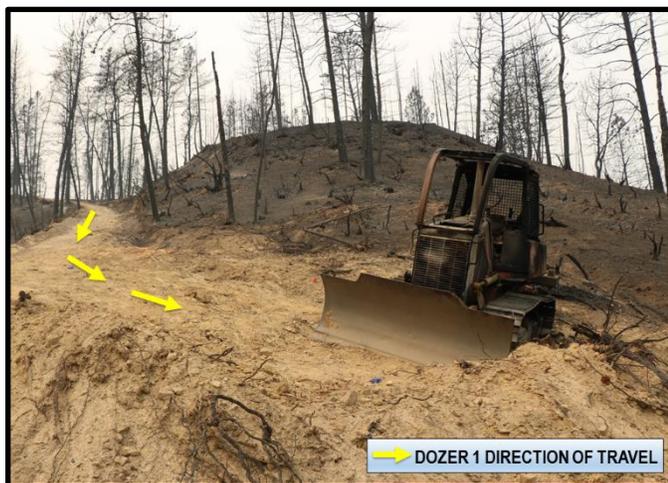
After a clearing in the smoke, HLCO noticed Dozer 1 was engulfed with fire. HLCO did not observe any sign of a shelter deployment. After fire intensity decreased, two Fire Captains (FC1 and FC2) from the handcrew strike team attempted to approach Dozer 1's location, but they were forced to turn around due to heat and smoke. At approximately 7:00 p.m., FC1 was able to make access down the dozer line. FC1 confirmed that the dozer operator suffered fatal injuries during the burn over.

Picture 4- The final resting place of Dozer 1.

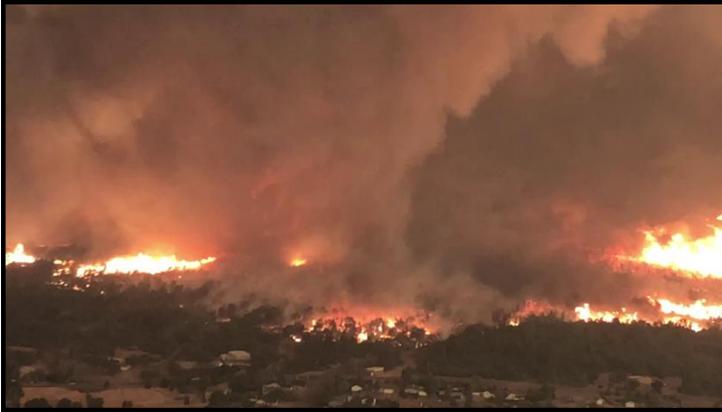
Picture 5- Helicopter Coordinator looking southeast at fire tornado over Lake Keswick Estates. [Click here to view video](#)

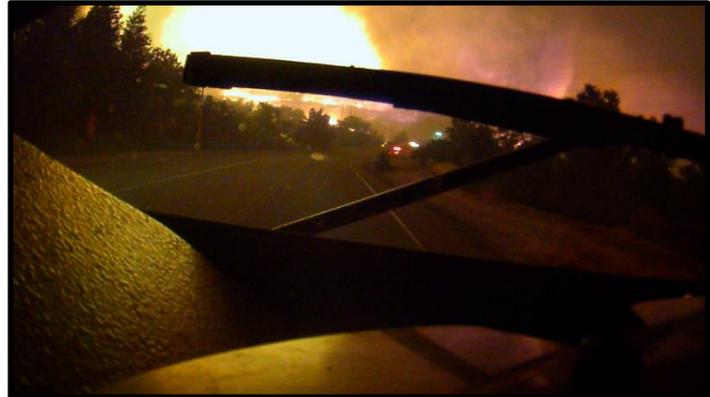
Picture 6- ENG4 looking north from Buenaventura and Sutro Mine Road at fire tornado. [Click here to view video](#)

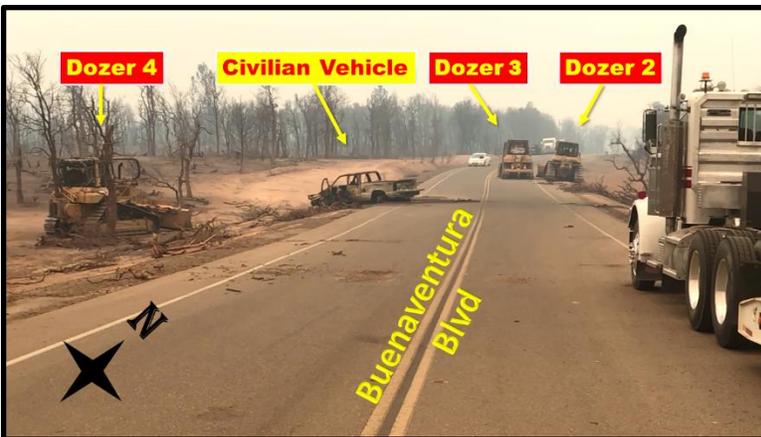
Dozer 4 became disoriented when impacted by the flying debris. As a result, the dozer hit a civilian vehicle that was stopped along Buenaventura Boulevard. The impact caused the dozer operator to land on the floor of his cab. The dozer continued to travel until it came to rest against a tree. Once stopped, the operator tried to drop the fire curtains. Due to burn injuries on his hands, he was unable to manipulate the straps, and had to cut the straps with a razor knife to deploy the curtains. He successfully dropped three out of the four curtains. The operator then deployed a fire shelter. In order to escape the intense heat, he exited the cab and sought refuge under the dozer, but saw a tree blocking his route. When the dozer operator reentered the cab, he saw emergency vehicle lights on Buenaventura Boulevard. He ran up to the vehicle where PREV1 directed him into the backseat. Once in the pickup truck, the dozer operator noticed there was also a civilian in the vehicle.

Picture 7- Final resting location of Dozer 2, Dozer 3, Dozer 4 and the civilian vehicle on Buenaventura Blvd.

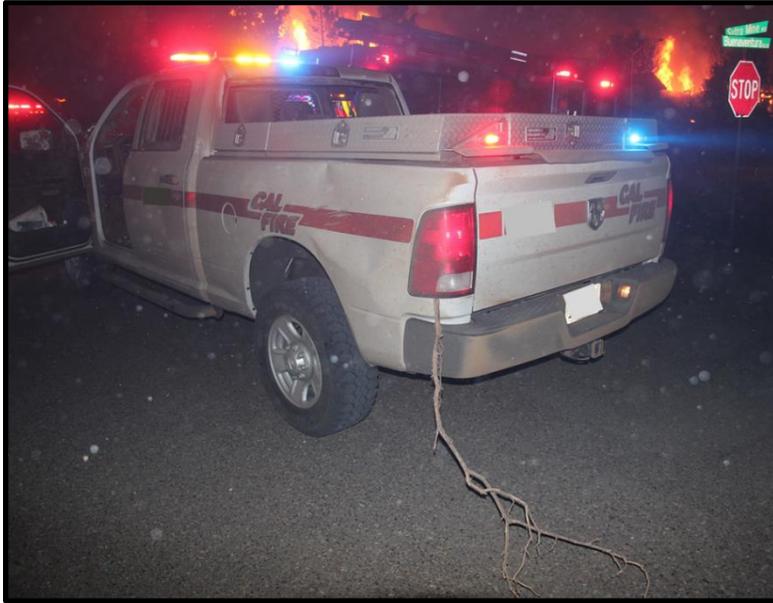
Picture 8- Damage to PREV1 pickup truck. Note shattered windows and dents to body of the vehicle.

As PREV1 slowly approached the burning vehicle, he felt his pickup truck get "pushed" from the west. All the windows in his pickup truck except the windshield shattered. PREV1 took refuge in his vehicle. Approximately 30 seconds later PREV1 observed a male civilian attempting to get in his pickup truck. PREV1 directed the civilian to get in the back seat. Moments later, PREV1 saw a second individual (Dozer 4 operator) running toward him wrapped in a fire shelter. PREV1 directed the dozer operator into the back seat. PREV1 asked if they
