Eicks Fire Smokejumper Fatality

Learning Review – Technical Report

Spring 2022

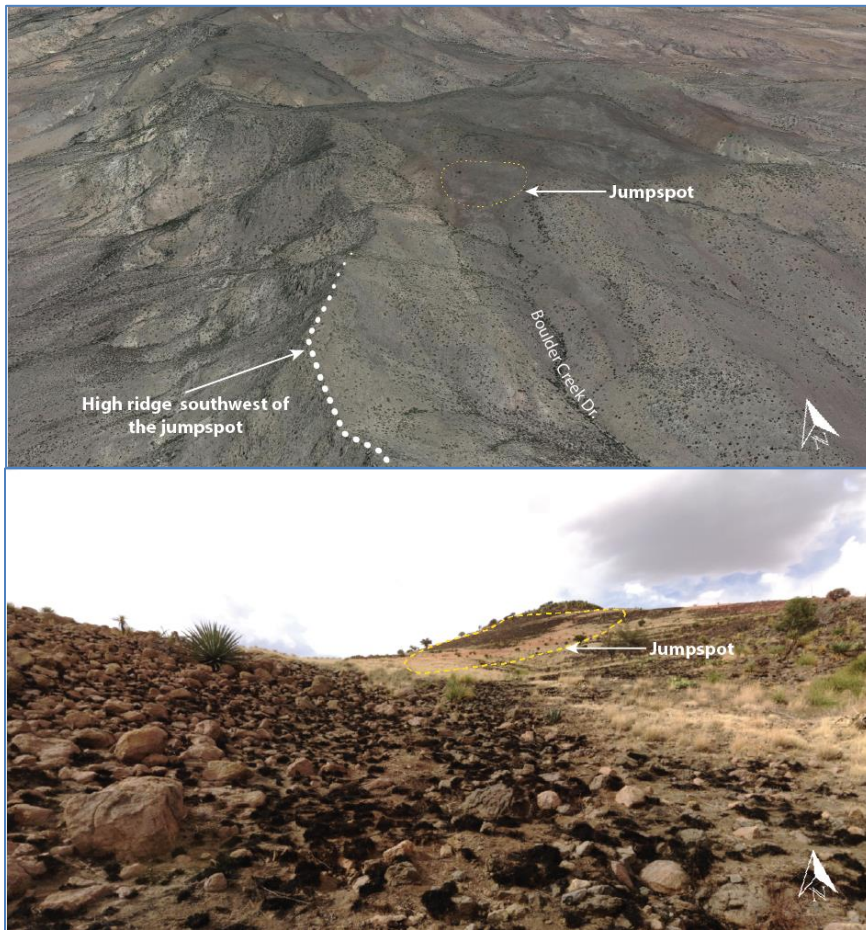
Figure 3. Aerial (above) and ground-level versions of the Eicks Fire jumpspot.

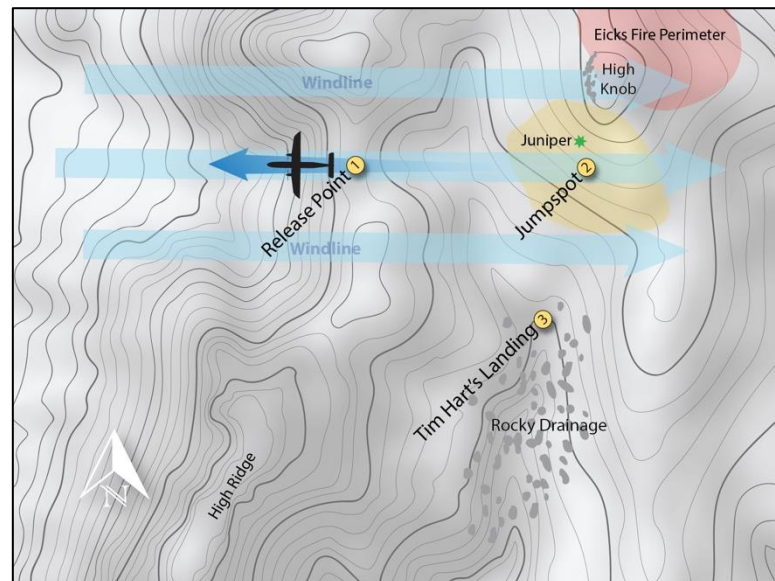
Figure 9. This diagram depicts locations relevant to the incident amid land contour lines.

the last portion of flight, his canopy was observed pitching forward, resulting in a rapid rate of descent and forward speed. He landed into rising terrain at the bottom of a small spur drainage.

Based on accounts from fellow Smokejumpers and damage to Tim’s gear, it does not appear he was able to effectively flare³⁰ his canopy before striking rising terrain at a high rate of descent and speed. According to those on the ground who saw his flight—his jump partners and pilots (SEAT, jump plane, air attack, and medevac)—and from wind models obtained by the LR team, mechanical and thermal wind turbulence was a significant factor affecting the final seconds of Tim's flight. The environmental conditions appear to have changed from those identified by the streamers and experienced by the first two sticks of Smokejumpers. The environmental change in conditions was first experienced by the third stick of Smokejumpers, Tim’s jump stick.

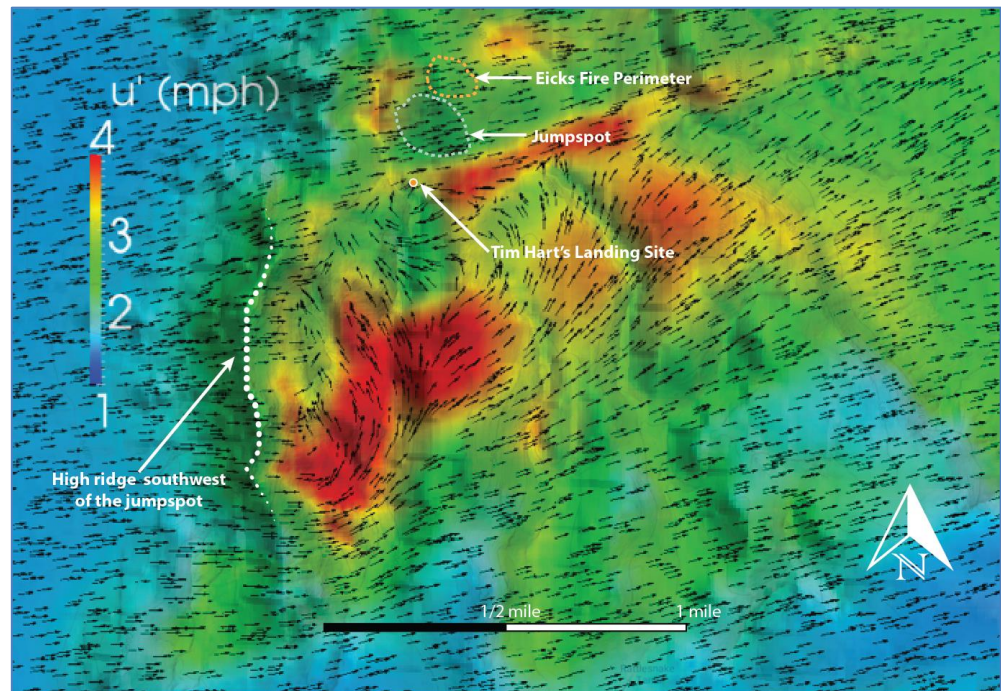
Figure 12. Average turbulent velocity fluctuations (u') about the mean velocity and mean wind vectors (the black arrows) on a terrain-following surface at 300 feet AGL. The reds and oranges indicate areas of higher turbulence. Note the re-circulation zone in the mean flow near the landing site; this is a region of strong vertical wind shear, with westerly flow aloft and easterly flow near the ground.

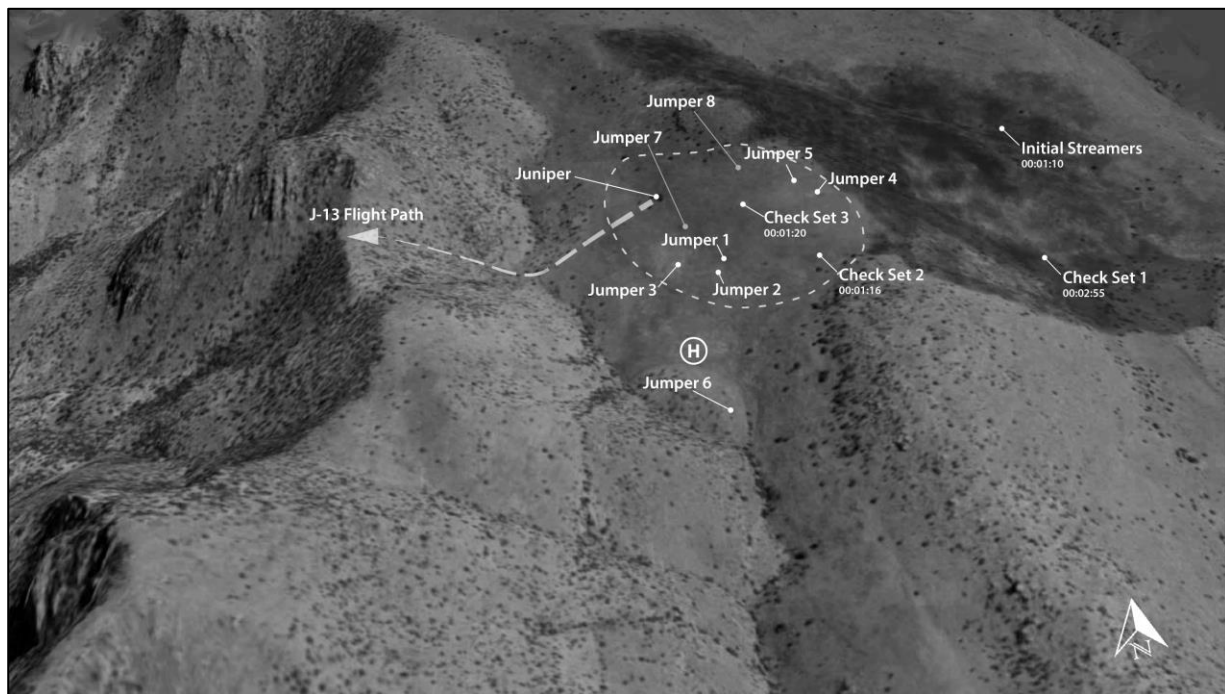
The Aft Spotter identified the juniper in the middle of the spot as the initial streamer release point to the Pilot, Fore Spotter, and the JIC when he was lining up the plane with the streamers to spot run. He may have also mentioned this in his briefing to the Smokejumpers, but we do not know whether the Smokejumpers understood the juniper to be the focal point for the spot or just a handy reference for the Spotter. None of the Smokejumpers appeared to be, or talked about, aiming for the juniper.

Figure 13. Smokejumper and streamer landing locations and helispot location.

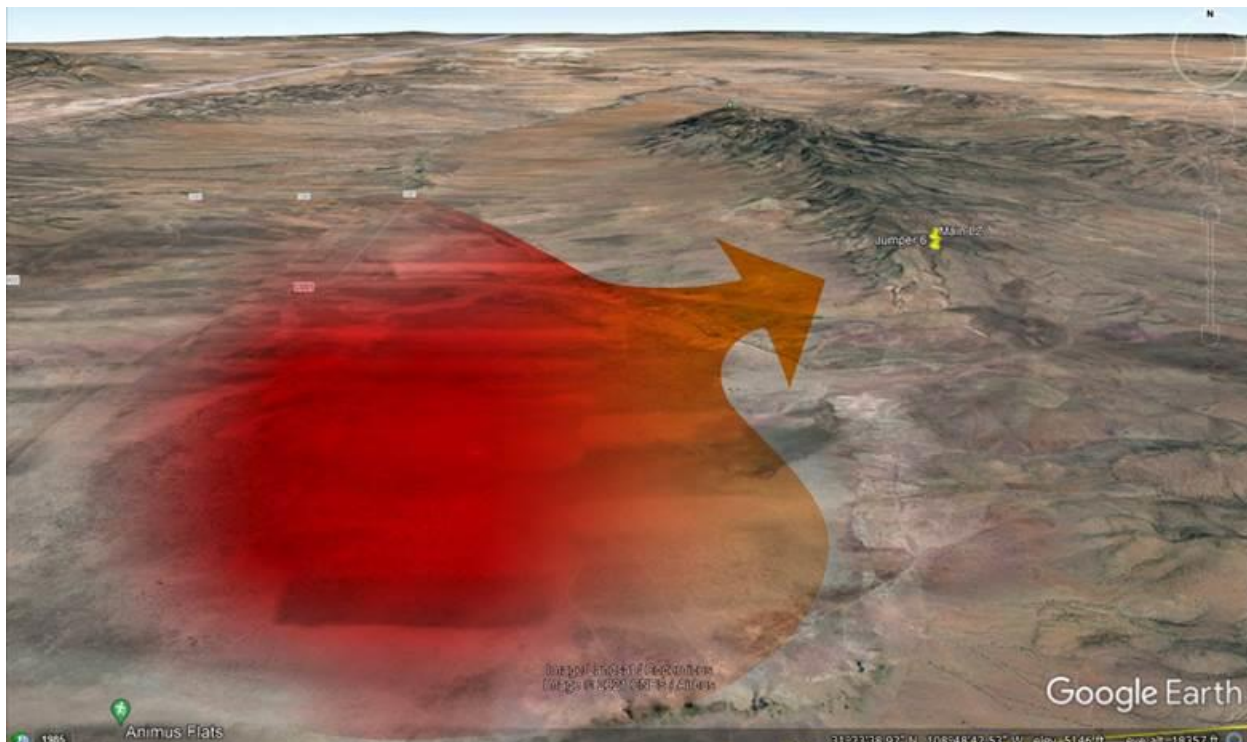
An illustration of the dry lakebed and valley to the west of the LZ and the direction this heat would be influenced to.

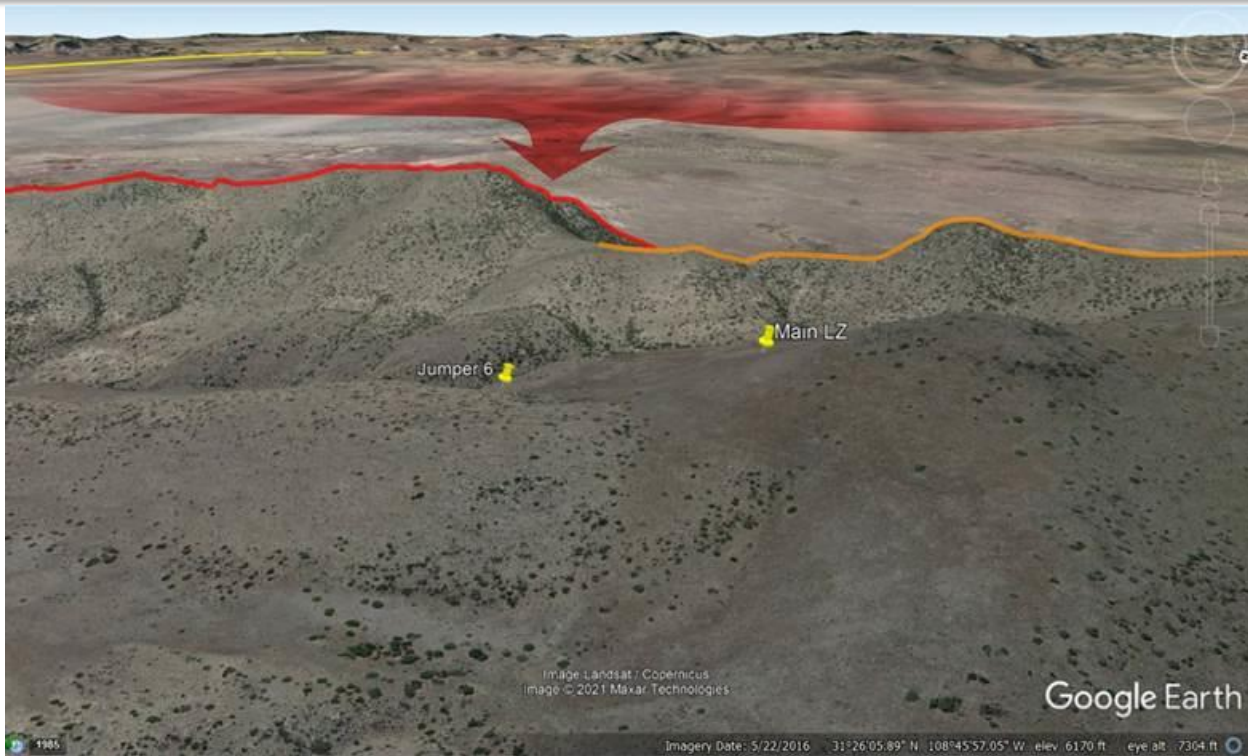
Jumper 6 landed behind higher terrain. From this perspective it is less clear that Jumper 6 landed further west, closer to the ridge than the main LZ was, but that is also notable.

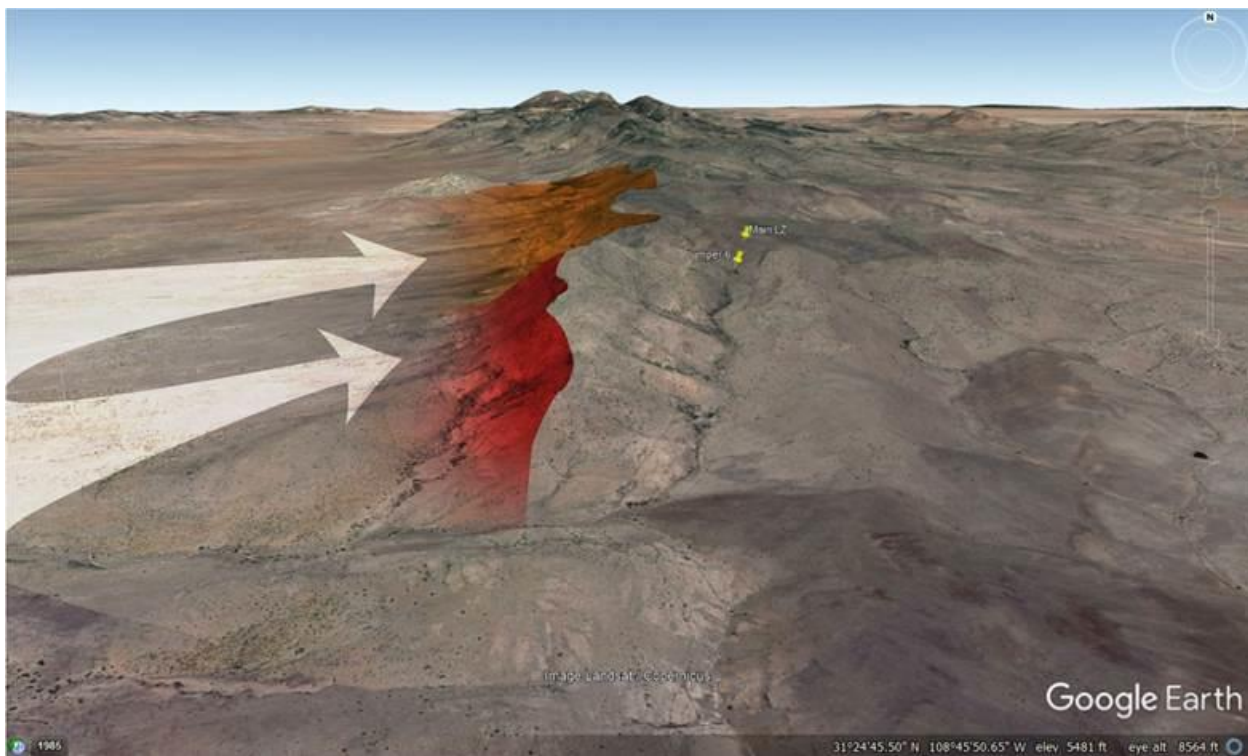
In addition to the prevailing wind pushing over the ridge to the west of the LZ, there would also be pulses of anabatic flow climbing the 1.5 mile long draw directly to the south of the LZ (that flow is not pictured).

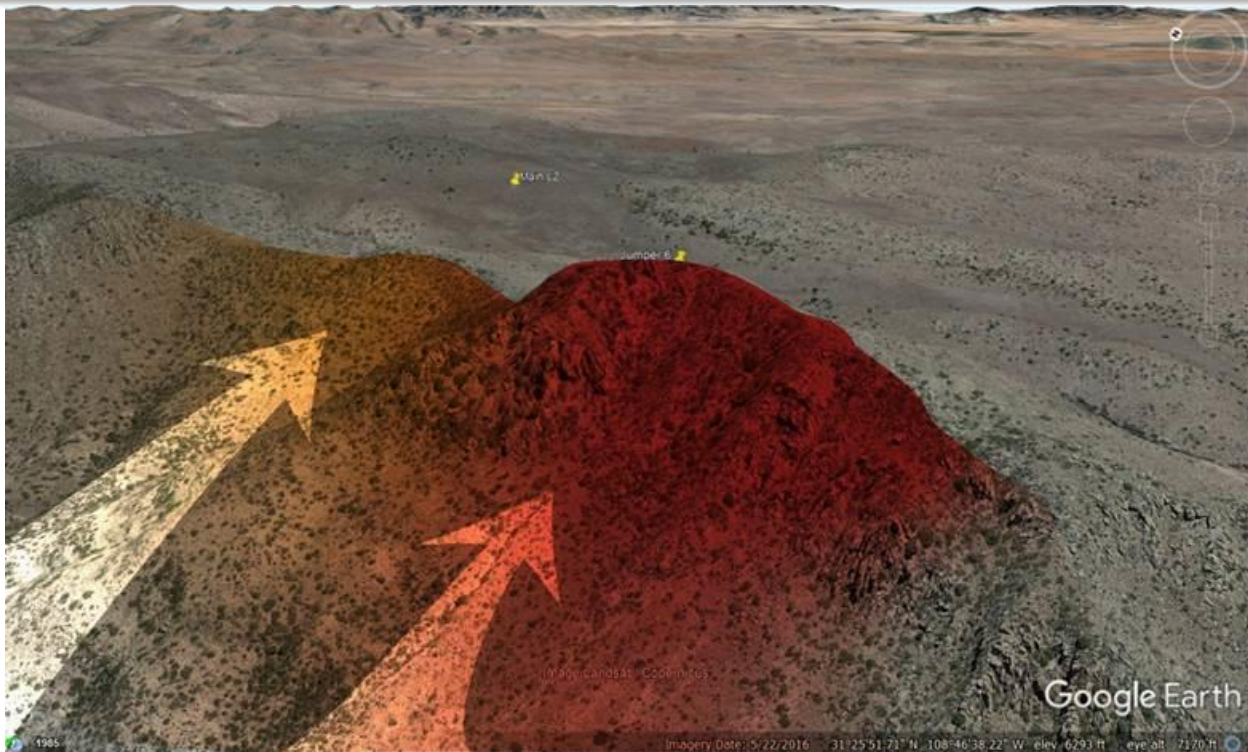
Approximate wind direction, showing Jumper 6's landing area being closer behind taller terrain compared to the main LZ.
