# Engine Rollover Lessons Learned Review

Fawn Fire  
Northwest Colorado District, White River Field Office

July 2018

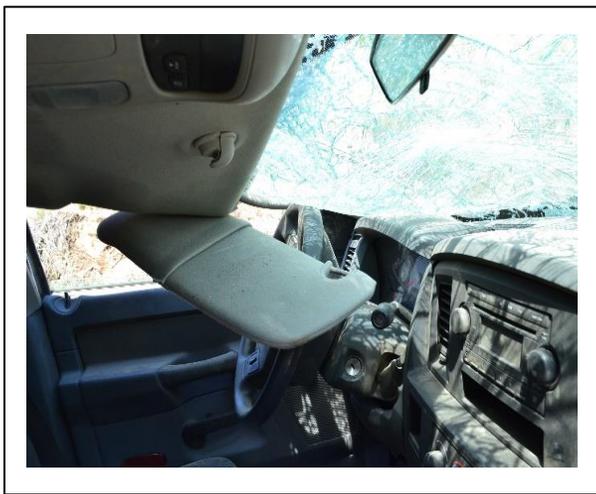
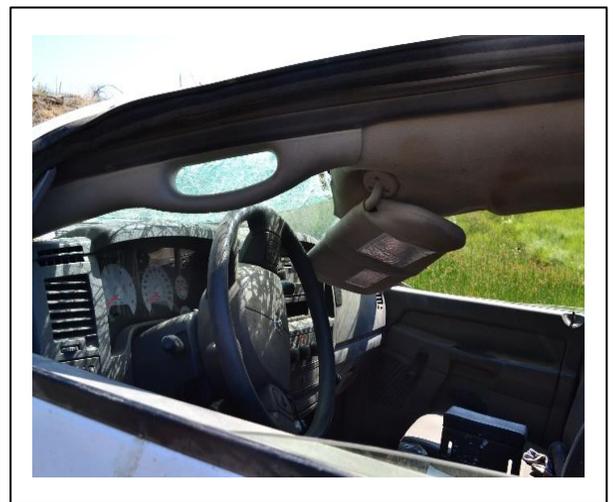
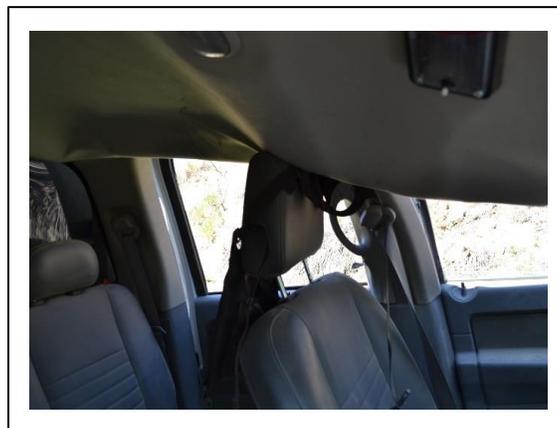
The crew of Engine 2 chase was the first to arrive on the scene of the accident with the TFLD arriving shortly thereafter. There was some difficulty locating Engine 1 due to the darkness and Engine 1’s resting position below the road. The damage to the cab of the engine was extensive, especially on the driver’s side.

The Engine 1 crew reflected on the value of the headache rack in this particular accident, and how it appeared to have kept the cab from getting crushed any worse than it did. While not all Type 6 engines may have a headache rack or a roll bar, this one did, and it could have been a life saver.

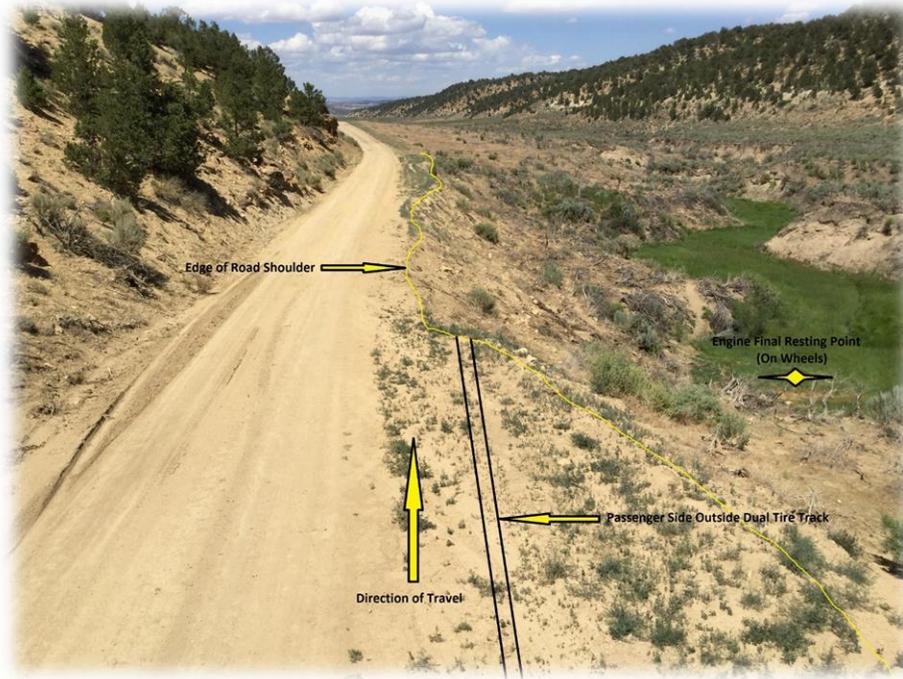
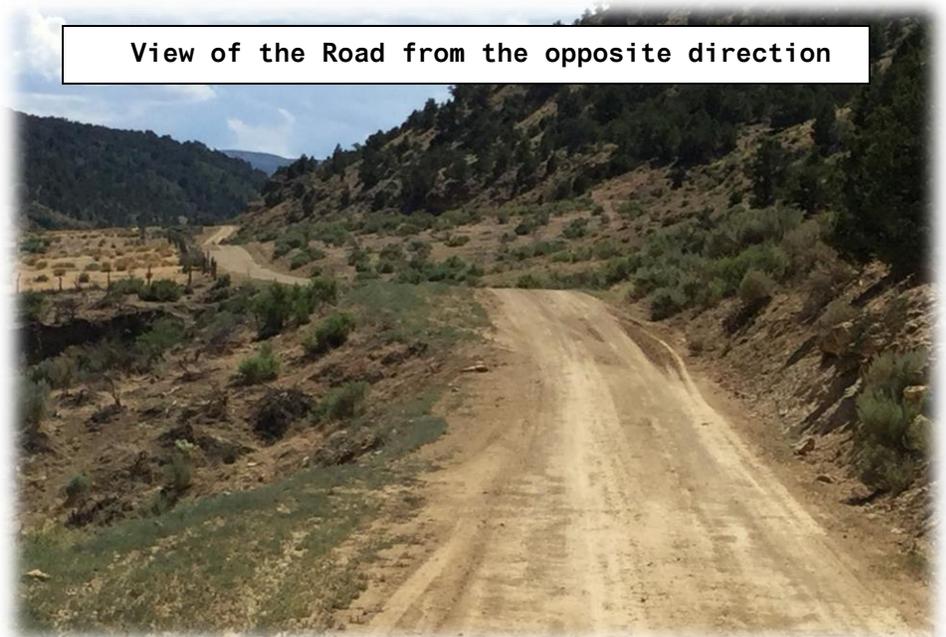
It might be expected that everyone's attention would be focused on the worst part of their travel between the fire and ICP. Once down off the dozer line and onto county road 29 traveling back toward ICP, the roadbed is graded and maintained. However, after having several pieces of heavy equipment, watertenders, multiple engines and pickup trucks, the roadbed turned into

deep dust typical to many areas of the arid west. The roadbed in most places, including on both sides of the accident site, is approximately 25 feet wide. There are some spots on the county road however, where past erosion caused the roadbed to narrow to approximately 16 feet. As illustrated in the photos above and below, the narrowing of the roadbed is quite dramatic. Additionally, there is a slight uphill and a curve to the left immediately preceding the narrowing of the road. With reduced visibility from the dust and the darkness from the late hour, that change in roadbed width could have had dramatic results.

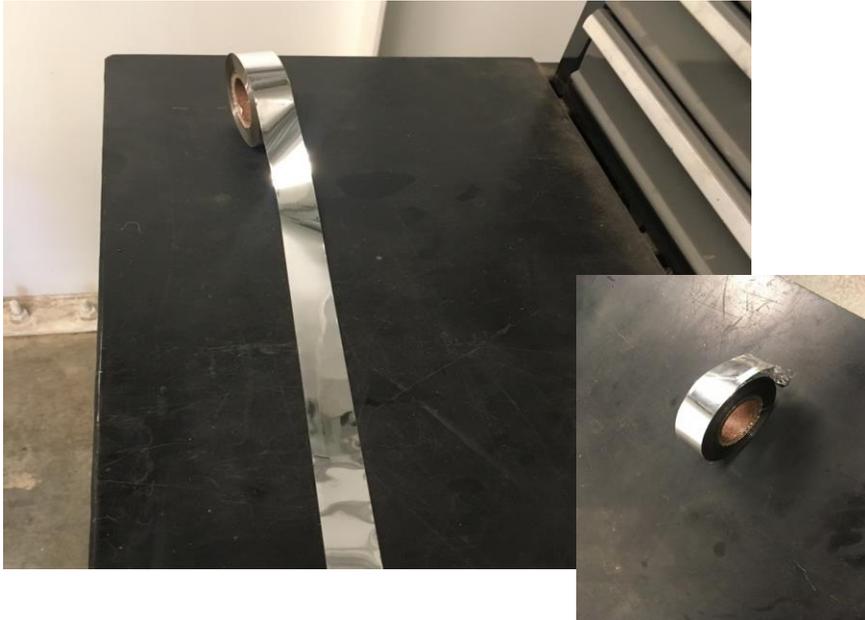
In hindsight, one of the fireline overhead told the Review team that he wished he had flagged the section of road where the rollover occurred. He had noticed this particular section of road earlier in the day. This observation spurred a discussion of whether or not flagging would even be visible in the dark and dusty conditions. One of the Review team members retrieved a roll of flagging from his work truck. It was a silver mylar reflective type of flagging that is much more visible in the dark.
