# Informational Summary Report of Serious or Near Serious CAL FIRE Injuries, Illnesses and Accidents

# GREEN SHEET

## Fire Shelter Deployment

Kincade

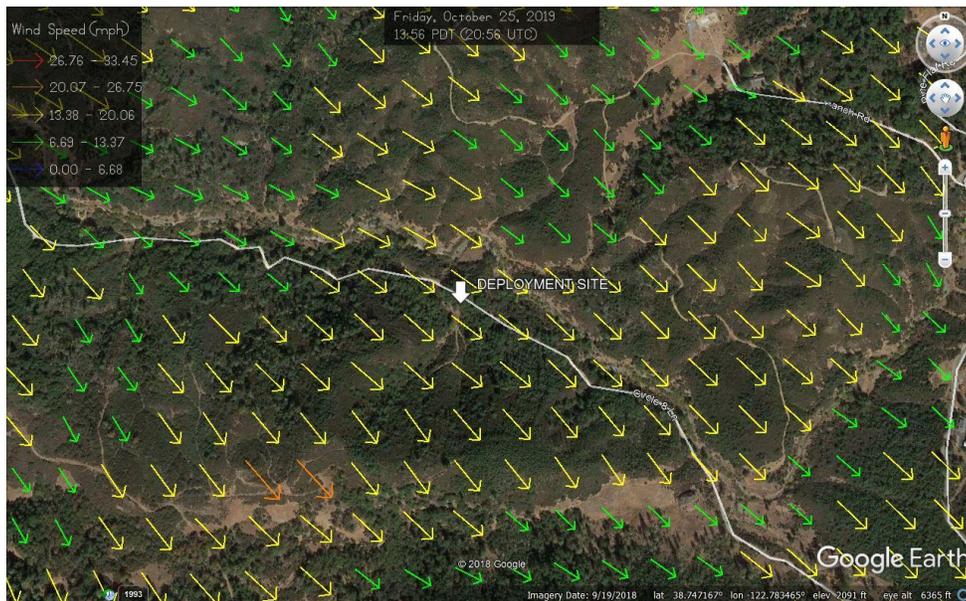
Prior to the shelter deployment, there was a **significant directional wind change** from a westerly wind to a northerly wind. This northerly wind was in alignment with the drainage associated with the shelter deployment. At the time of the incident, the area was experiencing a northwest wind between 10 and 16 miles per hour. This flow aided in pushing the fire spread from the northwest to the southeast and up the drainage of Little Sulphur Creek.

**Wind conditions near the time of the shelter deployment.**

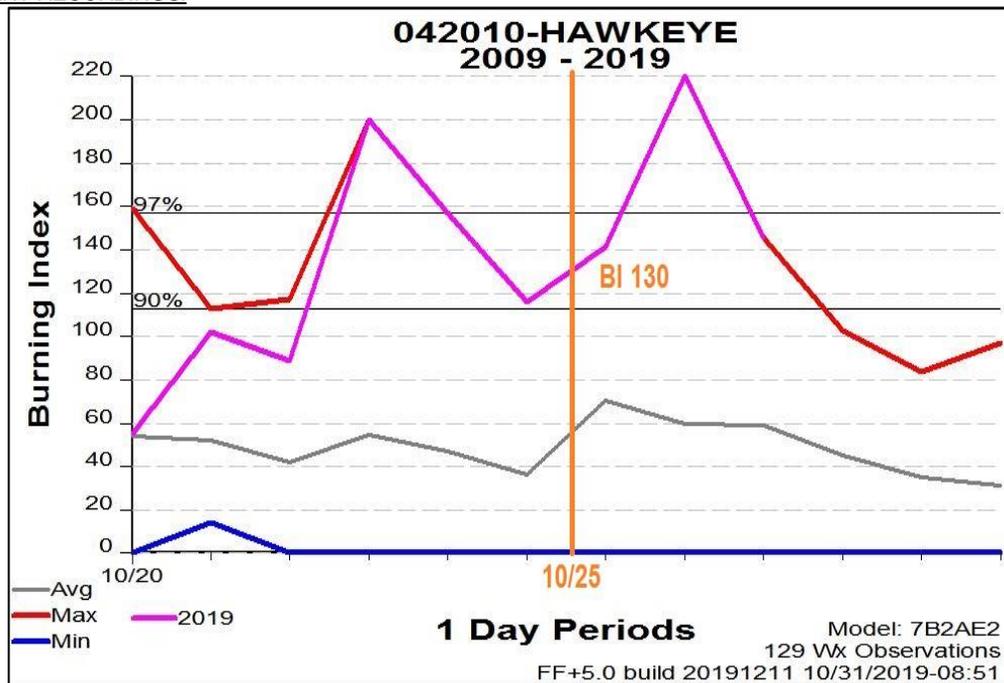
The Burn Index recorded from October 23 through October 28, 2019 broke the historic Burn Index Record for that respective time period at the Hawkeye RAWS.

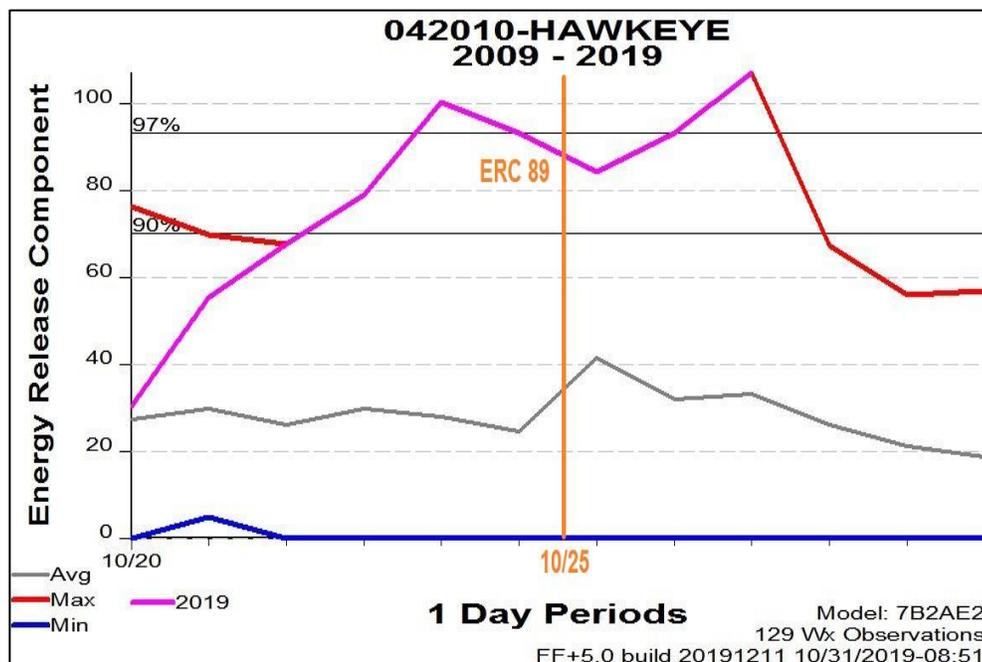
The Energy Release Component recorded from October 22 through October 28, 2019 broke the historic Energy Release Component for that respective time period at the Hawkeye RAWS.

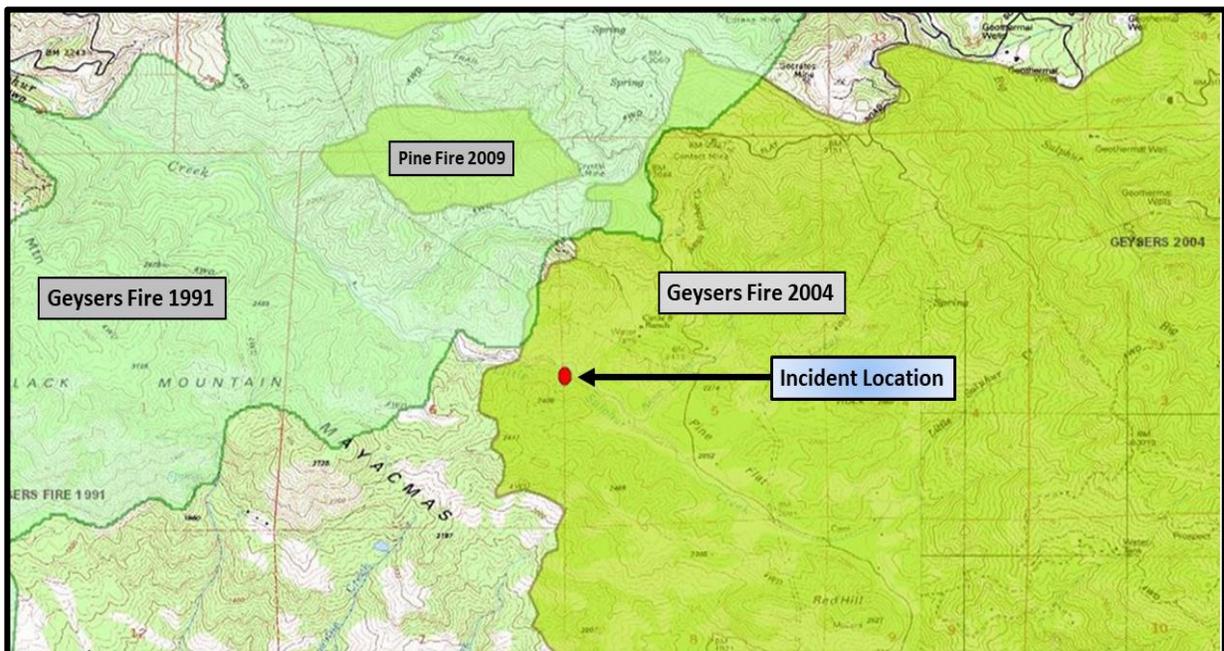
**Fire History Map displaying the Geysers Fires of 1991 and 2004 as well an area southwest of the incident site with no recorded large fire history in the prior 70 years.**

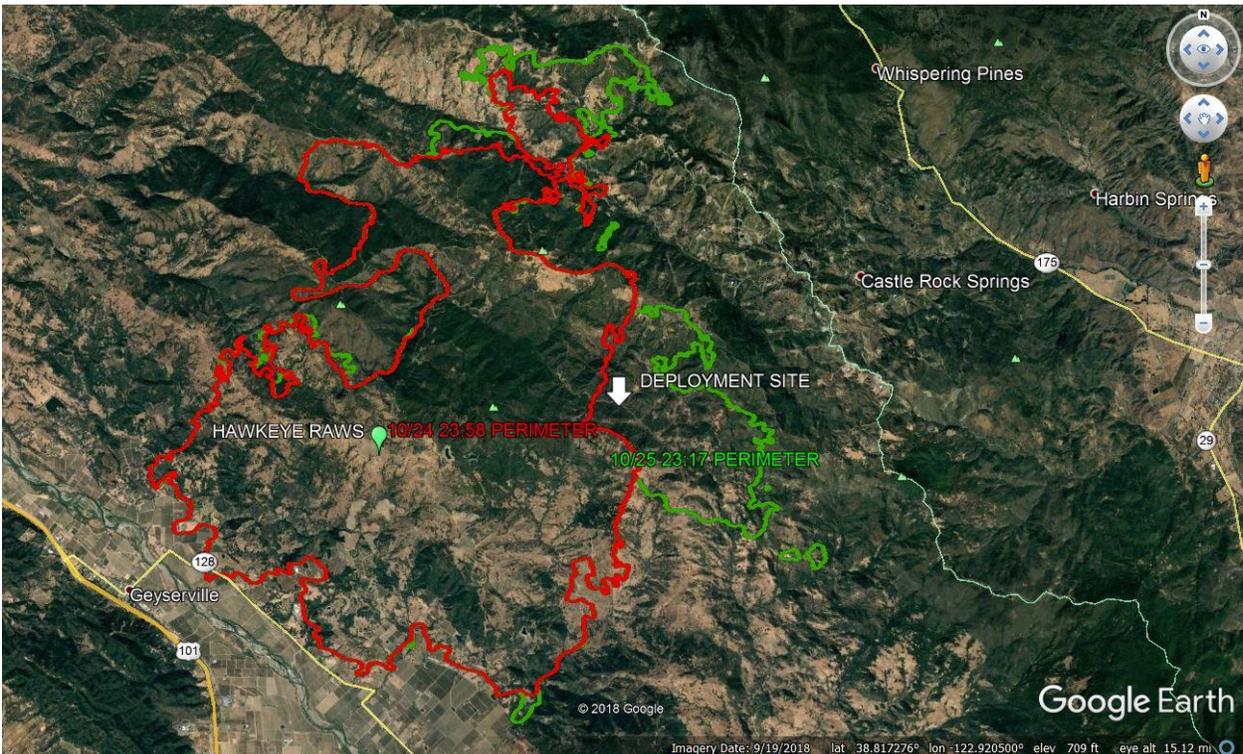
**Aerial image of the Kincade Fire perimeter the day before the shelter deployment.**

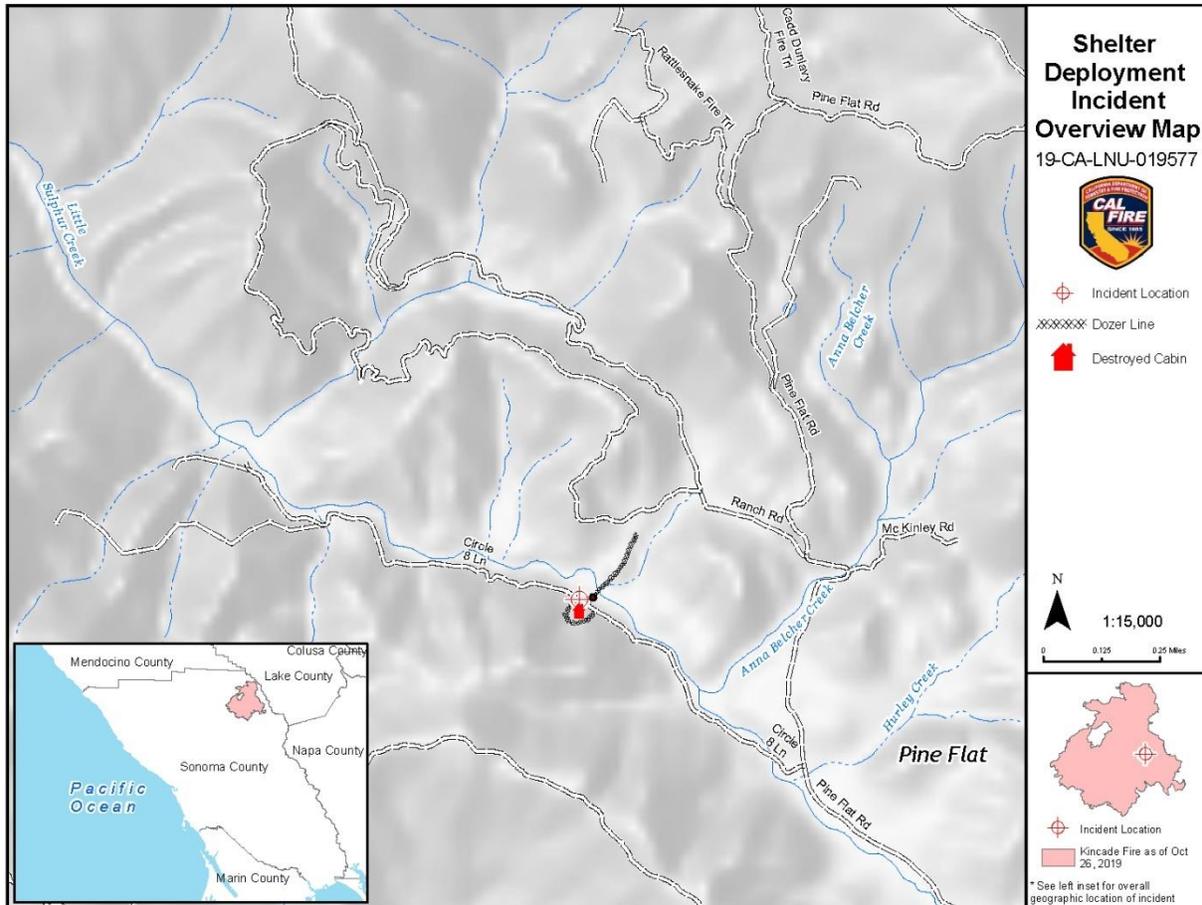
**Map 1- Overview showing incident location in relation to the Kincade Fire perimeter on October 26, 2019.**

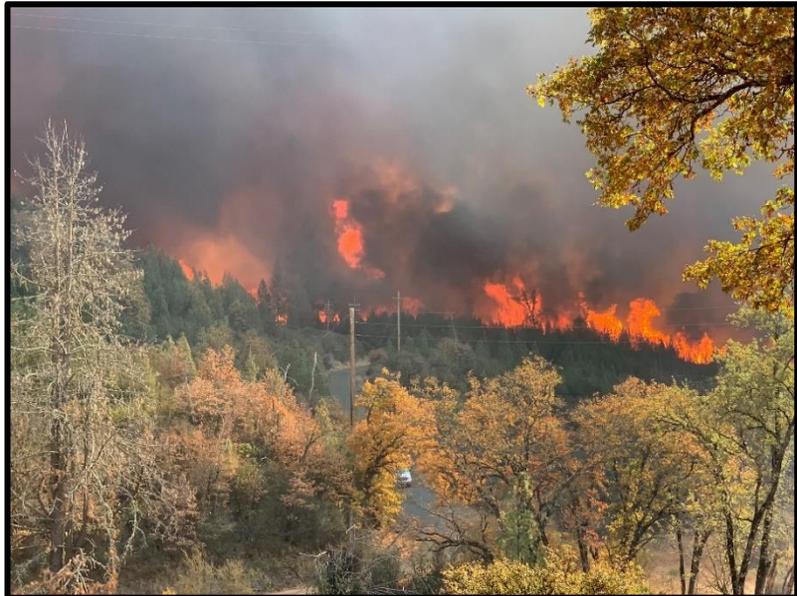
**Photo 1- Fire behavior as viewed looking south toward the drainage of the shelter deployment (4:06 PM, 10/25/19)**

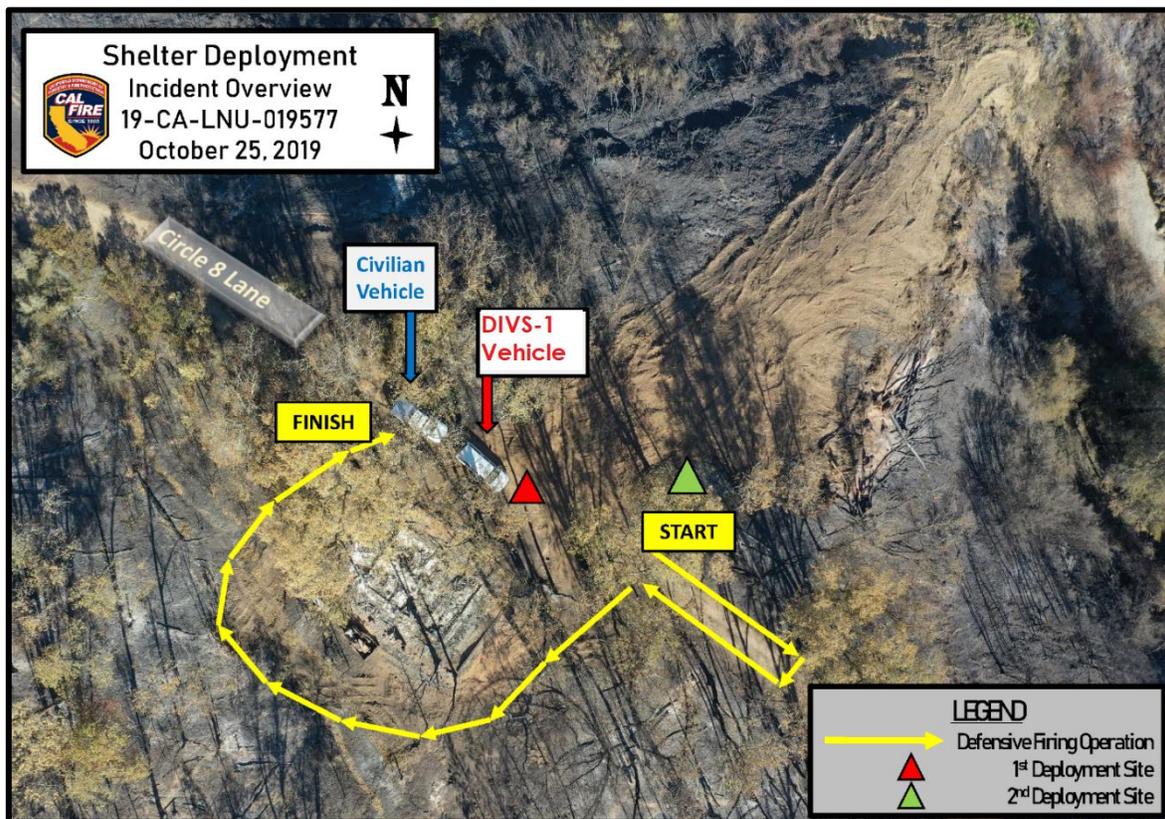
Utilizing a fusee, DIVS1 conducted a defensive firing operation to create a larger area of refuge. The firing operation was initiated southeast along the downhill side of Circle 8 Lane, returning on the opposite side of the road. Firing continued around the cabin on the outside edge of the dozer line (Photo 2). At approximately 4:14 PM, as DIVS1 completed the firing operation, a pick-up truck with two civilians arrived at DIVS1's location on the road and stopped behind DIVS1's vehicle. These two civilians were travelling east toward the cabin site from another residence located at the end of Circle 8 Lane.

**Photo 2 - Aerial overview of deployment location showing approximate location of vehicles, firing pattern along road and around cabin (destroyed), and dozer line coming up from drainage to the northeast.**

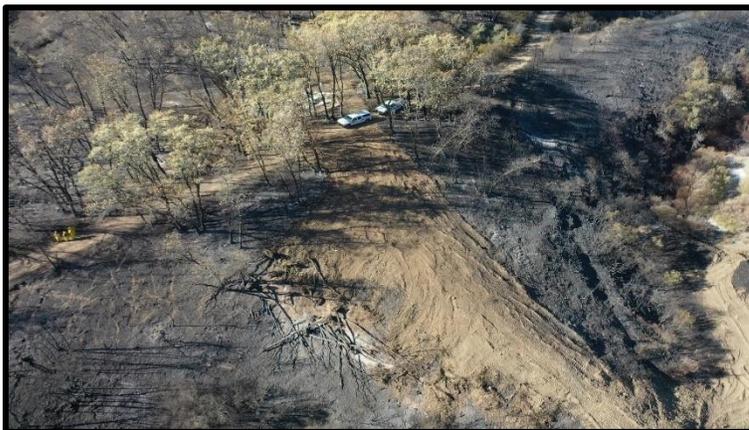
**Video 1- Aerial overview of deployment location showing decreased fire intensity due to firing operation around cabin.**
