North Eden Fire

Faciliated Learning Analysis

Date of Incident: August 16, 2018

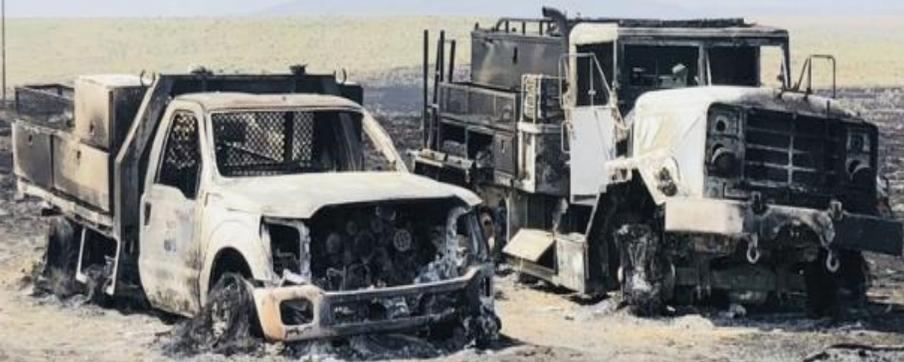
Figure 1 – Cover Photo of the two burned vehicles on the North Eden Fire on August 17, 2018. Photo Credit: Brandon Everett.

At 1415, Dispatch was notified that two vehicles were damaged. Two fire trucks were engulfed in flames. A disabled vehicle in combination with advanced fire behavior and a resistance to suppression created an instance that could have easily led to a loss of life or injury. All firefighters involved in this event escaped with no injuries. This was a close call that leads to many learning opportunities.

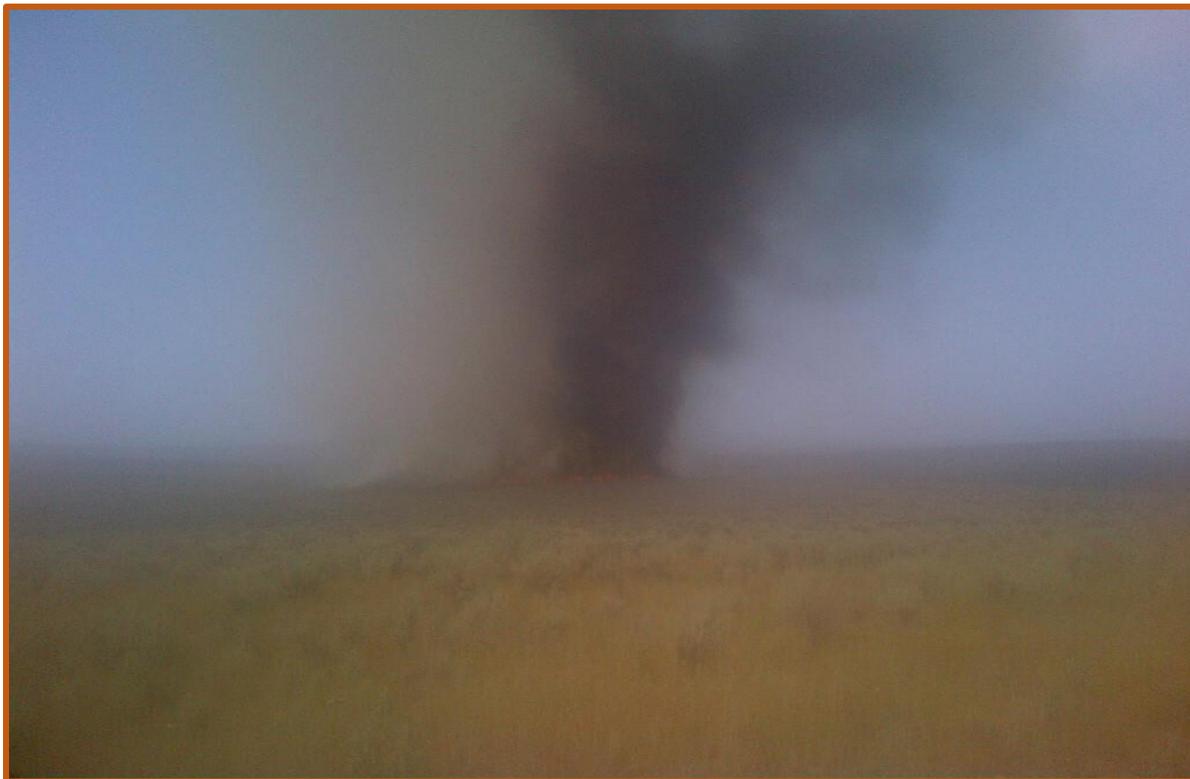
Figure 3 – The North Eden Fire on August 16 at 1336 hours. While this image is blurry, it is the only photo taken upon arrival at the fire, showing relative fire size. Photo Credit: Rob Leifson, Woodruff Fire Department Chief.

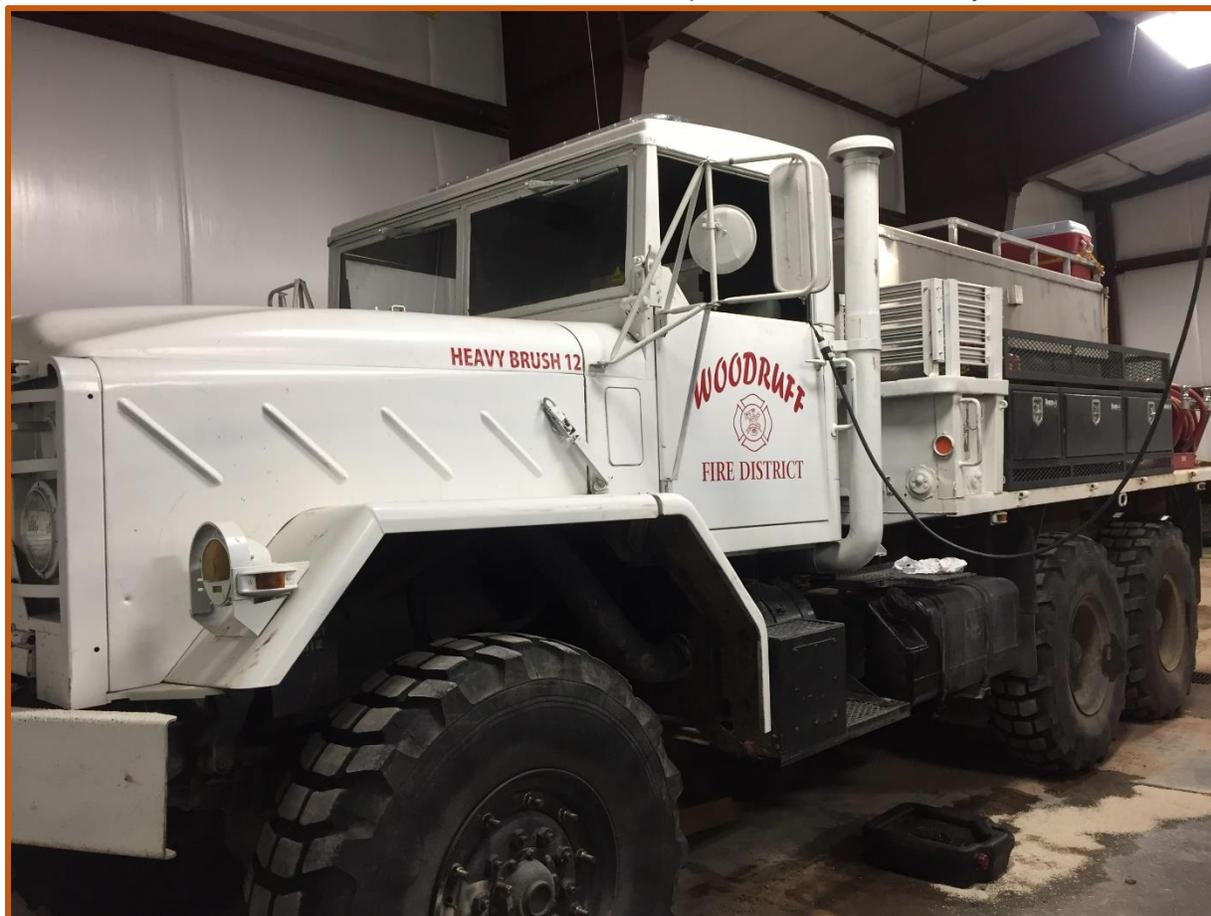
Figure 4 – The Woodruff Fire Department’s Heavy Brush 12, 5-ton truck. (This is the sister truck to Heavy Brush 13 that was burned over in this incident). Photo Credit: Susie Tracy.

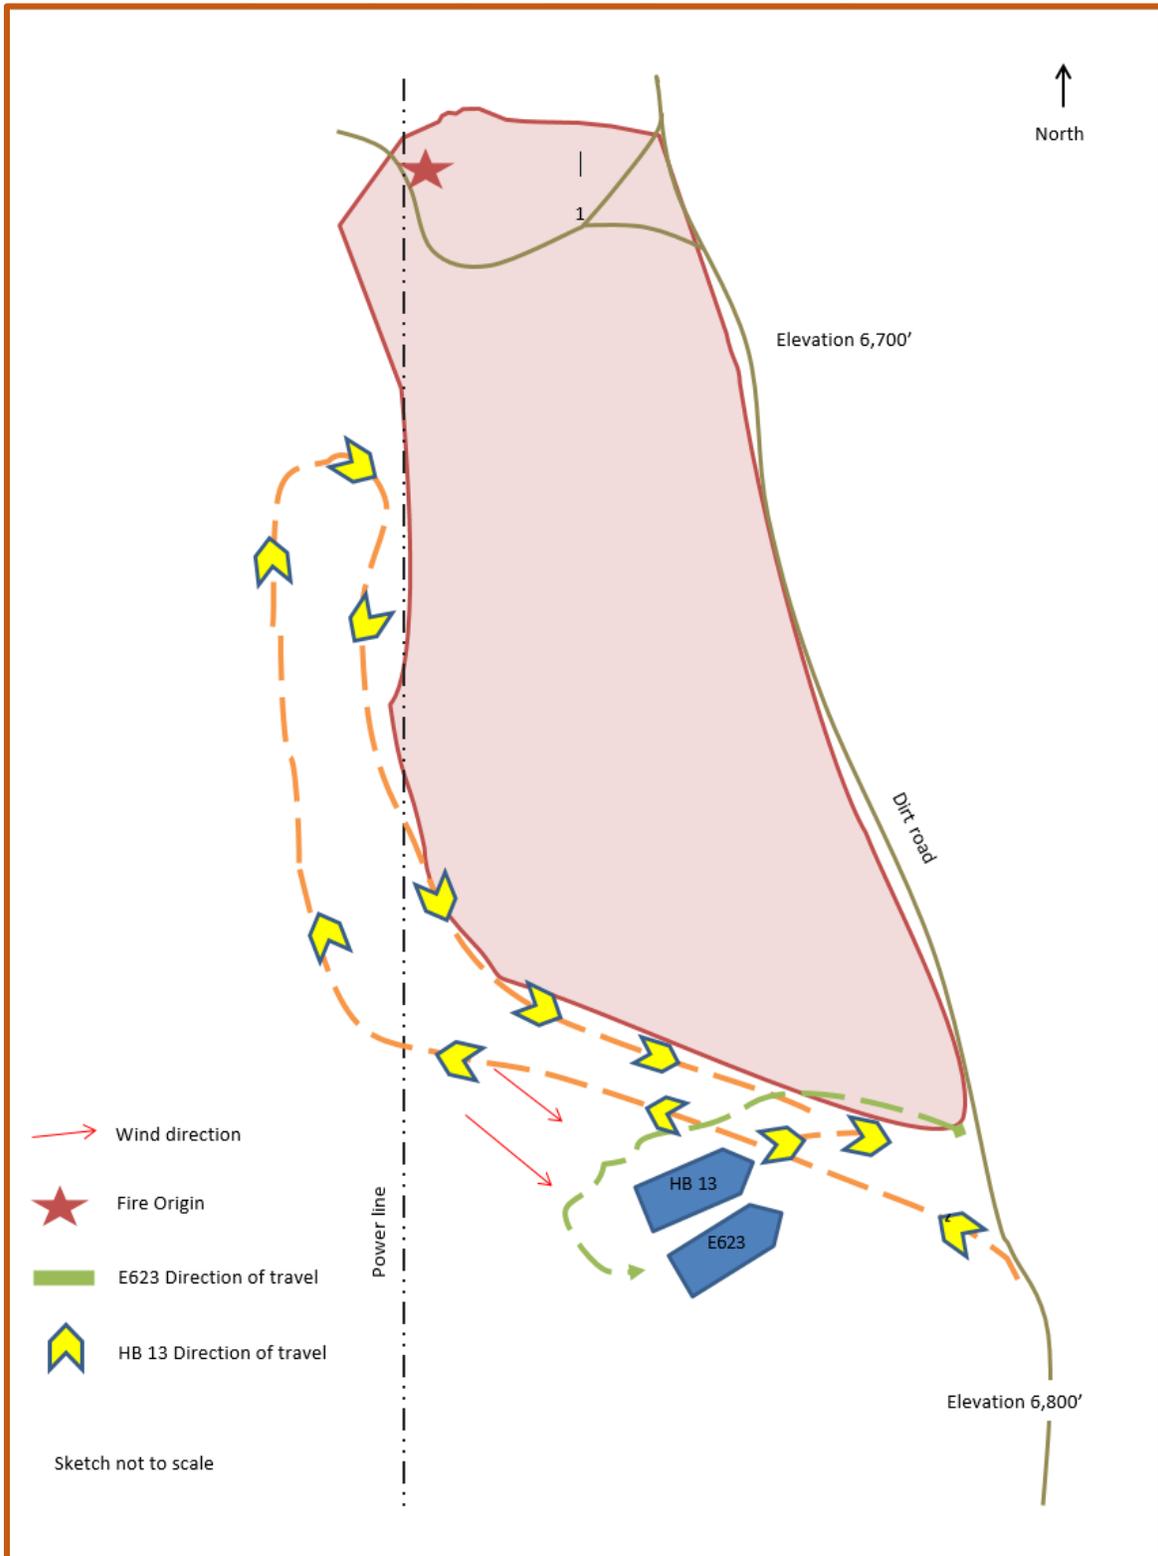
Next, the Heavy Brush 13 Operator stopped and began to back-up to reinforce his wet line. While traveling in reverse, the operator noted an increase in heat intensity inside the truck and turned to avoid the heat (see Figure 6).

Figure 6 – Depiction of travel for Heavy Brush 13 and Engine 623.

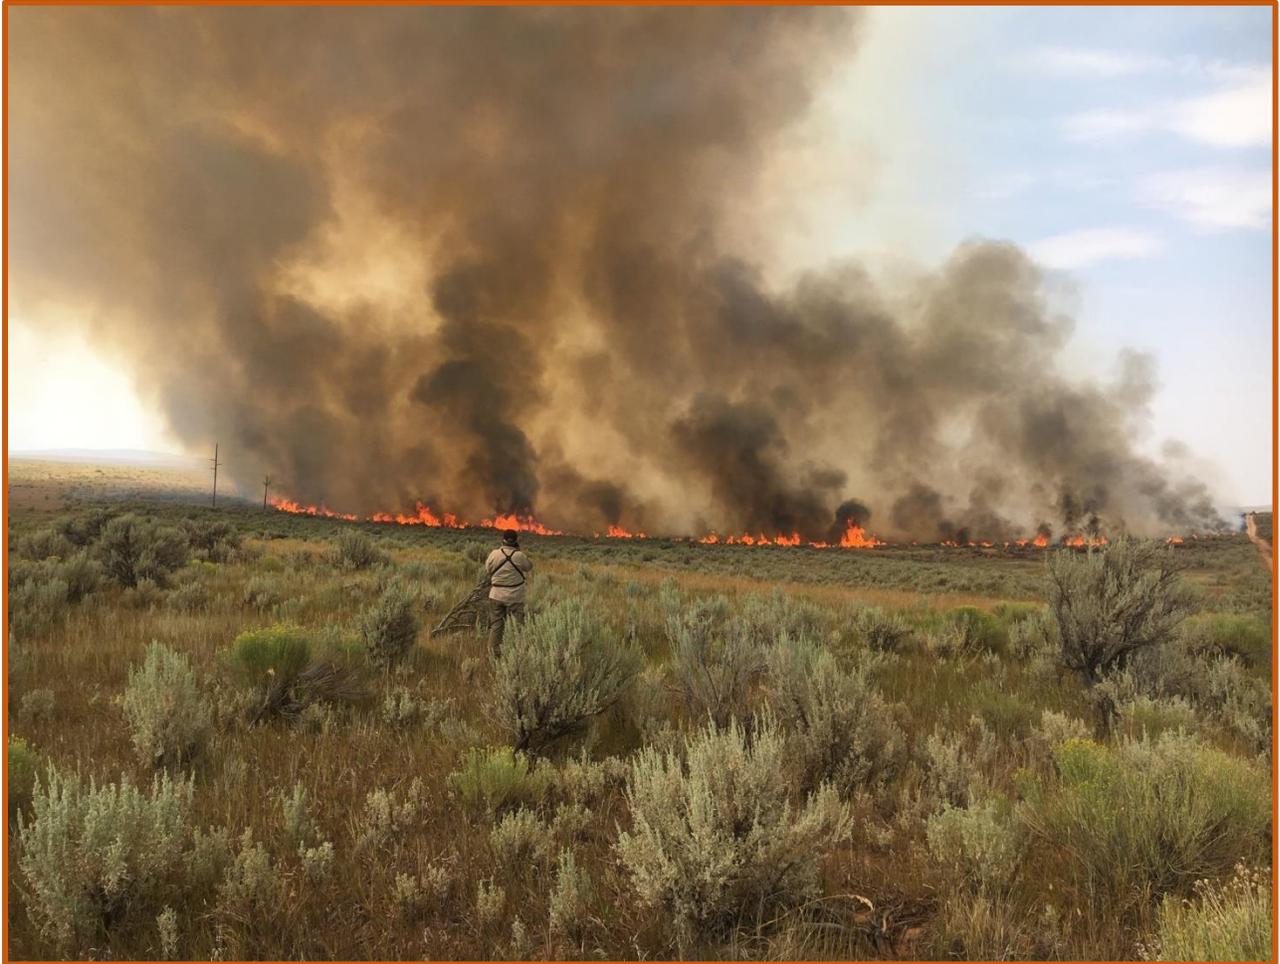
Figure 7 – One hour after burn over at 1451. This photo shows this incident’s fuels and topography. Photo Credit: David Stacey, Woodruff Fire Department.

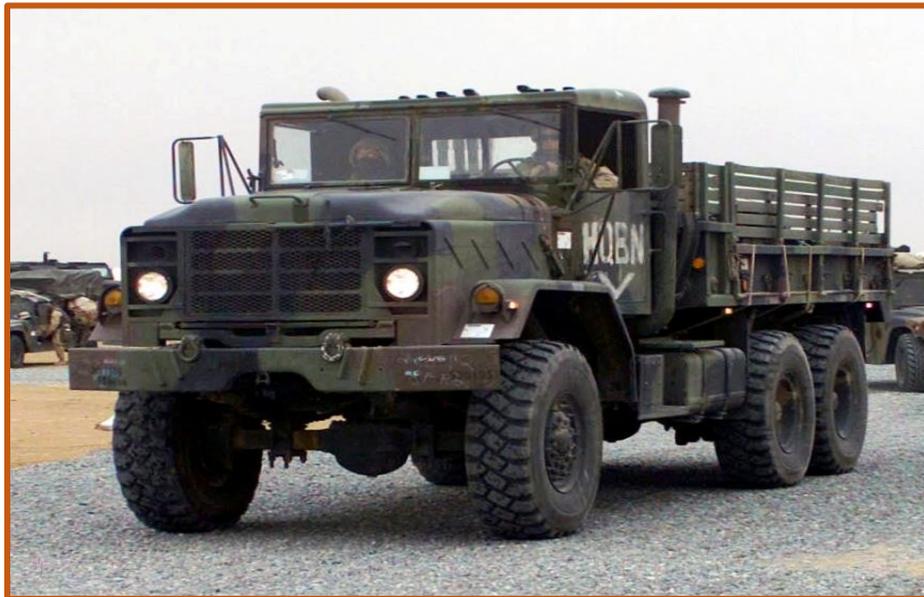
Figure 9 – A “5-Ton”. Photo Credit: Wikipedia.

The significant difference between these two pieces of equipment is the extensive use of air systems in the newer M928A2. An air compressor feeds three separate air tanks and components that use this system in the 6-wheel drive, parking and braking systems. Air brakes are used on many wildland fire vehicles like Crew Carriers, Type 3 and 4 Engines. Many new contracts for fire engines are being specified to provide protection to these critical components.

Air brake systems require compressed air to work. If a loss of air occurs, the brakes will engage and the truck cannot be moved.

Recommended Action: Education of owners and operators that the newer 5 ton Military Vehicles are Air Controlled Systems, which are more susceptible to failure from heat and snagging hazards. This is very different from the M35 6X6 "Deuce & 1/2", which are hydraulically controlled. Continued examination of poly airlines and their condition is recommended. In addition it is recommended to inspect after each operational period. Owners and operators need to be situationally aware of the fuels driven through and possible heat/flame exposures. Shielding of the airlines with heat/flame resistant materials, relocation of airlines, or replacing with more durable and fire resistant braided lines is recommended.
