Collision with terrain involving Lockheed Martin EC-130Q, N134CG

50 km north-east of Cooma-Snowy Mountains Airport (near Peak View), New South Wales, on 23 January 2020

ATSB Transport Safety Report

AO-2020-007

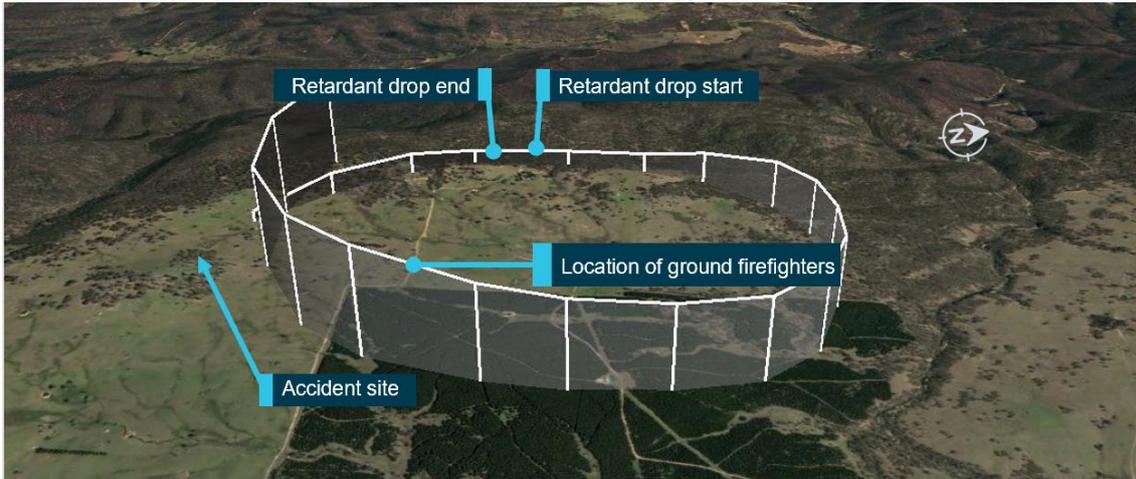
Figure 4: Accident circuit and location of the firefighters and retardant drop

At 1315:15,²⁷ a partial retardant drop was conducted on a heading of about 190°, at about 190 ft AGL (3,600 ft above mean sea level). During the drop, about 1,200 US gallons (4,500 L) of fire retardant was released over a period of about 2 seconds. A ground speed of 144 kt was recorded at the time of the drop.

At about 1315:37, the aircraft collided with terrain and a post-impact fuel-fed fire ensued. The 3 crew were fatally injured and the aircraft was destroyed.

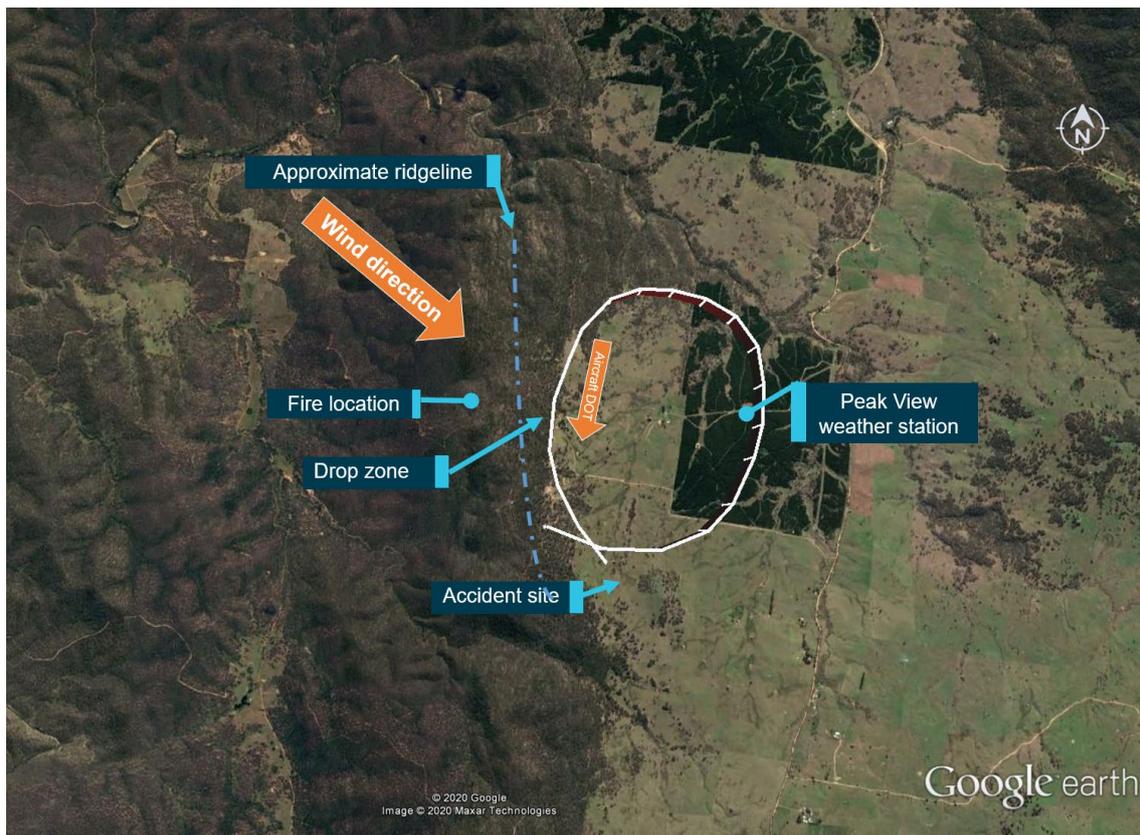
Figure 6: Accident circuit with predominant wind direction, direction of travel (DOT), and terrain

A personal weather station at Peak View, located about 1.3 km from both the drop and accident sites (Figure 6), recorded the conditions twice per hour. At about 1309 (7 minutes prior to the accident), the station recorded a mean wind of 15 kt from the west and a peak gust of 32 kt from the north, a temperature of 30 °C, and a QNH of 995 hPa.⁵² At about 1330 (14 minutes after the accident), the station recorded a mean wind of 16 kt from the west and a peak gust of 42 kt from the north-west.

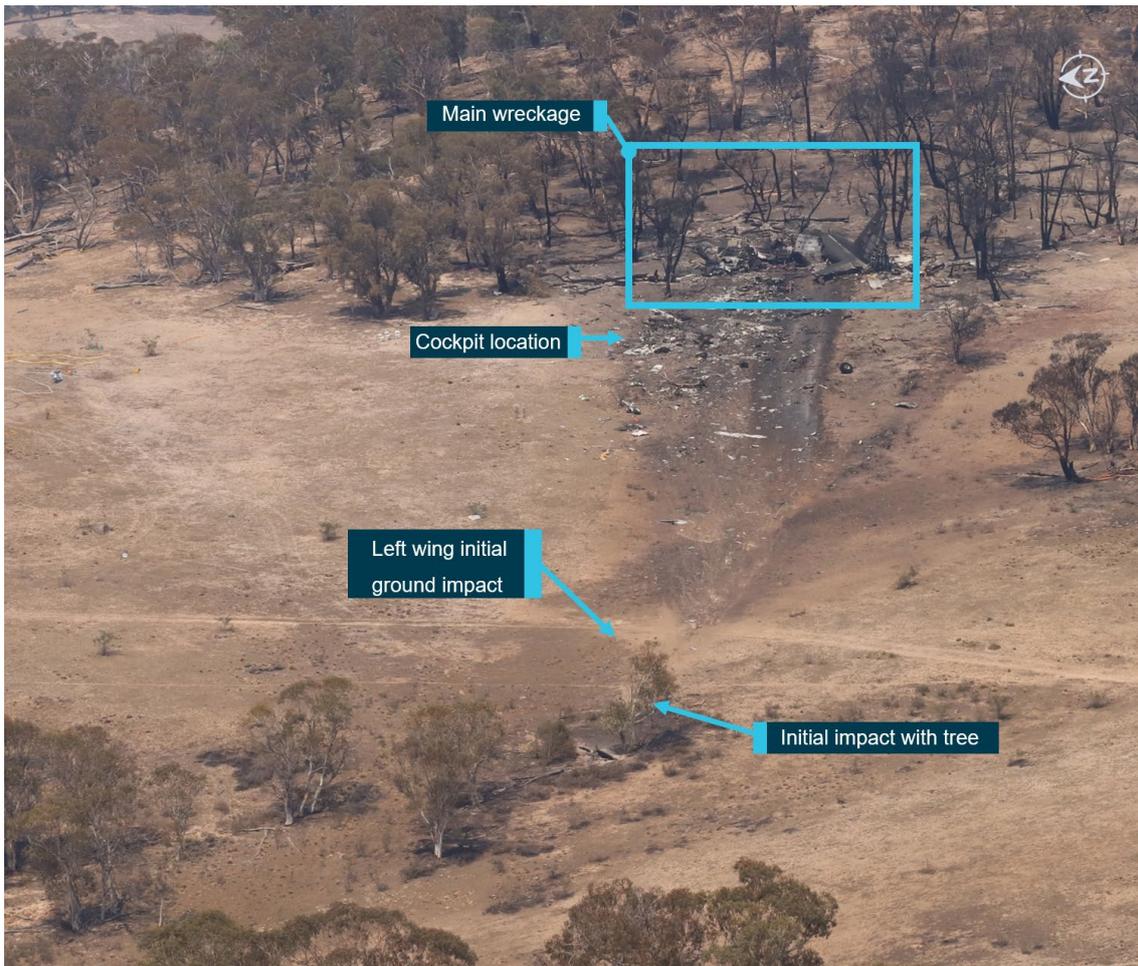
Figure 9: Accident site overview showing the wreckage trail

The RADS tank remained upright, with no fire retardant identified between the drop area and the initial impact location. However, a large amount of retardant was located in the wreckage near the tank. The system was badly damaged, with the doors fragmented throughout the wreckage, and its operational state could not be established.

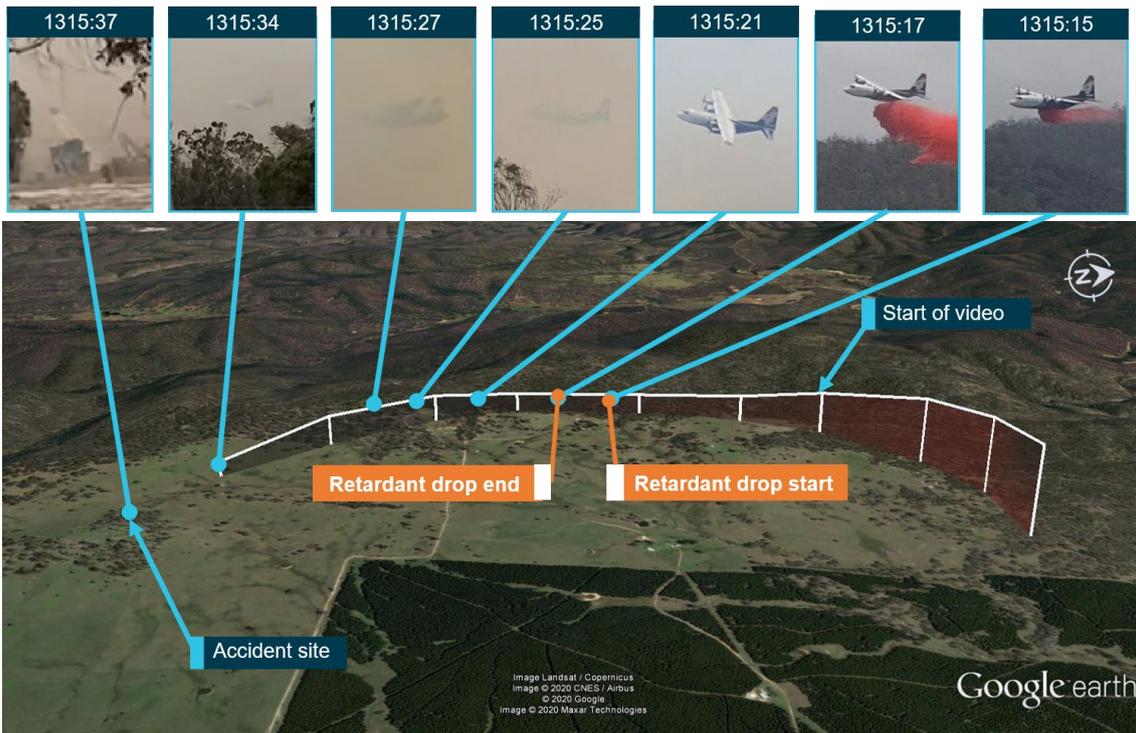
Figure 11: Aircraft attitude and approximate flight path at key times

From 1315:27 the aircraft was obscured by smoke, and the attitude could not be determined using SynthEyes. The general attitude could be determined from basic photogrammetry at limited points from this time.

For about 10 seconds after the completion of the drop, a positive rate of climb was achieved, with the aircraft climbing about 170 ft (to 3,770 ft AMSL) from the drop height. Following this, the aircraft was then observed descending. At 1315:34, the aircraft was seen at a very low height above the ground, in a slight left bank, immediately followed by a significant left roll just before ground impact. The elevation of the terrain, while undulating, also increased by about 40 ft from the drop site to the accident site.

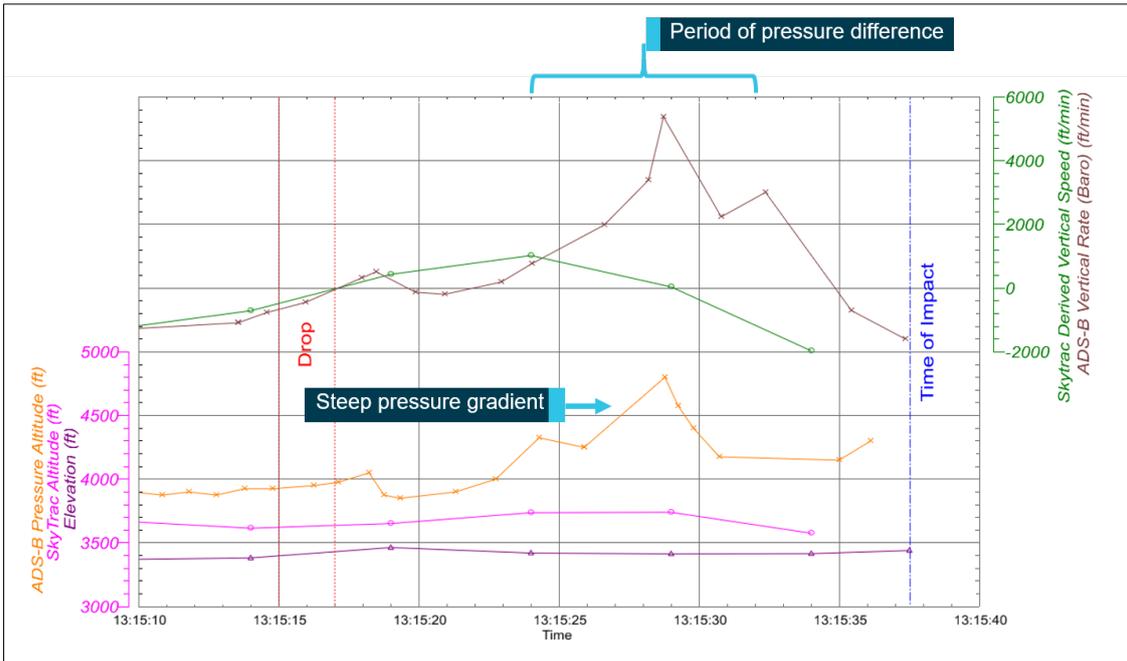
Figure 13: Comparison of SkyTrac and ADS-B altitude and vertical rate data showing the low-pressure spike

Note: ADS-B pressure altitude shown as recorded references the international standard atmosphere QNH rather than actual QNH.
 Source: ADS-B and SkyTrac, annotated by the ATSB

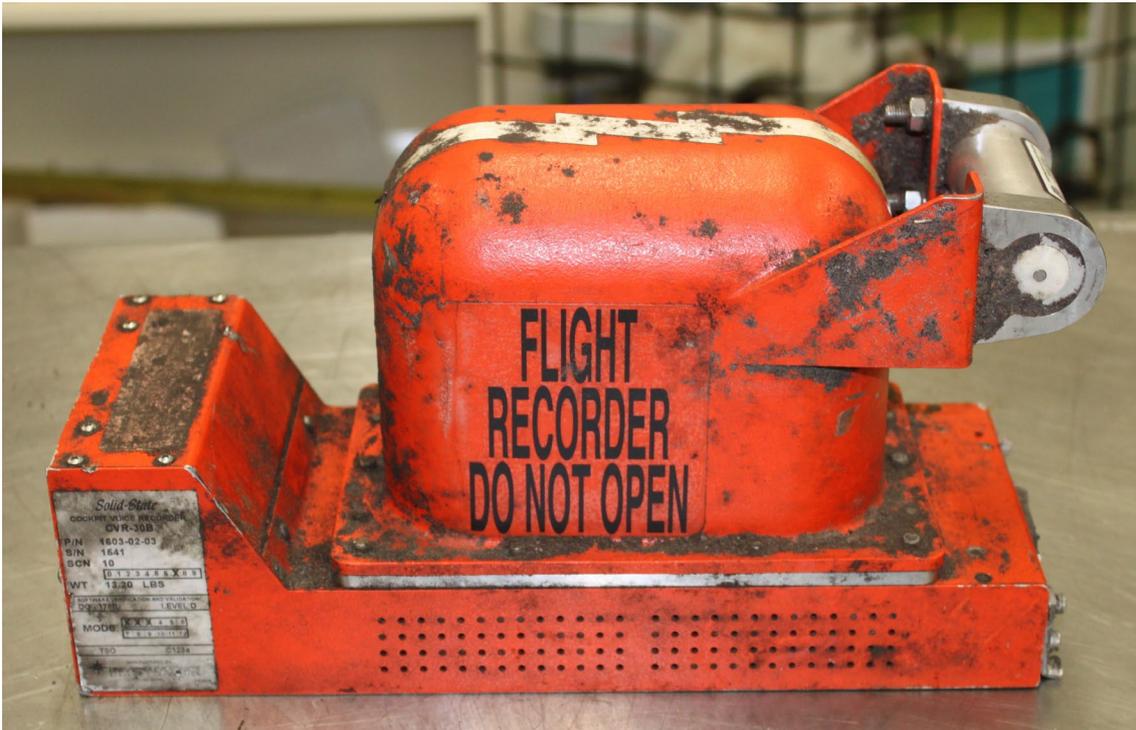
Figure 14: N134CG cockpit voice recorder

The CVR was recovered from the aircraft and transported to the ATSB's technical facility in Canberra on 25 January 2020 for examination and download. Thirty-one minutes of audio data was successfully downloaded. However, the audio was from a previous flight when the aircraft was operating in the US. No audio from the accident flight was recorded on the CVR.
