**Preliminary Summary Report of Serious or Near Serious
CAL FIRE Injuries, Illnesses and Accidents**

GREEN SHEET

Fatality Firefighter Entrapment

Thomas Fire

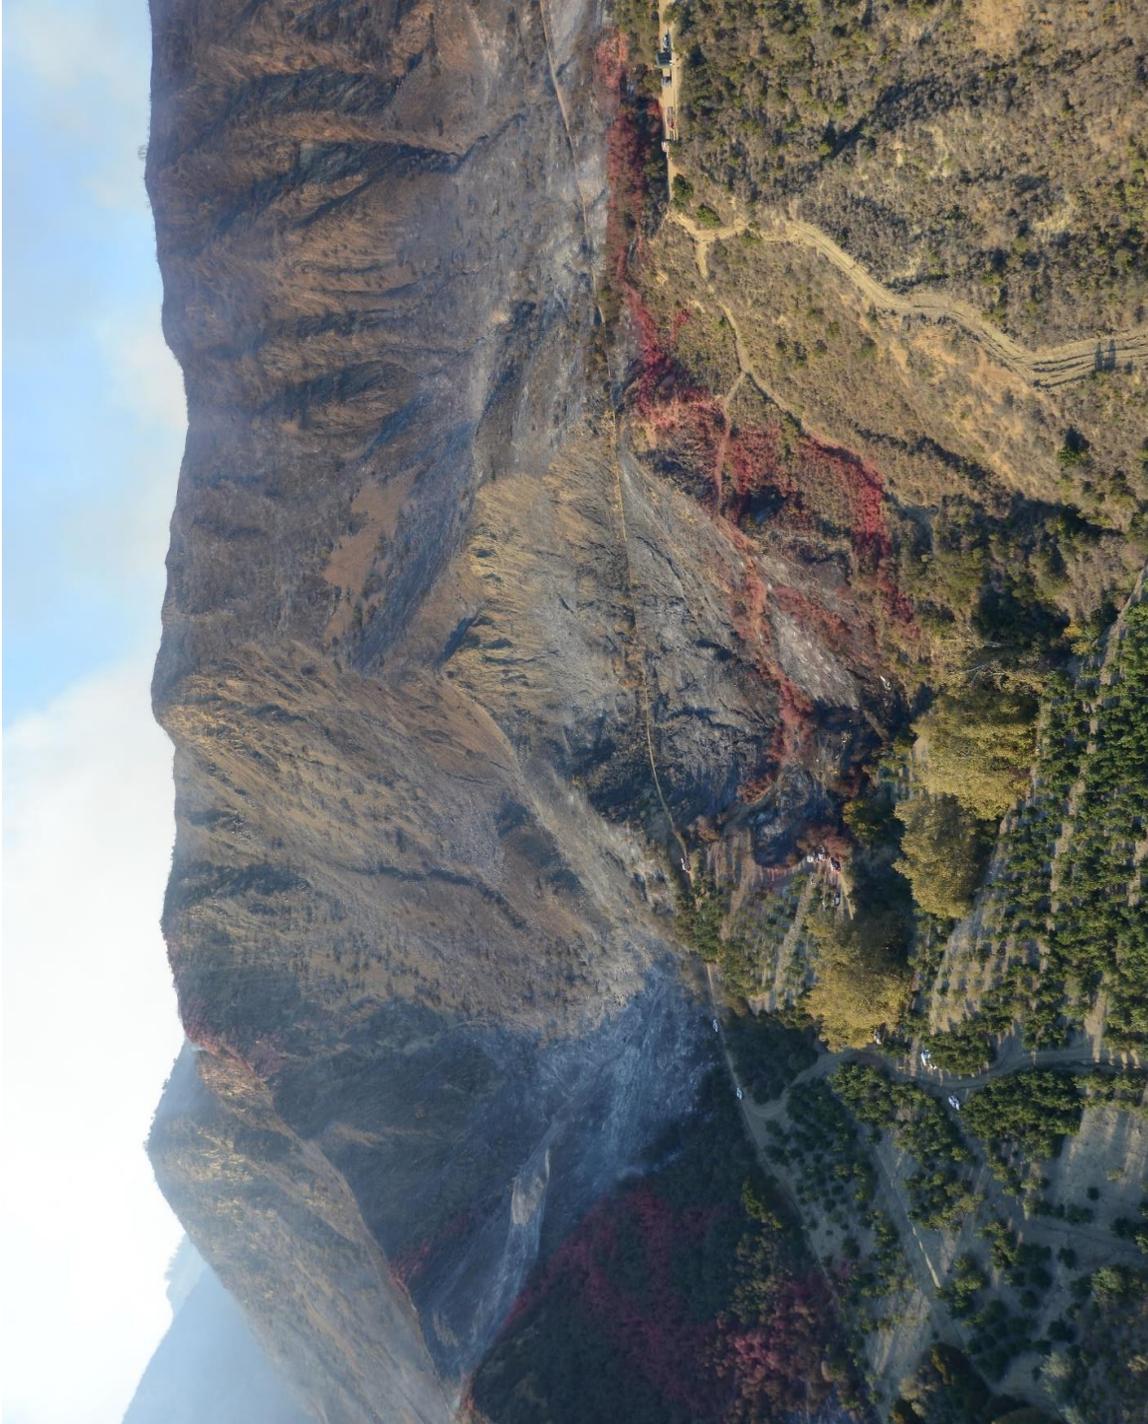
View of entrapment site looking northwest

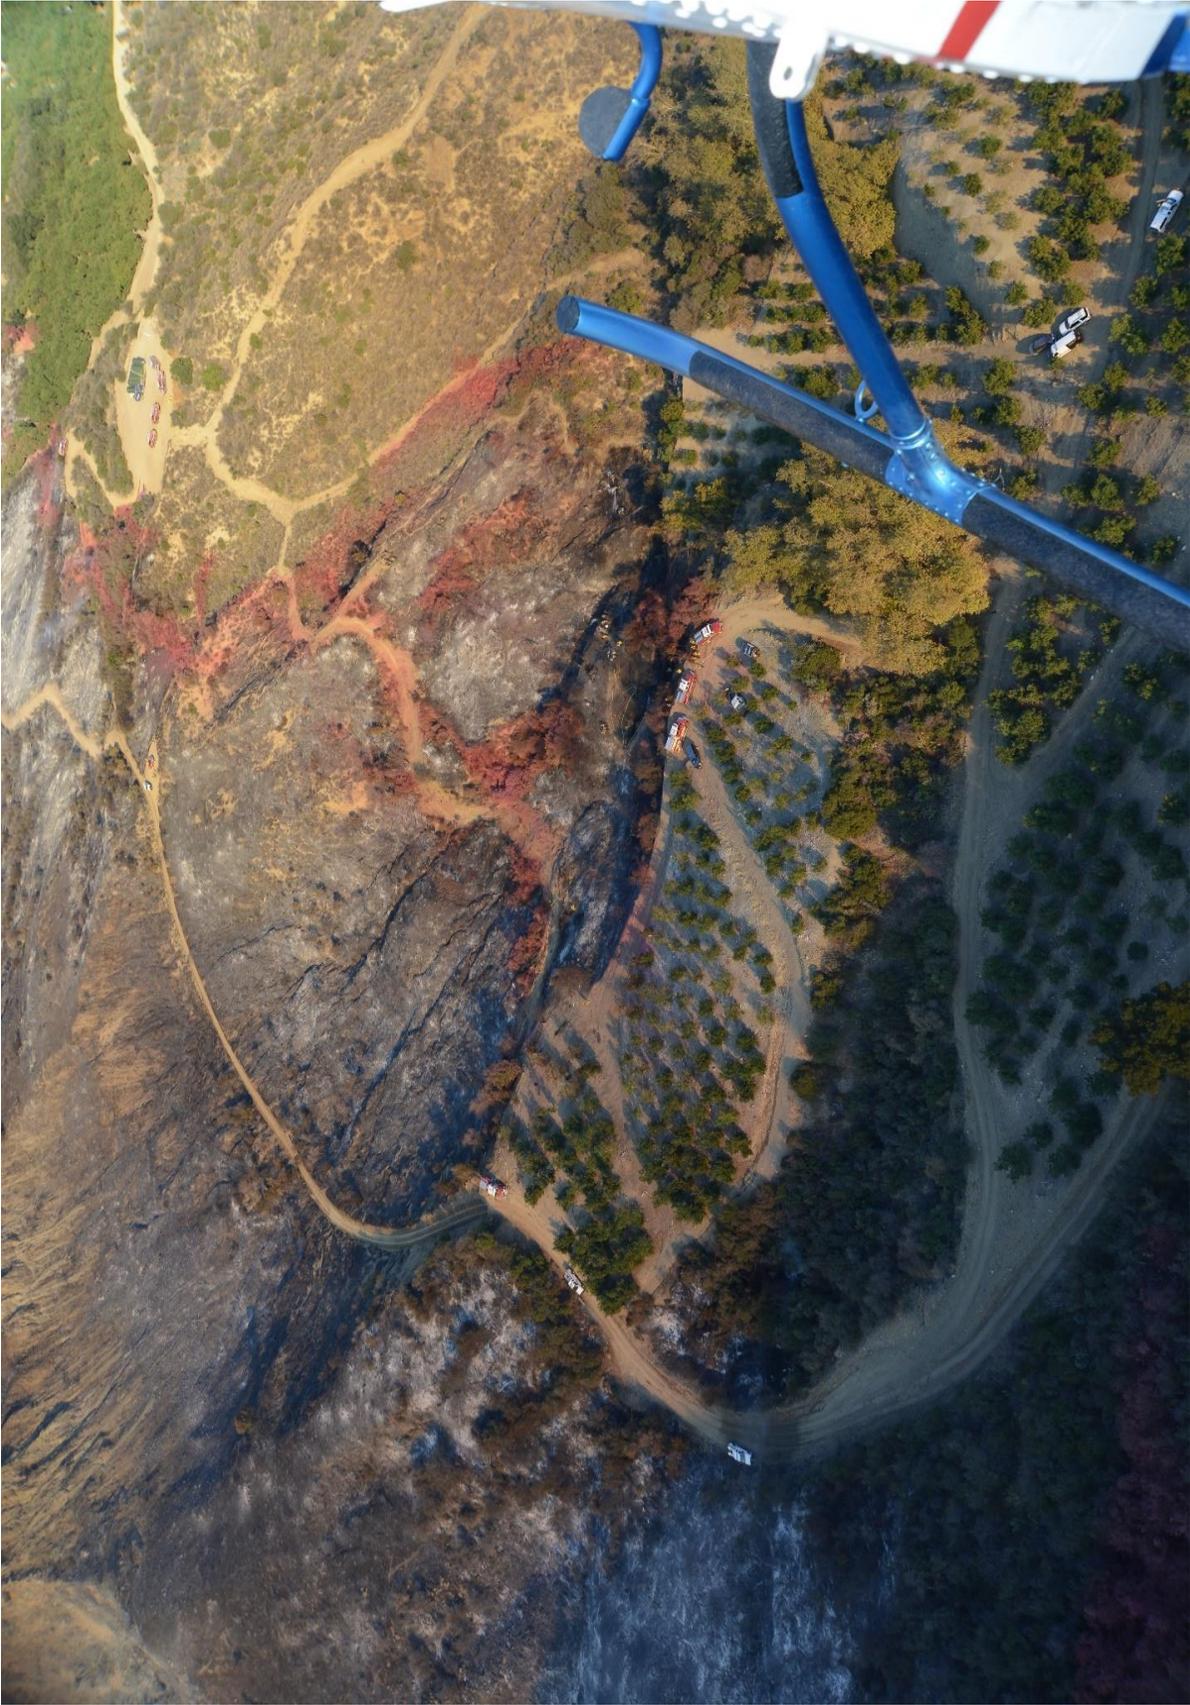
View of entrapment site looking northeast

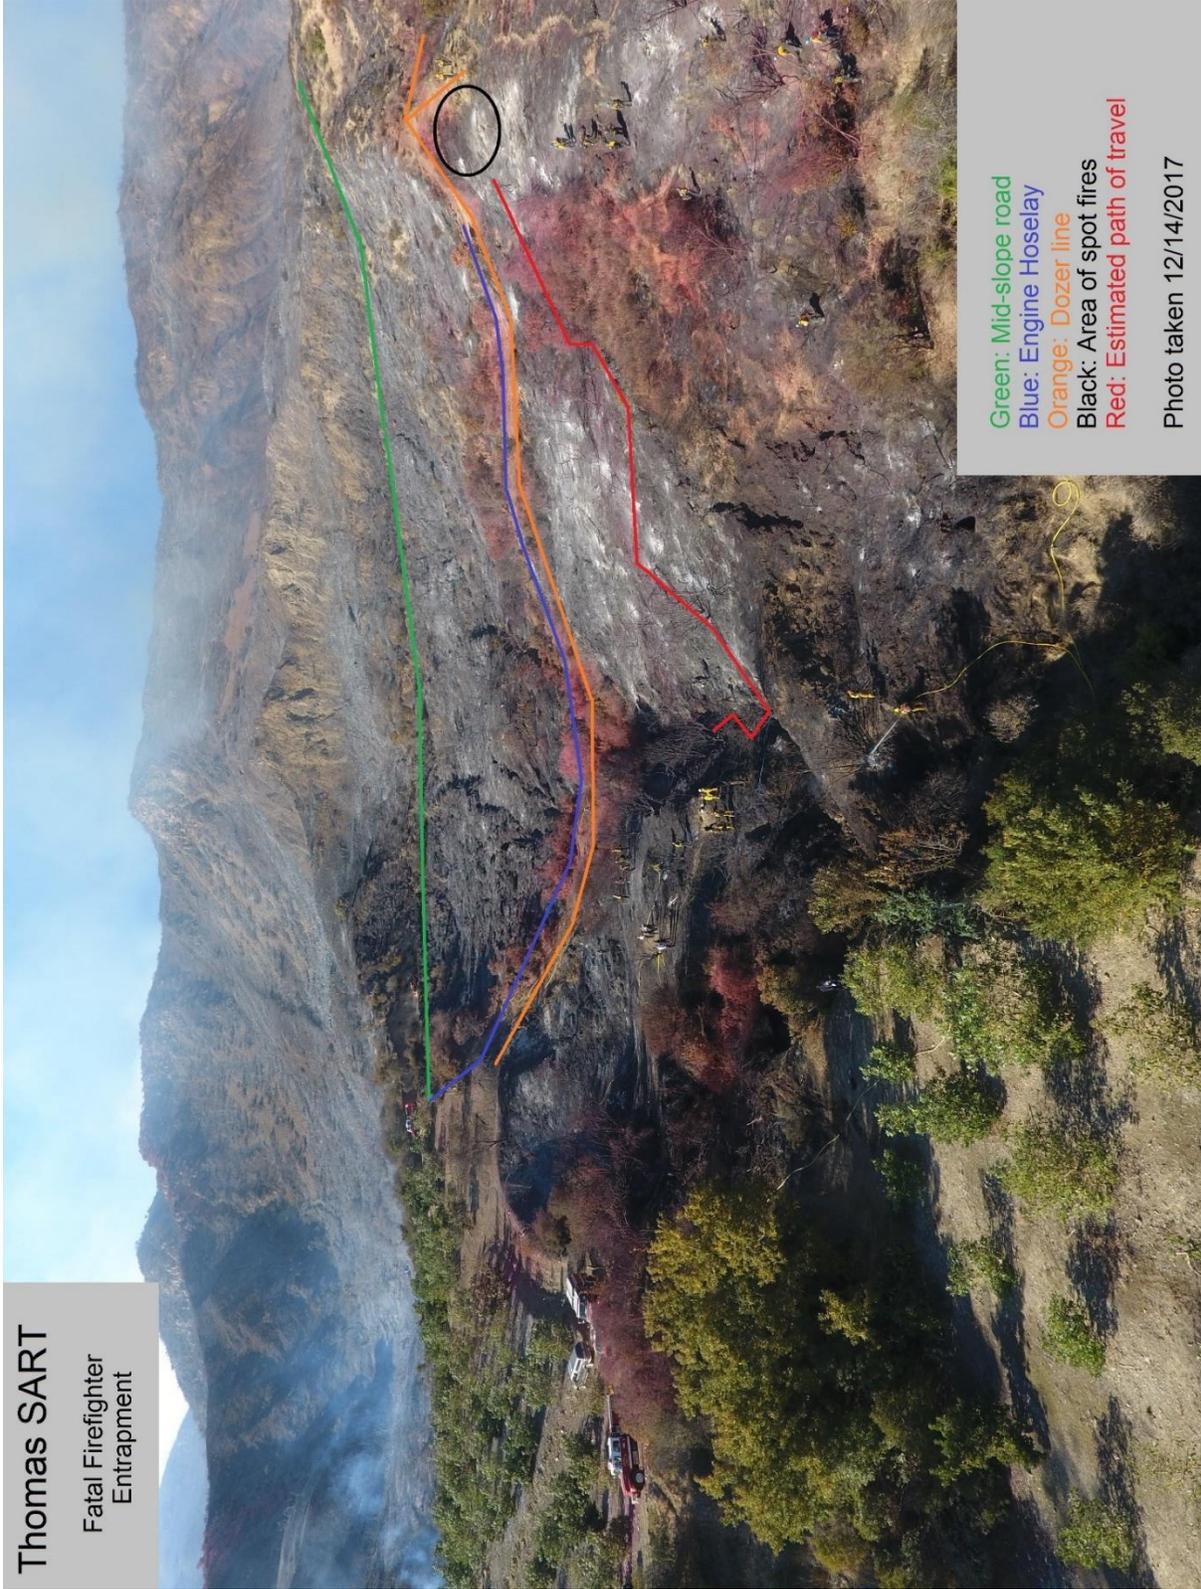
View of entrapment site looking northwest

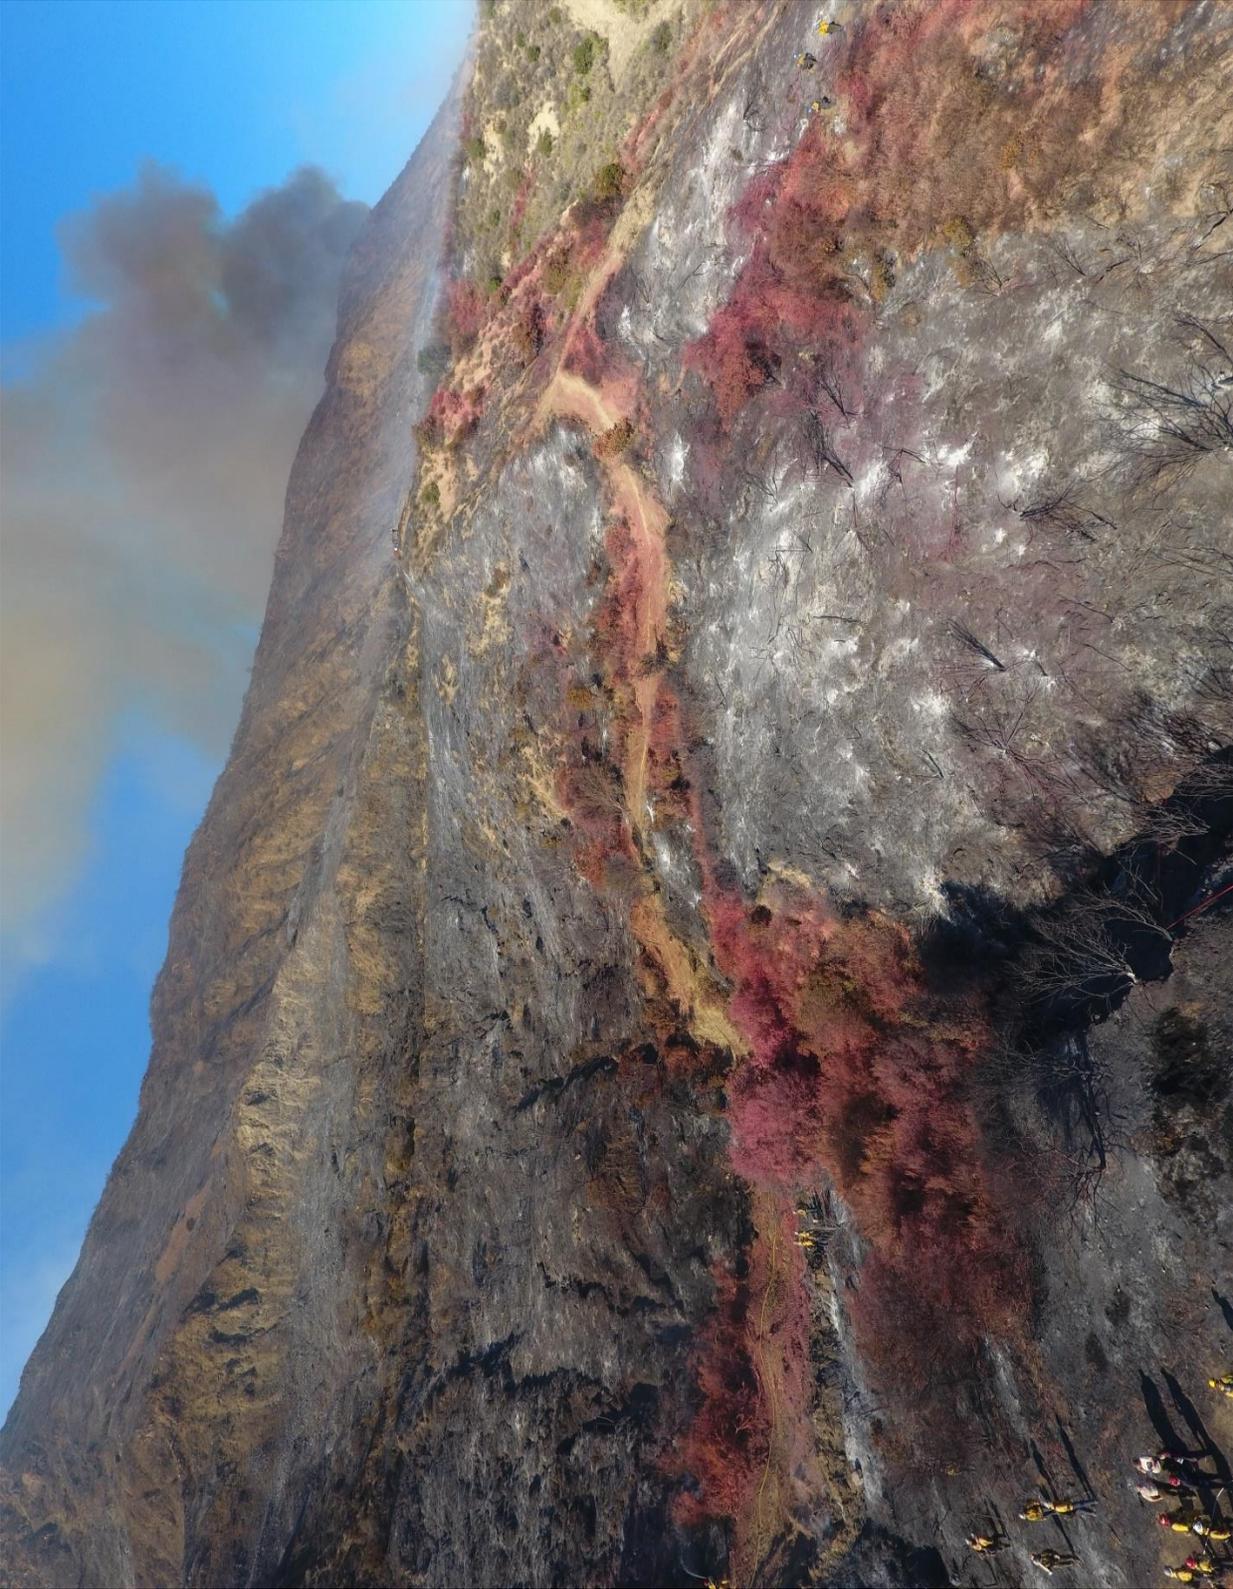
View of entrapment site looking north

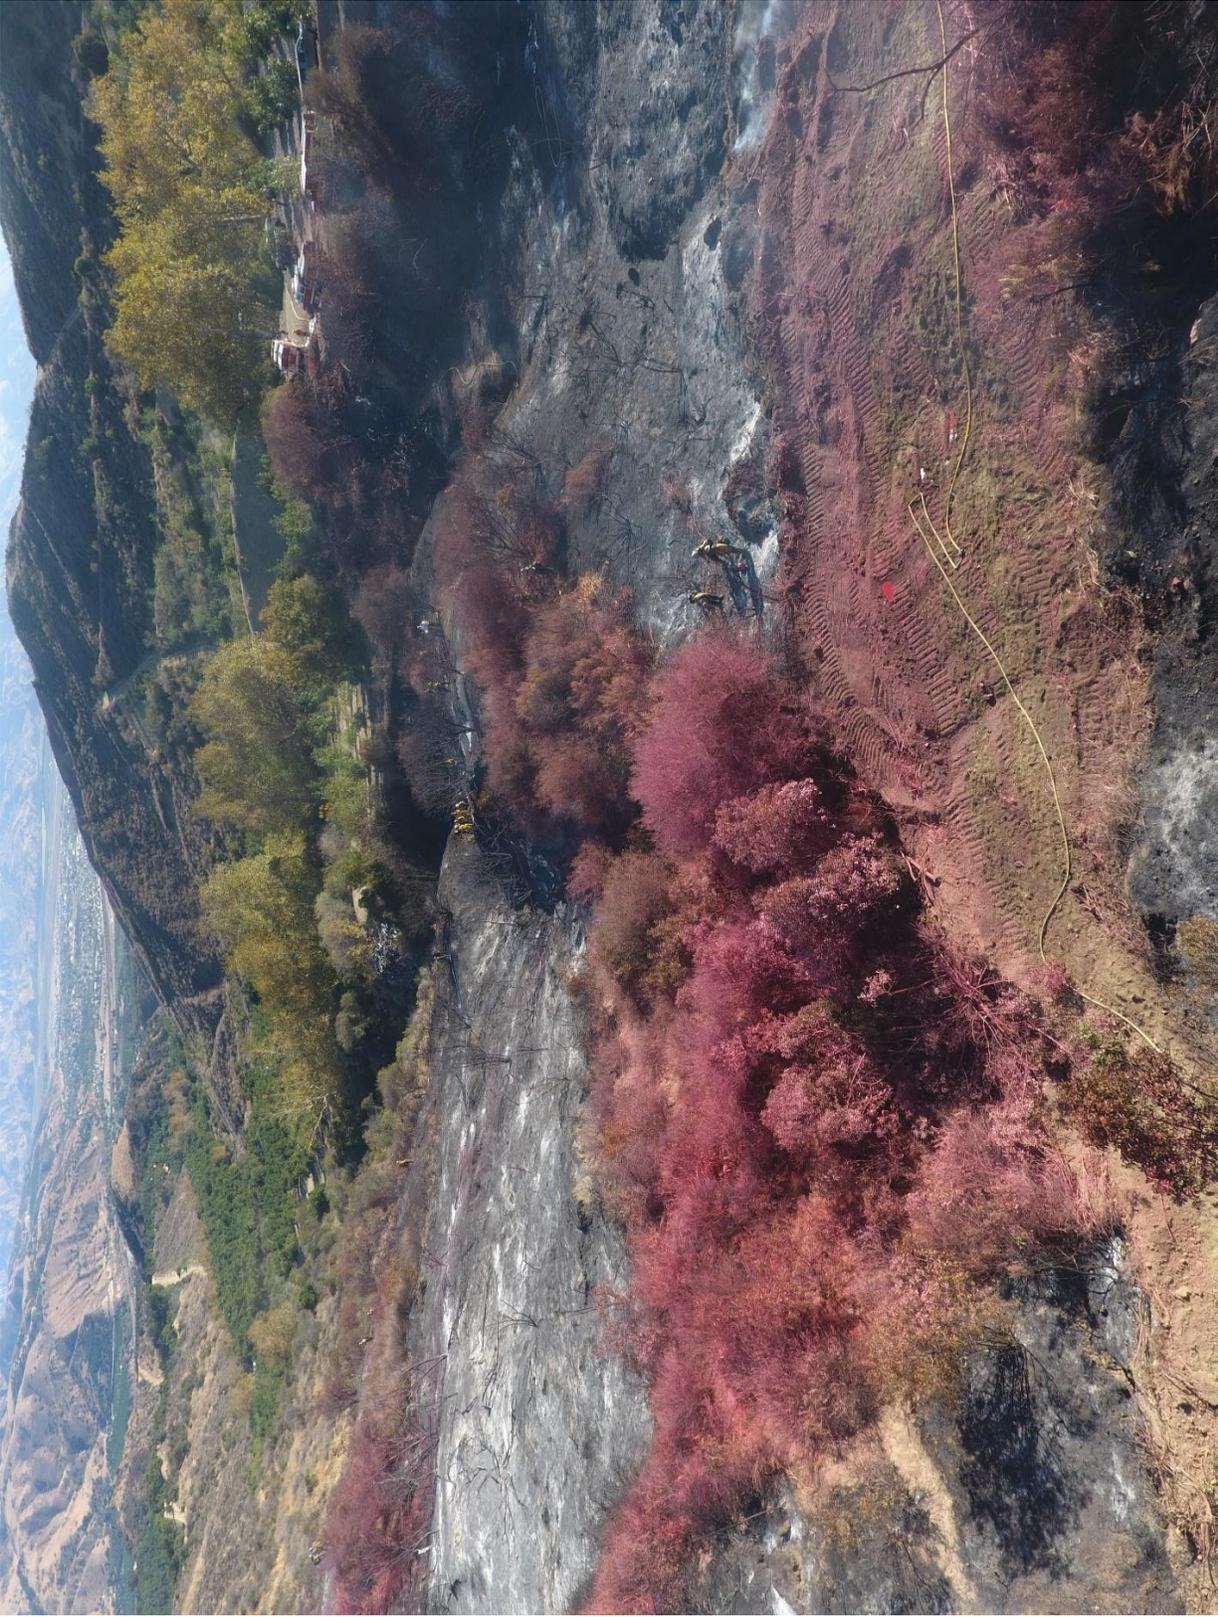
View of entrapment site looking south
