Serious Accident Investigation: Factual Report and Analysis

Fatality of NPS Arrowhead Interagency Hotshot Crew

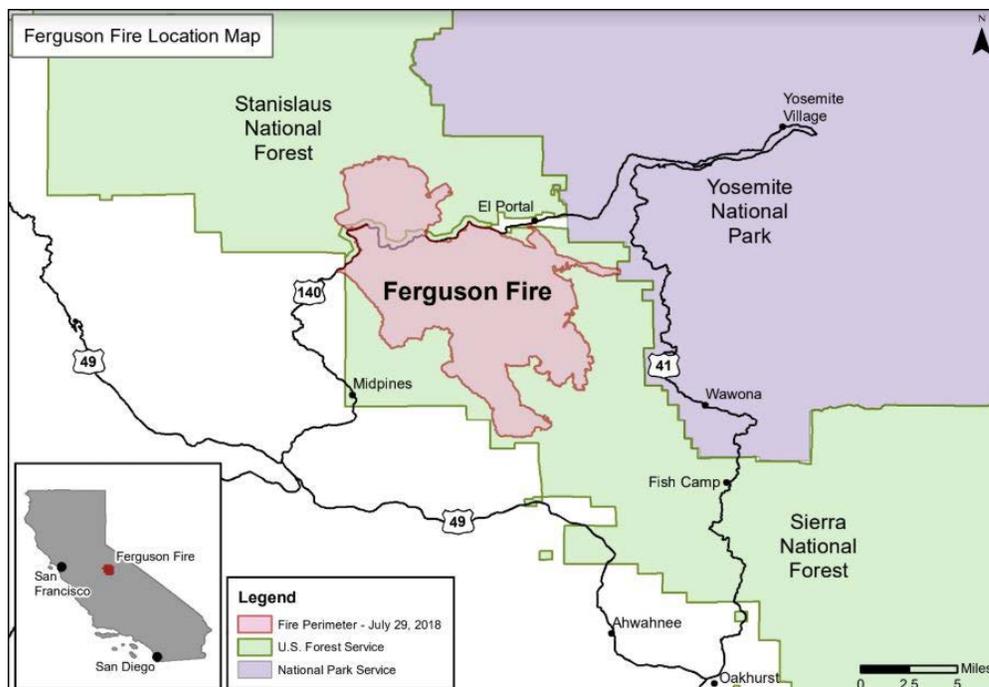
Figure 1: Map showing the general location of the Ferguson Fire on July 29, 2018 as well as the fire perimeter for that day.

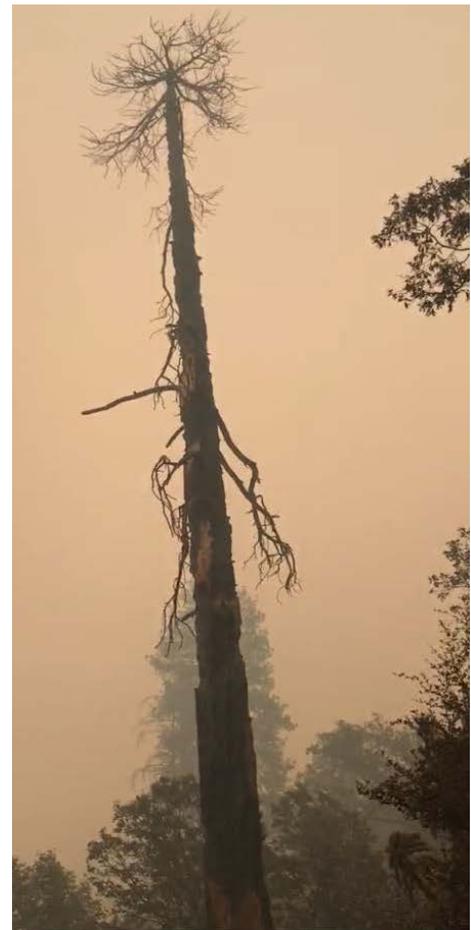
Figure 3: Photo of the ponderosa pine snag prior to falling operations.

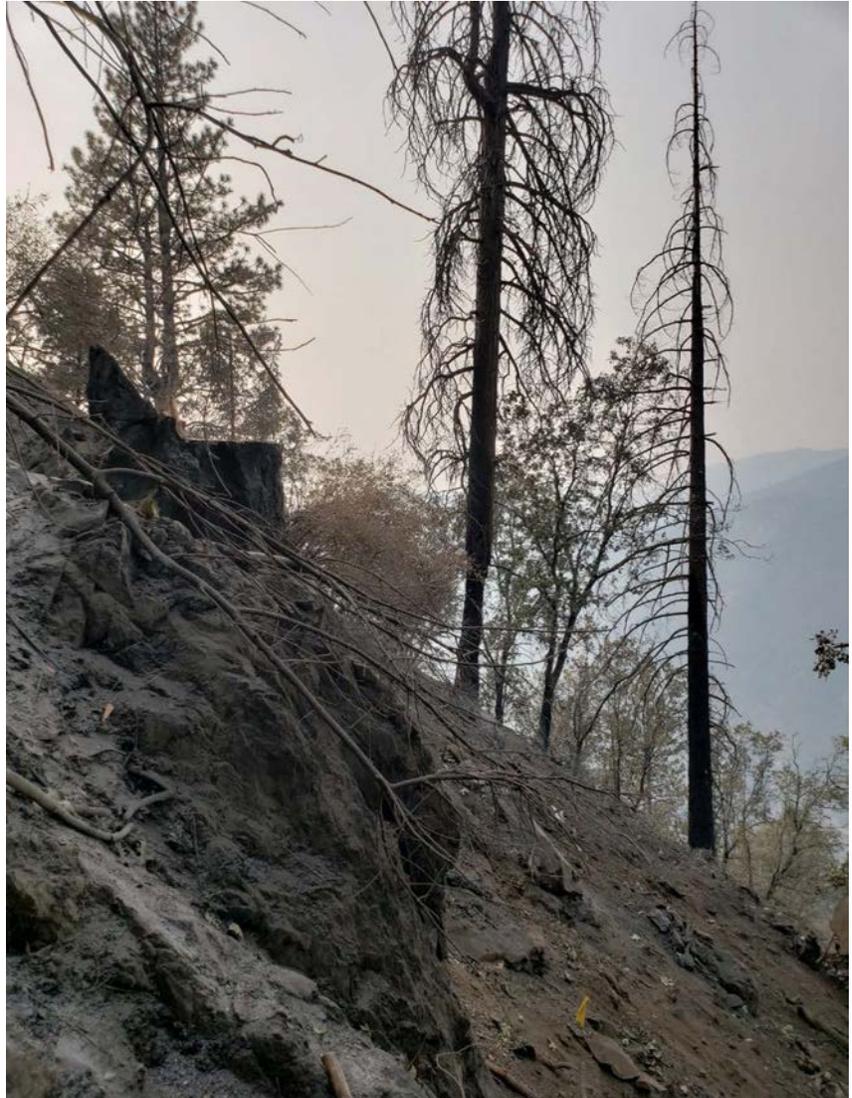
Figure 4: Cutting area showing slope and terrain. Pie wedge was re-placed on the stump

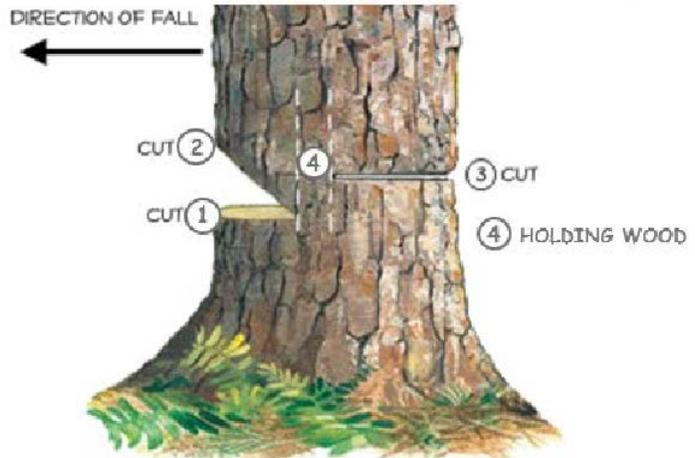
Figure 5: Illustration shows the terminology of the conventional cutting sequence, which is composed of the: 1) horizontal cut, 2) sloping cut, 3) back cut, and 4) the remaining holding wood.

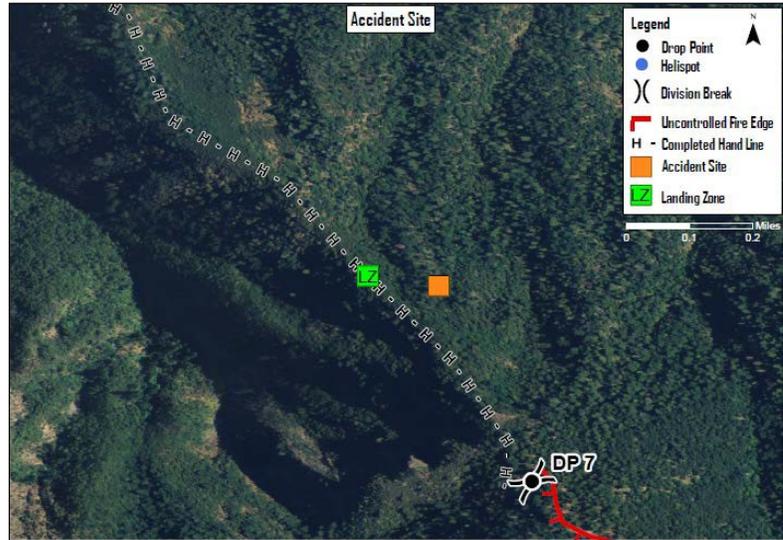
Figure 7: Map showing the location of the accident site and the helicopter landing zone.

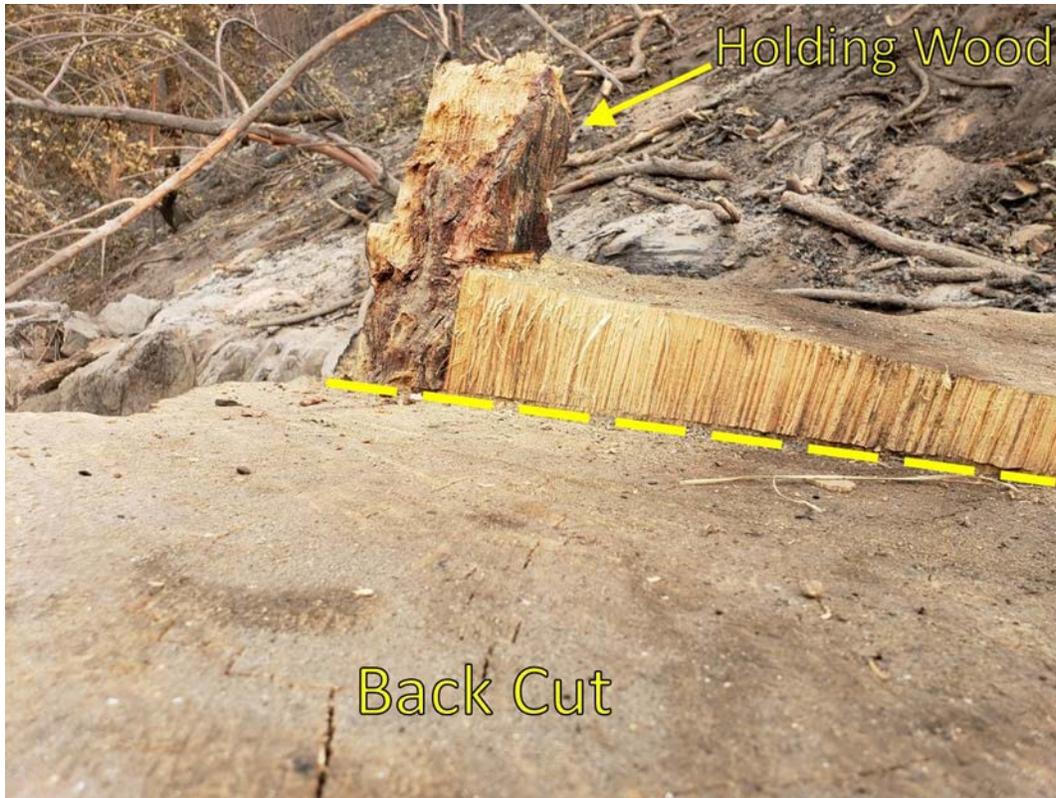
Figure 14: View of stump showing surface planes for the face and back cuts. Dashed line indicates the height difference between cuts on the offside.
