Hauser Road Engine Rollover

Facilitated Learning Analysis

On Tuesday, Sept. 12, 2017 a Type 6 Engine was involved in this a rollover accident while returning from a smoke investigation. An isolated storm had turned the clay-based road the engine was traveling on into slippery mud.

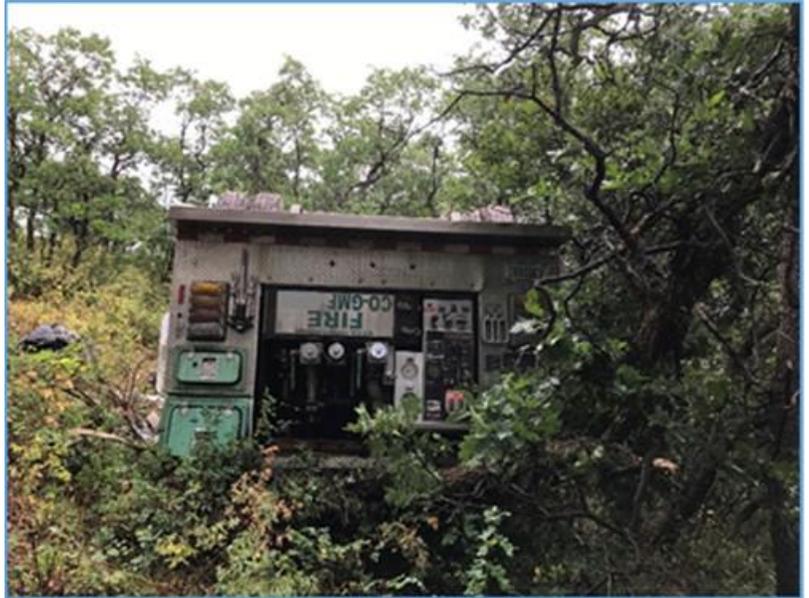
Because its compartment was pinned against the oak, the engine's trauma bag was unavailable. Fortunately, the crew carried field trauma packs in their line gear and were able to access those.

Initial evaluation showed all three to be in relatively good condition. A laceration was located on Captain 36's right elbow. Engineer 46 had some slight pain in his side and stated that he was feeling slightly nauseated. Engineer 46 had been riding in the back seat. Because of his 6-foot 2-inch height, he had been riding sideways for comfort.

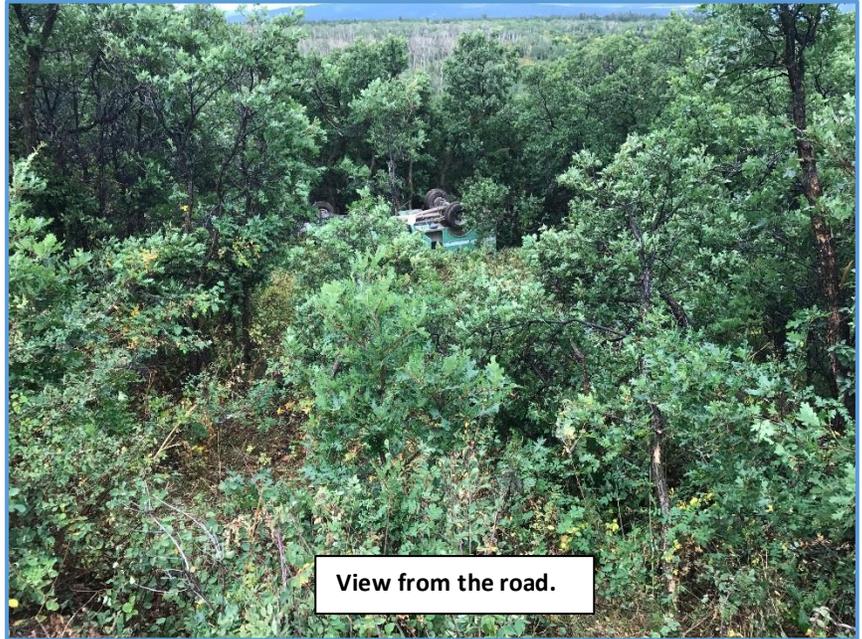
- ✓ **Equipment (Engine) Standardization 2011 National Specifications** – Require a Rear Cab Protection Rack (headache rack), Supplemental Restraint System (side curtain airbags), as well as all safety features available to the vehicle from the manufacturer. In addition to seatbelts being worn, these features led to a successful outcome of minor injuries to those involved in this rollover.

- ✓ **Field Trauma Kits** – While fortunately not needed, the crew had access to small trauma packs carried in their line gear. The main trauma bag was unavailable due to the compartment being pinned against the oak brush. However, if needed, the crew had backup trauma gear available.

- ✓ **Notifications/Communications** – The established emergency “phone tree” notification process operated efficiently. Cell phone reception was available in this location and was utilized due to the vehicle radio being damaged and the handheld radios not being able to hit a repeater.
