Informational Summary Report of Serious or Near Serious CAL FIRE Injuries, Illnesses and Accidents

GREEN SHEET

Burn Over Fatalities

Carr Incident

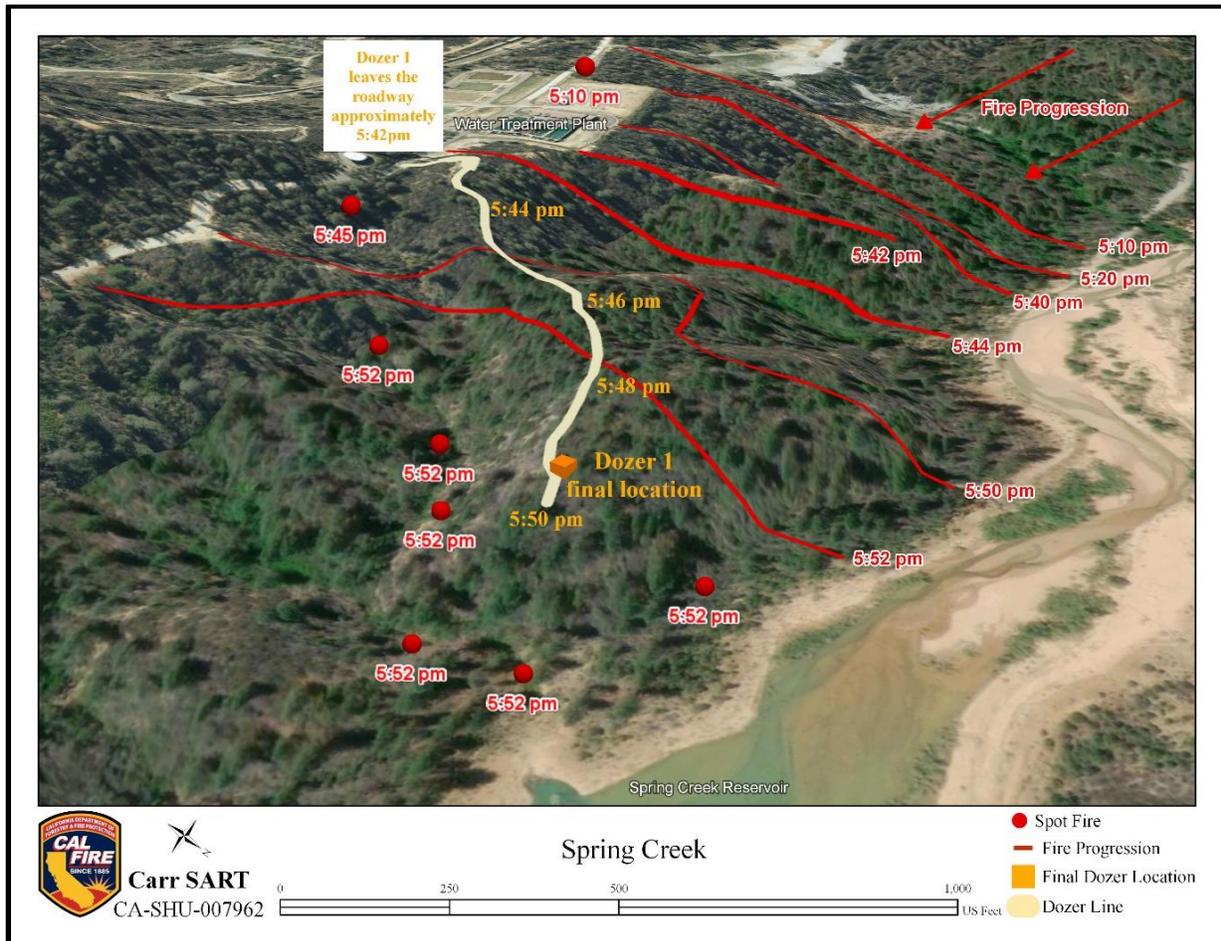
Aerial overview sequencing approximate timelines of events.

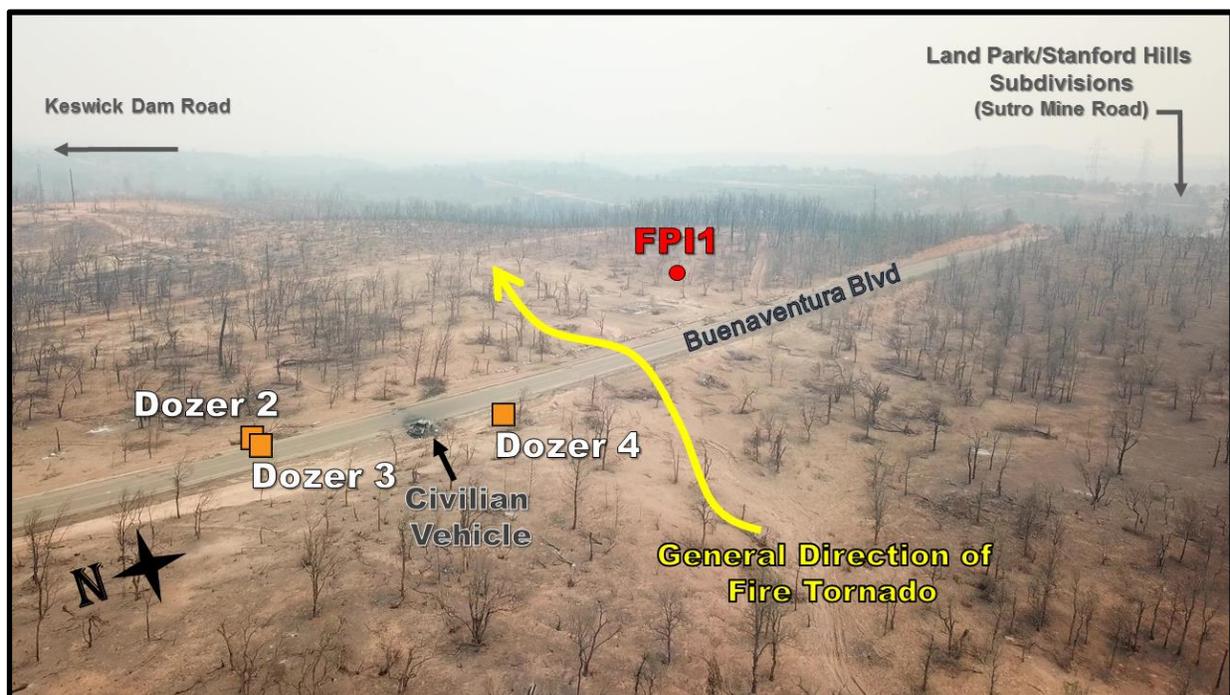
Buenaventura Incident overview depicting general location of resources following passage of fire front and fire tornado.
