Eicks Fire Smokejumper Fatality

Learning Review – Technical Report

Spring 2022

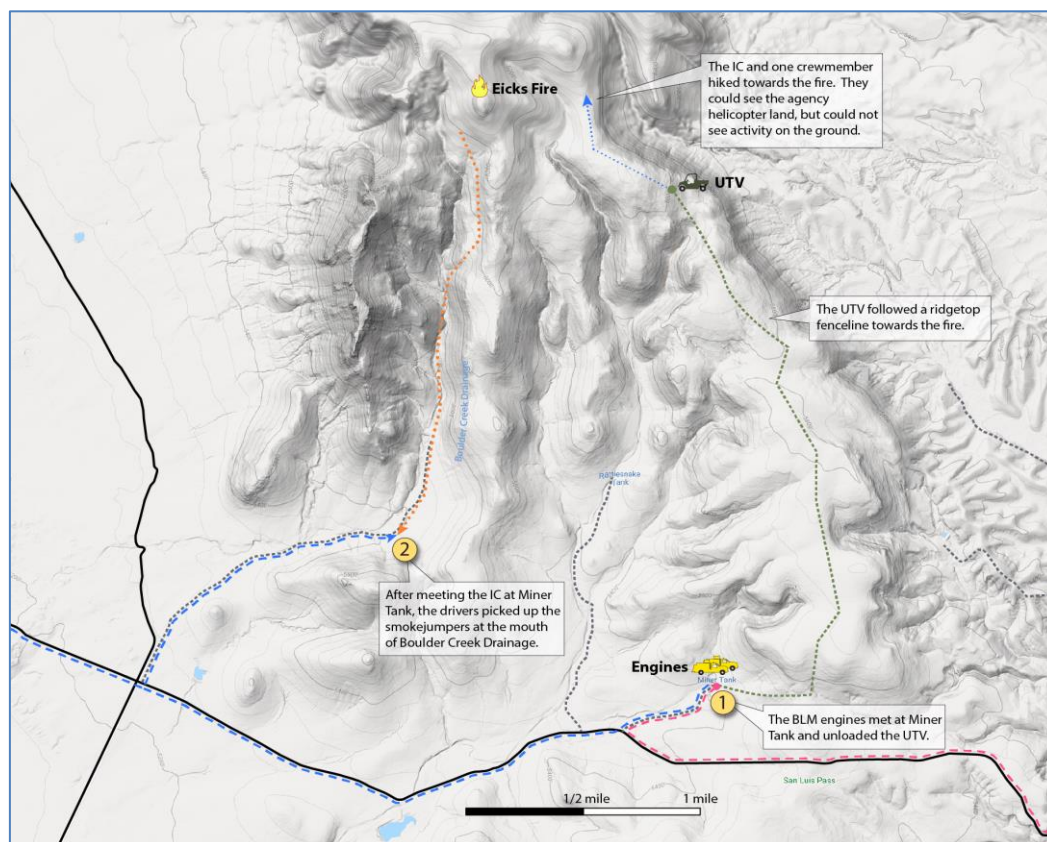
Figure 7. The Engine Crews worked their way into the fire from Miner Tank, and the Smokejumper chase vehicles picked up the Smokejumperers at the bottom of the Boulder Creek Drainage.

Engine E-2 finally arrived on the ranch at 1543. The two Engines met at Miner Tank, on the north side of San Luis Pass Road, about 3 miles southwest of the fire (see Figure 7). Once they parked, Captain E-2, the IC, and two crewmembers loaded into the UTV to find better access. The remaining crew members stayed with the vehicles to assure they were secure, a standard precaution this close to the border. The UTV worked its way in, navigating “boulders the size of trash dumpsters.” They picked a rough path on the top of a ridge, following one of the ranch’s fence lines. Once on top, they continued the slow trek towards the black. When they arrived, they estimated the fire to be 30 to 50 acres, 60 percent active, and primarily backing. They could see jump operations taking place at the fire’s south end.

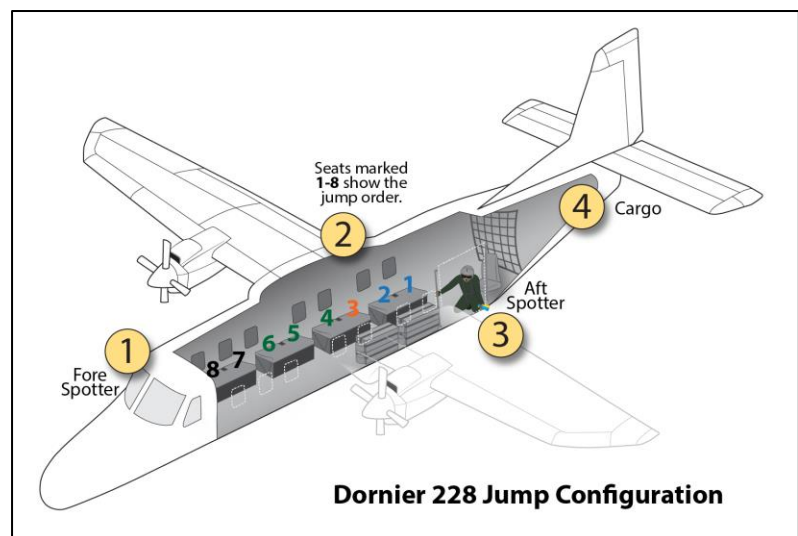
Figure 10. This interior diagram of the Jump Plane shows Jumper positions prior to their jumps.

Tim was the sixth of eight Smokejumpers on the plane, the third in a stick of three Smokejumpers. While only portions of his flight were witnessed, it can be stated with confidence that the last 5 to 8 seconds of Tim's flight was in excess of 400 yards²⁸ to the right (south) of the windline.²⁹ The flight's final portion was over identified ground hazards in an area down drainage from the intended jumpspot. The base leg was parallel to the main ridge, flying up drainage. After his canopy turned, his final leg initially flew downslope, but in the final two seconds there was a slope reversal as he crossed the bottom of the drainage. During

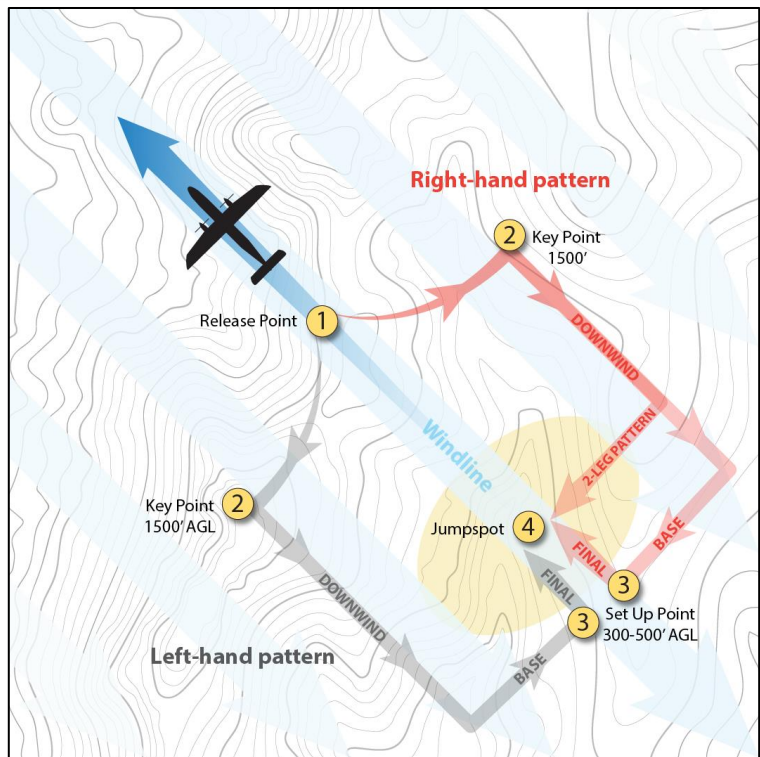
Figure 11. This windline diagram demonstrates left- and right-hand patterns.

Patterns are flown to get jumpers into a jumpspot in an organized, predictable, and safe manner (see Figure 11). The pattern legs on a standard pattern—downwind, base, and final—follow traffic patterns aircraft use for landing. Arriving to an acceptable “set-up point” (start of the final) is considered by many to be the most critical in having an accurate and safe jump. Parachute pilots must arrive to a set-up with sufficient altitude to make adjustments on their final descent while “minimizing flight over hazards (RATG, 2021, p. 120). Parachute pilots decide whether to do a left-vs. a right-hand pattern. When jumping into terrain with the intention of landing on a hillside or a ridge (or even if the shape of the spot dictates), the pattern needs to be adjusted so pilots are not exposing themselves to leeside turbulence or slope soaring⁴¹ down a hill. In these cases, parachute pilots will try to set up on a contour or along the ridge and fly to the desired spot while making adjustments for changes in wind direction and velocity. Often referred to as a “base to final” or a “2-leg pattern,” the set-up and final leg remain the most important part of the descent, and in order to get to an appropriate set-up, parachute pilots need to position themselves by adjusting for wind conditions and flying to that set-up point.
