# Engine Rollover Lessons Learned Review

Fawn Fire  
Northwest Colorado District, White River Field Office

July 2018

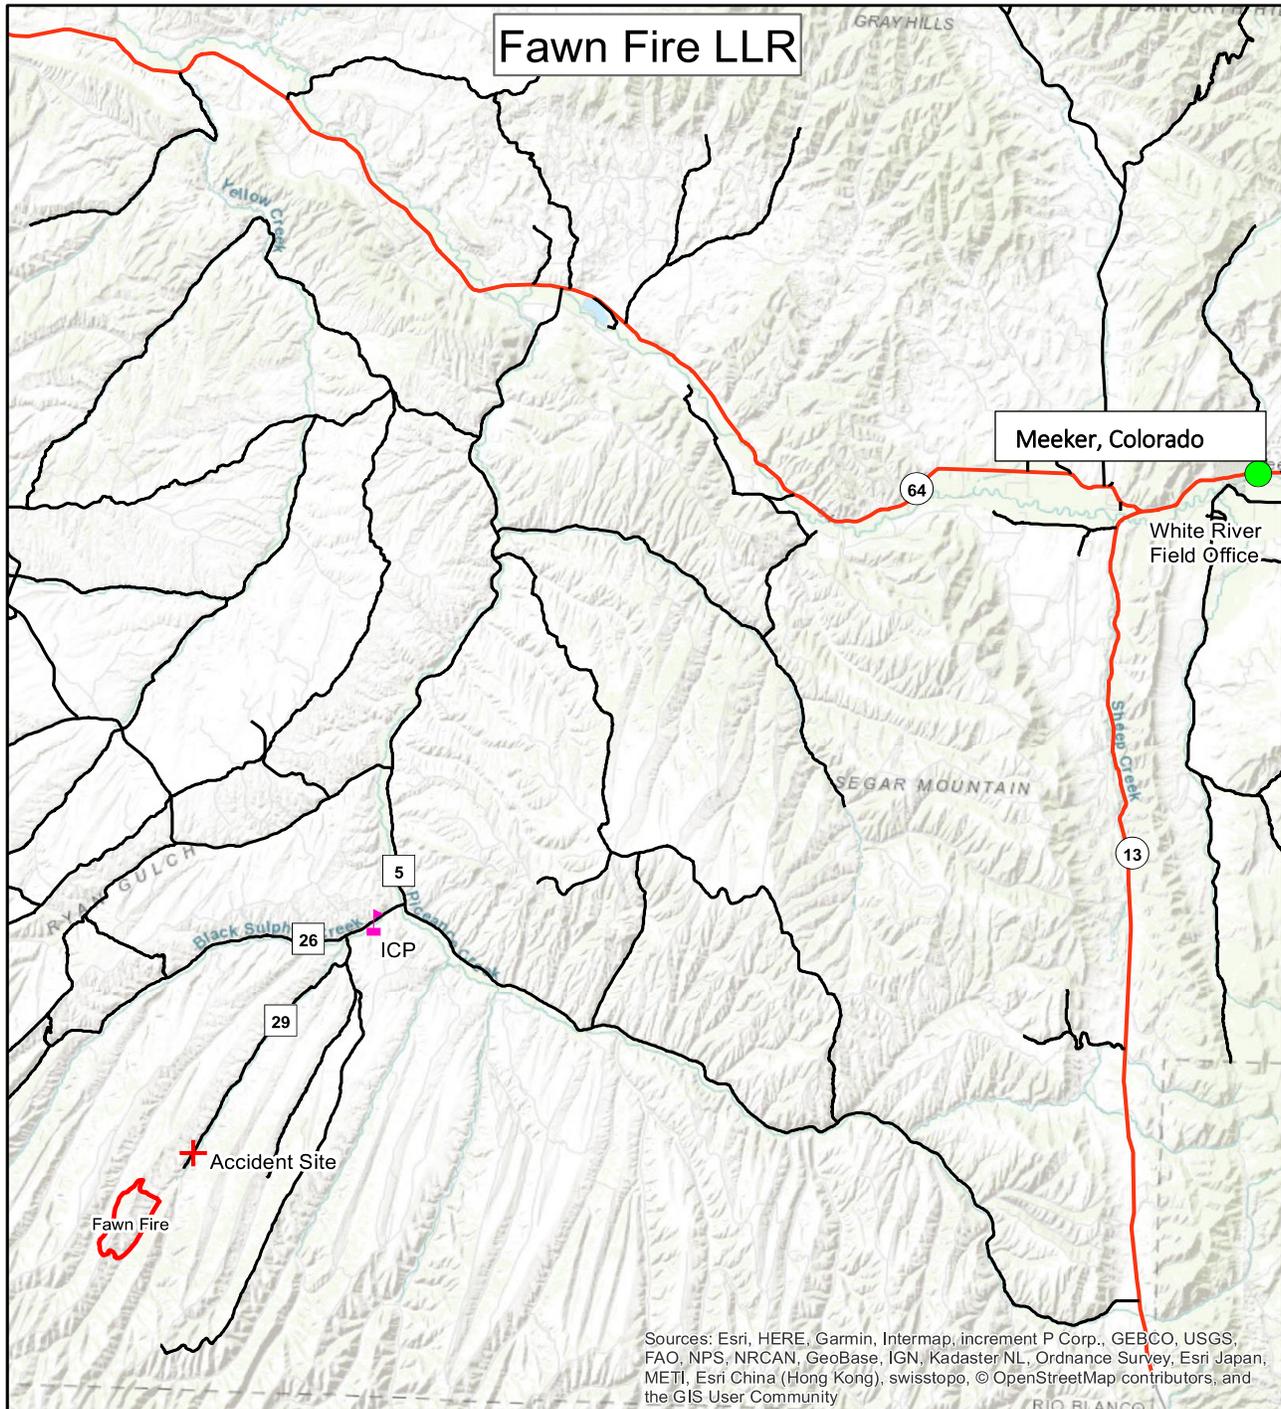
Map 1

Accident Site

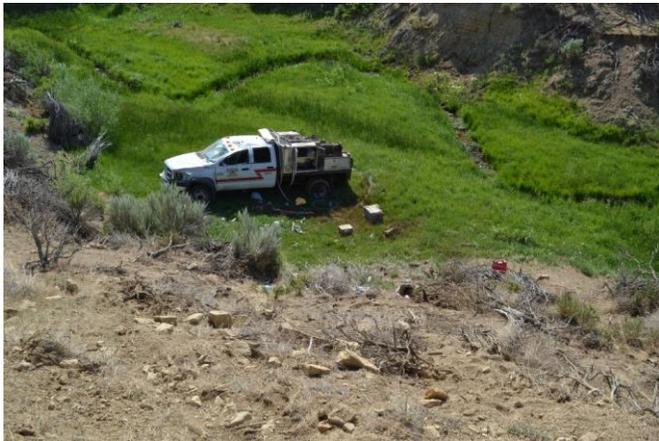
Approximately one-half mile from where the dozer line ends country road 29 begins, the engine operator mentioned that the visibility quickly went from “tough to see” to “can’t see at all” as the dust from the road obscured virtually all visibility in front of the engine. As the engine operator slowed the engine down, Engine 1’s passenger side front wheel traveled off the edge of the road, and the engine departed the roadway, and rolled 75 feet, coming to rest on its wheels at the bottom of the hill.

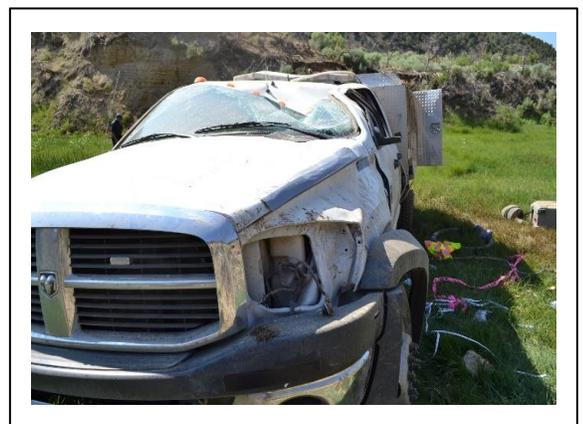
The crew of Engine 2 chase was the first to arrive on the scene of the accident with the TFLD arriving shortly thereafter. There was some difficulty locating Engine 1 due to the darkness and Engine 1’s resting position below the road. The damage to the cab of the engine was extensive, especially on the driver’s side.
