# Informational Summary Report of Serious or Near Serious CAL FIRE Injuries, Illnesses and Accidents

# GREEN SHEET

## Fire Shelter Deployment

Kincade

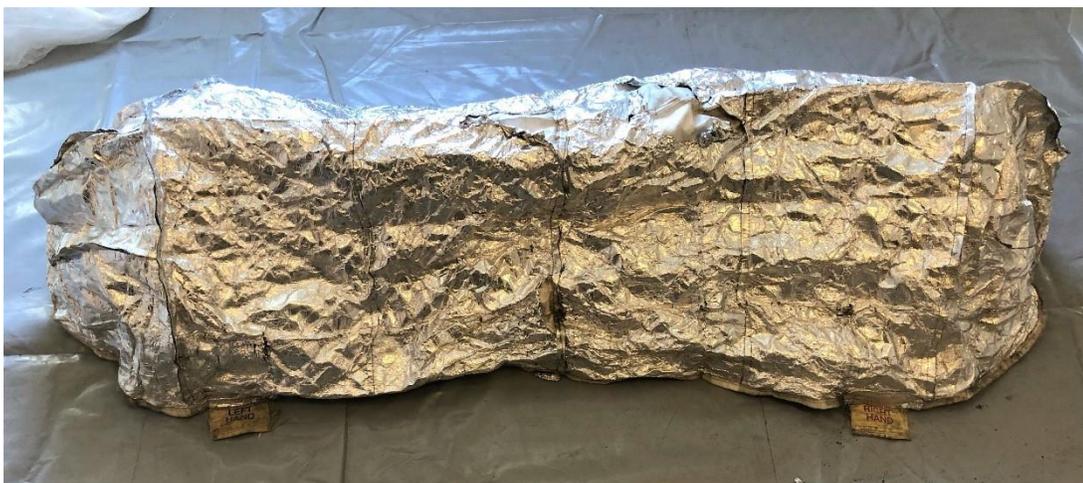
- Shelter Deployment Site – The two-track road and dozer line was an area cleared of surface fuels. It appears that the small burnout done by DIVS1 provided a shelter deployment site that did not receive direct flame contact – important for a successful shelter deployment. The site was mainly exposed to radiant heat energy.

- Having three people, DIVS1 and two civilians, inside the shelter coupled with moving locations and DIVS1 leaving and reentering the shelter, likely increased the amount of structural damage to the shelter – although a successful deployment.
