Collision with terrain involving Lockheed Martin EC-130Q, N134CG

50 km north-east of Cooma-Snowy Mountains Airport (near Peak View), New South Wales, on 23 January 2020

ATSB Transport Safety Report

AO-2020-007

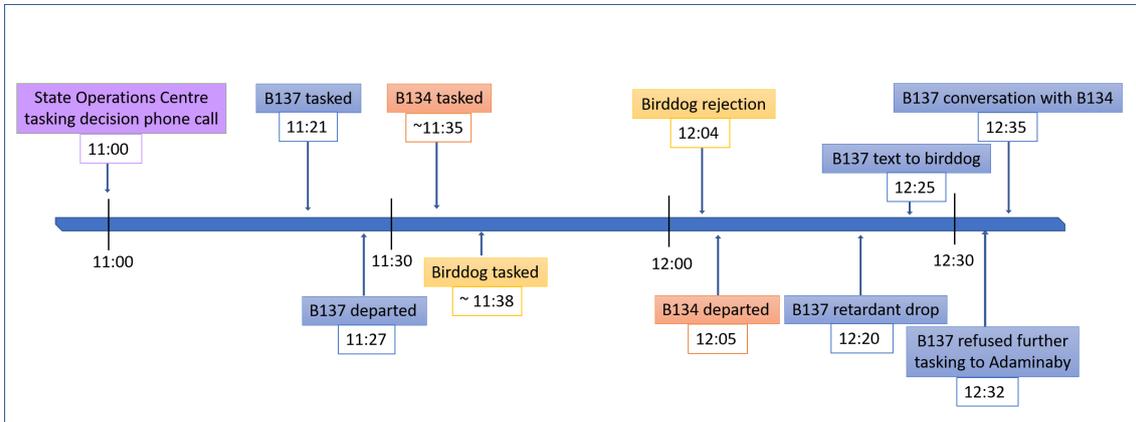
Figure 1: Timeline of tasking communications

Figure 1 provides a timeline of the key communications regarding tasking allocation for B134, B137 and the birddog.

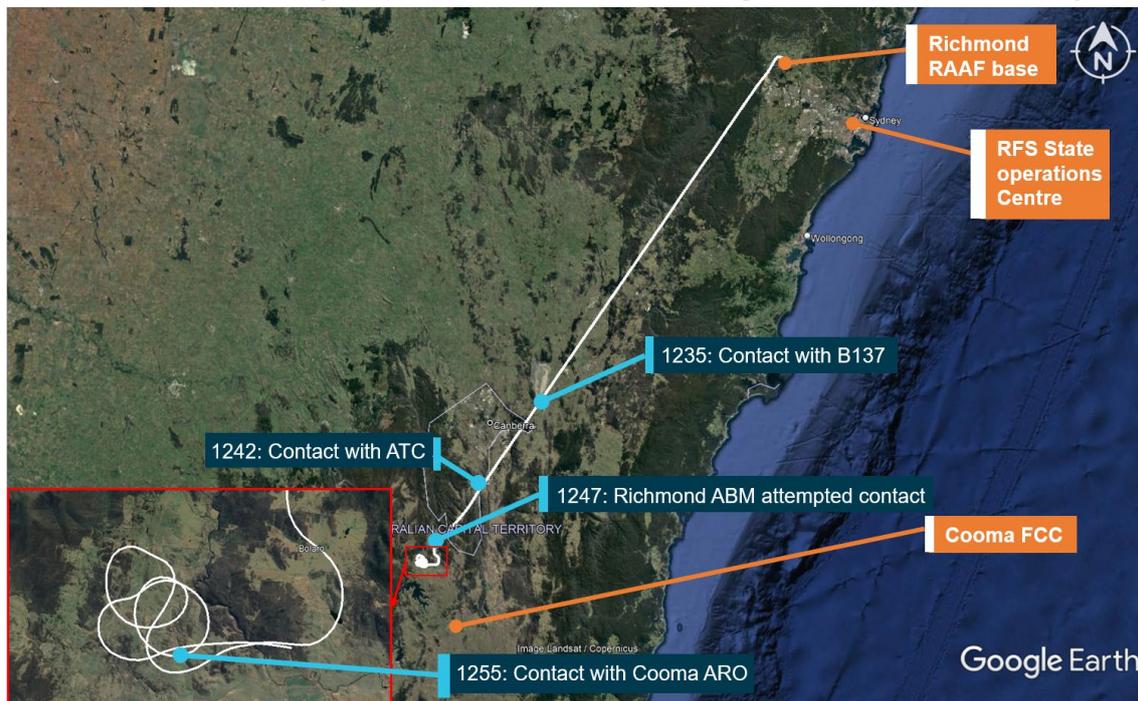
Figure 2: Flight track of B134 (white line), timing and location of external communications, and key locations, with an inset detailing the circuits at Adaminaby

The automatic dependent surveillance broadcast (ADS-B) data showed that, after arriving at the Adaminaby fire-ground at about 1251, the crew of B134 completed several circuits at about 2,000 ft AGL.²⁶ At about 1255, the crew advised the Cooma ARO that it was too smoky and windy to complete a retardant drop at that location. The Cooma ARO then provided the crew with the approximate coordinates of the Good Good fire, about 58 km to the east of Adaminaby. The ARO further indicated that they had no specific requirements, but they could look for targets of opportunity, with the objective of conducting structure and property protection near Peak View.

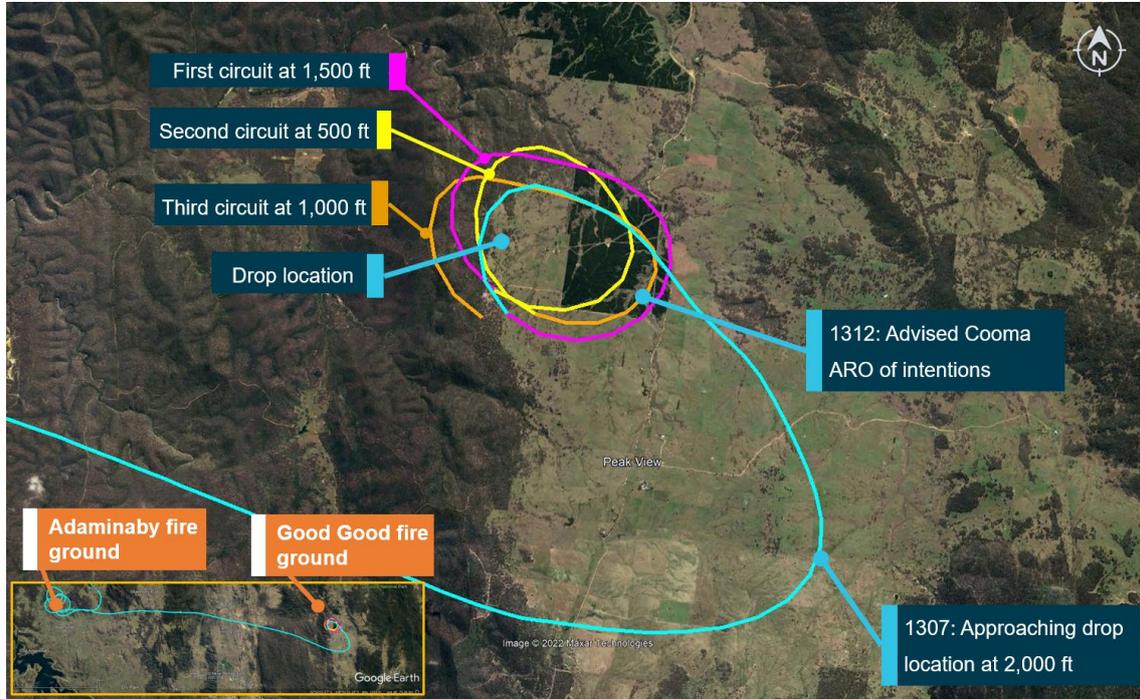
Figure 3: B134’s approach and circuits overhead the drop location; the inset shows the track from the Adaminaby to the Good Good fire-ground

At about 1307, B134 arrived overhead the drop area (Figure 3). The drop area was located to the east of a ridgeline, with the fire on the western side of the ridgeline. The aircraft’s recorded track data (SkyTrac) showed that the crew conducted 3 left circuits, at about 1,500 ft, 500 ft and 1,000 ft AGL respectively, prior to commencing the drop circuit (Figure 4). At about 1312, after conducting

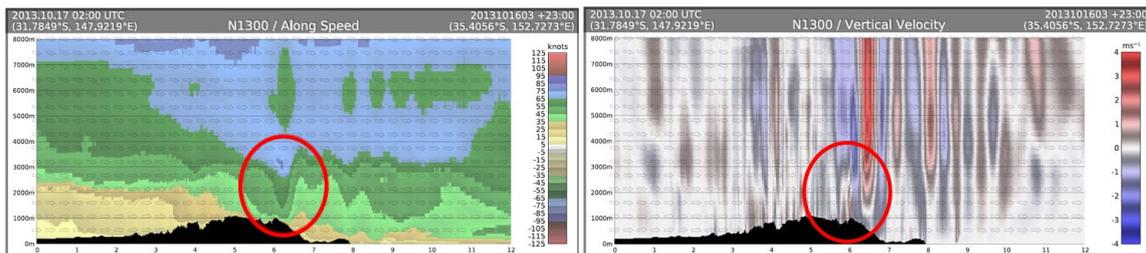
Figure 7: North-west to south-east cross section of fire, illustrating horizontal (left image) and vertical (right image) wind speed changes, with the fire located near the number 6 on the horizontal axis

Figure 7 shows a cross-section of the horizontal wind speeds (left image) and vertical wind speeds (right image) along a section passing from the north-west to the south-east through the State Mine fire-ground. The red circled region in the left image shows strong horizontal winds extending downwards towards the surface in the vicinity of the fire. Downwind (to the right) of the fire are oscillations (left image) in the wind speeds and alternating bands of ascending and descending air (right image), both of which are characteristic features of mountain waves. The note described mountain waves as:

While the purpose of the note was to consider the wind effect on the severity of a fire, this has potential implications for firefighting aircraft, particularly if low-level windshear was present. As a comparison, at position 1 on the horizontal axis (left image), the wind speed band of 45–55 kt would not be encountered until reaching a height greater than 8,000 ft (2,450 m) above the surface. However, at the fire-ground at position 6, these wind speeds could be encountered within a few hundred feet above the surface. The note also highlighted that this research revealed

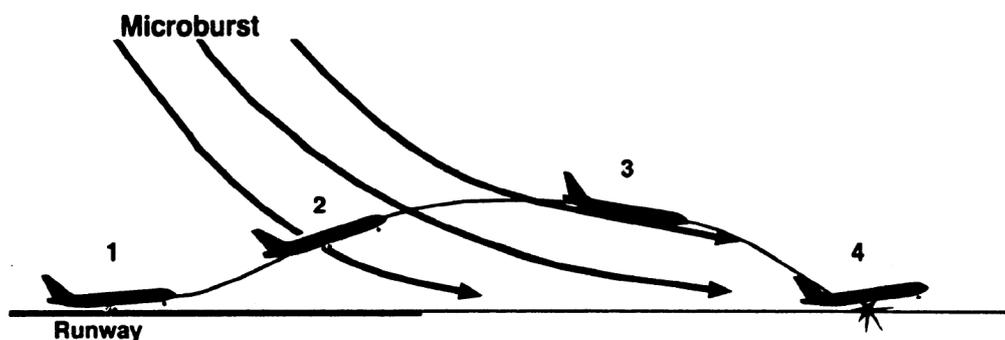
Figure 8: Effect of a windshear encounter on the aircraft flight path during take-off

Generally, the research showed that only 5 to 15 seconds may be available for the crew to recognise and respond to a windshear encounter. In describing a typical encounter shortly after take-off, with windshear encountered prior to a stabilised climb (Figure 8), for the first 5 seconds

the take-off appeared normal, with early trends in airspeed, pitch attitude, vertical speed and altitude appearing normal. However, as airspeed decreased, pitch attitude was reduced, limiting performance capability, and resulting in a loss of altitude.
