**Preliminary Summary Report of Serious or Near Serious
CAL FIRE Injuries, Illnesses and Accidents**

GREEN SHEET

Fatality Firefighter Entrapment

Thomas Fire

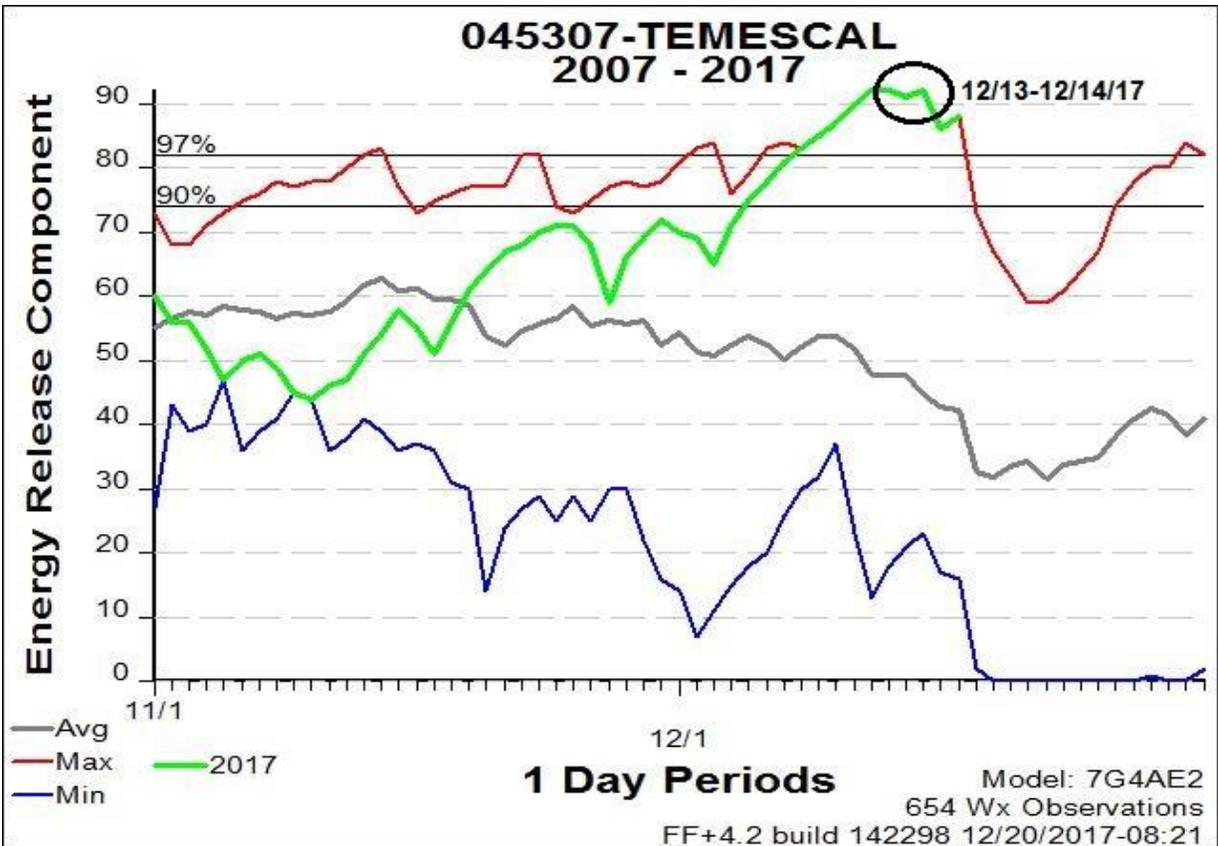
Fuel Model 4 made up the predominant vegetation. Live fuel moistures collected in the area between November 15, 2017 and December 15, 2017, showed a 7% drop to 53%, well below the critical stage of 60%.

The Energy Release Component was also at historical levels. On the day of the entrapment, the levels had reached a 10-year high of 92.
